# Investigation Report

Type of Occurrence:	Accident
Date:	29 June 2013
Location:	Eberswalde-Finow Airfield
Aircraft:	Airplane
Manufacturer / Model:	Moravan n.p. Otrokovice Czechoslovakia / Z 526 AFS-V
Injuries to Persons:	One person fatally injured
Damage:	Aircraft destroyed
Other Damage:	Photovoltaic equipment
Information Source:	Investigation by BFU external experts for field investigation
State File Number:	BFU CX008-13

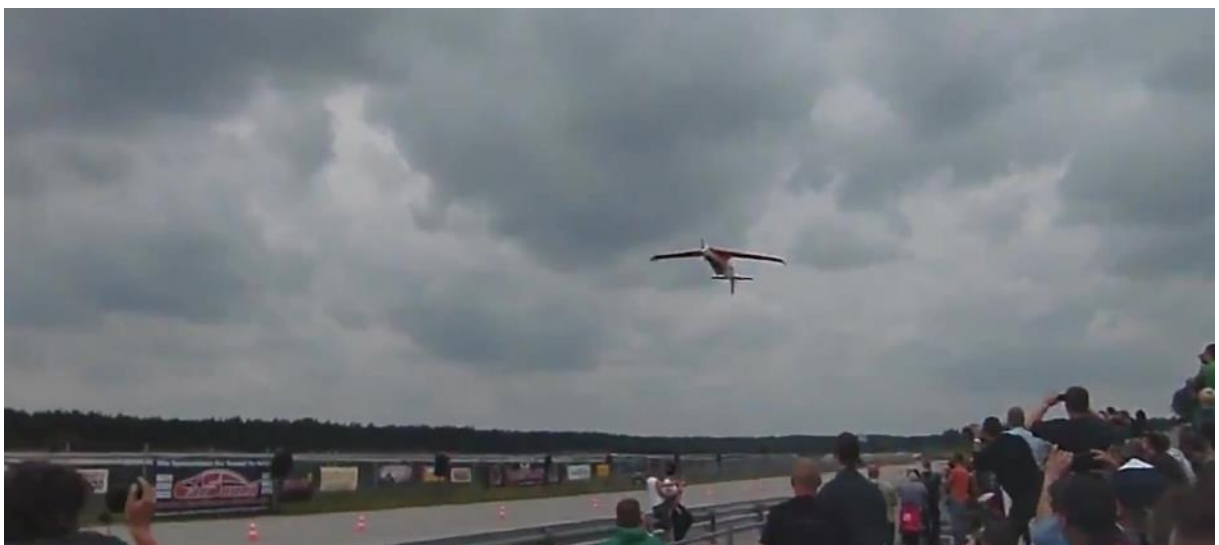
- 2:04 min.: The pilot flew westbound and then a stall turn to the right, followed by a Cuban eight.
- 01:30 min.: West of the audience stand he conducted a stall turn to the right.
- 01:10 min.: After a low pass along the audience he conducted another stall turn to the right east of the stand.
- 00:53 min.: Back on a western heading, he flew two slow rolls thereby passing the audience.
- 00:45 min.: Finishing the roll he headed south.
- 00:32 min.: In a wide turn to the right the pilot flew toward the audience stand once more coming from the west and thereby rolling the aircraft up-side down.
- 00:13 min.: He flew up-side down passing the audience heading east. The estimated height was approximately 20 to 50 m at a lateral distance of approximately 20 m.

Pass along the audience

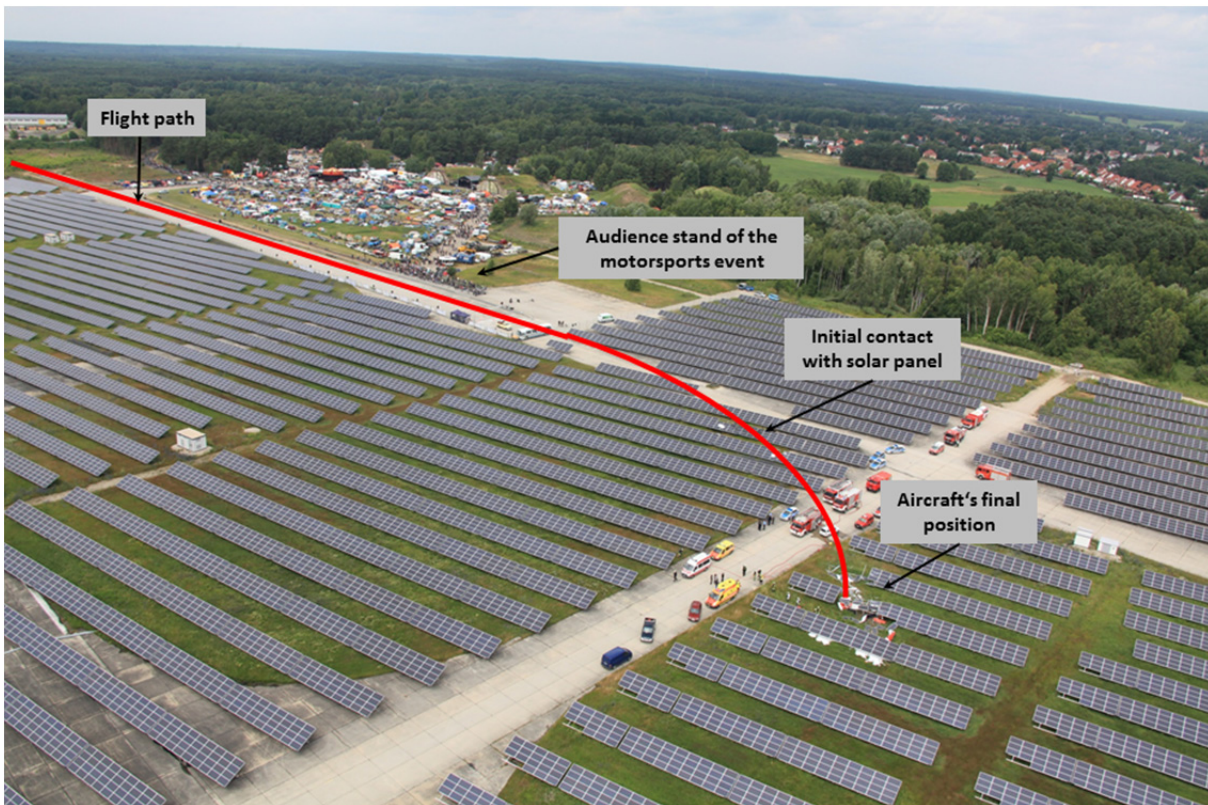
00:02 min.: The Pilot attempted to recover normal flight attitude by conducting a half slow roll to the left. In doing so he veered right by approximately 20°.

0:00 min.: The wing tip tank of the right wing collided with the solar panel and exploded.

Reconstructed flight path and accident site

After the initial collision, the aircraft inverted and crashed into several solar panels on the ground. The pilot was fatally injured and the aircraft destroyed.

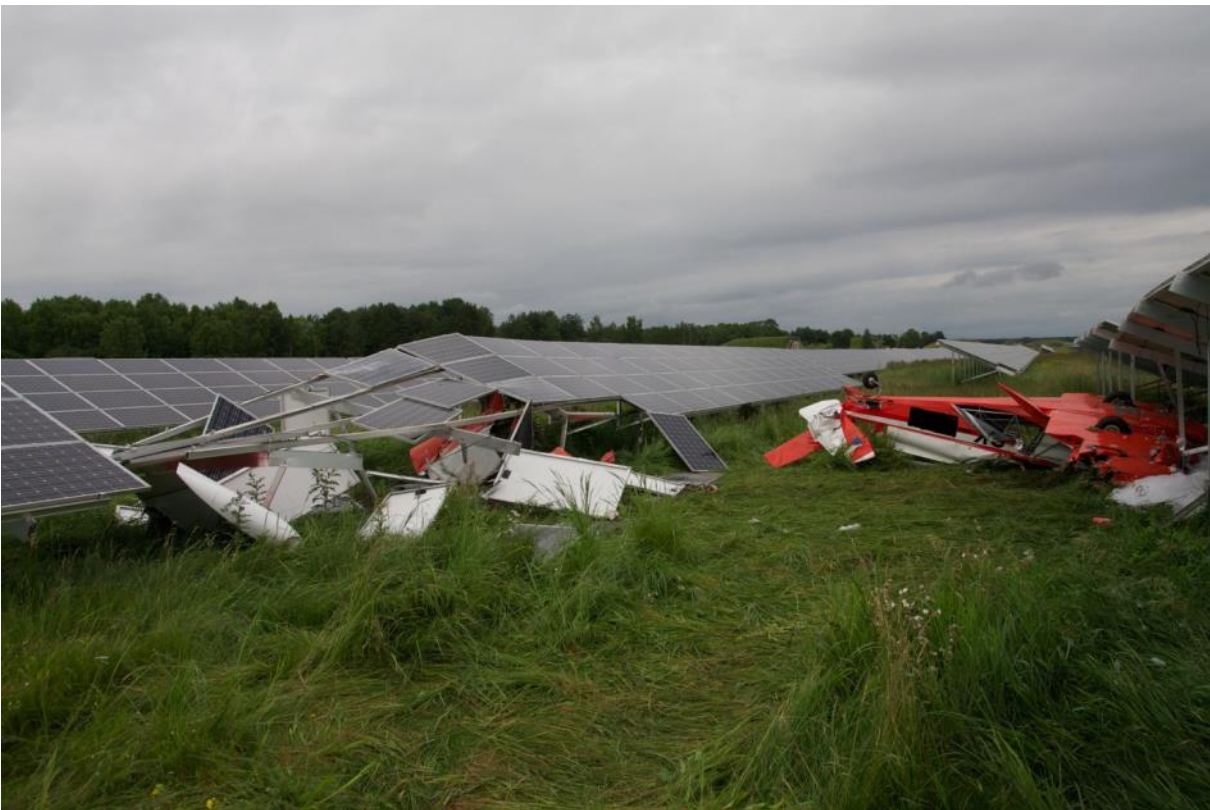
The accident site was located at a fenced in field with solar panels approximately 100 m north and approximately 700 m west of the threshold of runway 10 of Eberswalde-Finow Airfield. The aircraft was lying in inverted position among the solar panels. The airplane fuselage pointed in the direction of about 180°. The canopy was destroyed and the upper part of the cockpit was bent into the fuselage's welded steel tube structure. The cover panels of the fuselage's upper side were torn open between cockpit and tail section. The vertical tail had been torn from the fuselage and was compressed. The left elevator had been severed from the tail section and lay right of the fuselage's end. The right horizontal stabiliser was bent backward. The main landing gear was retracted.

Accident site

The examination of the fuel tanks showed that the left wing tank had been torn open and no longer contained any fuel. The right wing tank was undamaged and contained a low amount of fuel. The collector tank with a capacity of about 5 l was undamaged and empty. The left wing tip tank was empty and the front part destroyed. The right wing tip tank was also destroyed. Some parts of it were found a little distance from the initial contact of the aircraft with the solar panels. Both wings had been severed approximately 1 m from the wing root and were found approximately 5 m in front of the fuselage in impact direction.

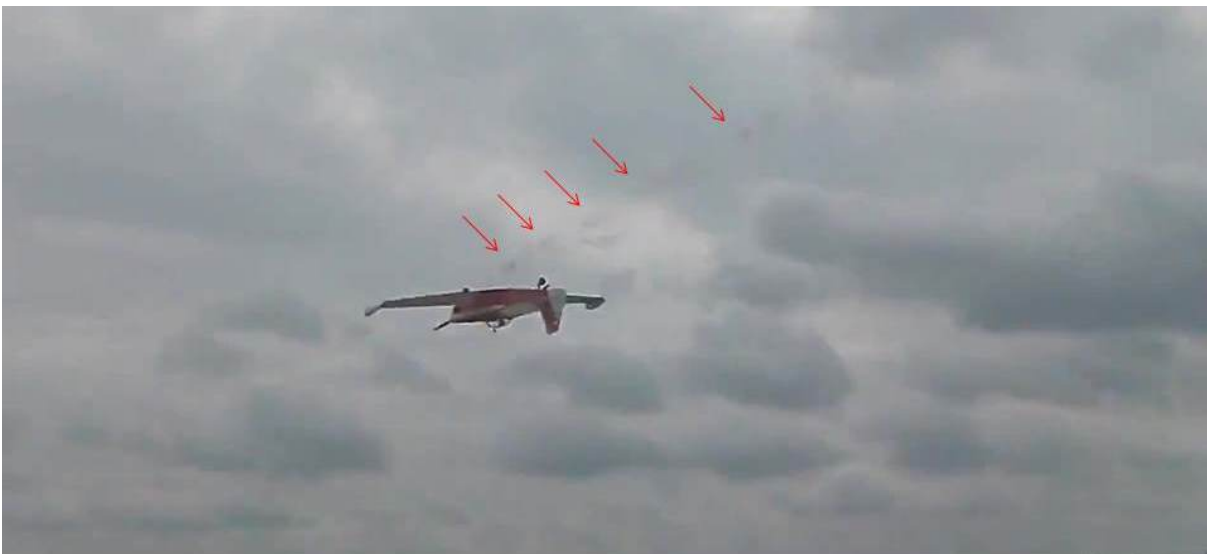
A photo taken by a bystander showed a change in colour of the exhaust fumes shortly before the collision (photo below).

The empty collector tank found at the accident site indicates that the engine was no longer supplied with fuel. It cannot be ruled out that the engine failed in the inverted position. An indicator for it was the slight colouring of the engine exhaust fumes immediately prior to the collision. The pilot tried to conduct a half roll from the inverted position to regain normal flight attitude.
