Investigation Report

Type of Occurrence:	Accident
Date:	26 August 2013
Location:	Gerbach
Aircraft:	Ultralight Aircraft
Manufacturer / Model:	Evektor Aerotechnik a.s. / EV 97 Eurostar 2000 R
Injuries to Persons:	Two persons fatally injured
Damage:	Aircraft destroyed
Other Damage:	Crop damage
State File Number:	BFU CX014-13

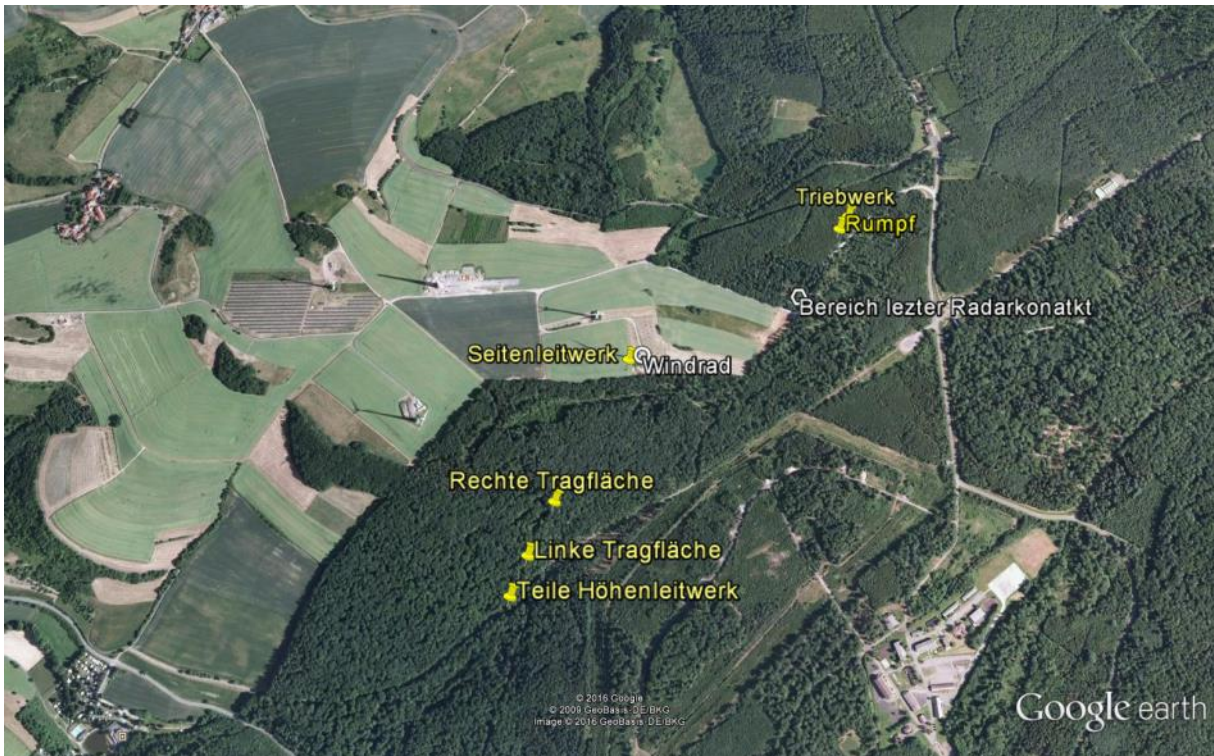
Wreckage distribution

The wreckage parts were spread over a distance of approximately 1,300 m.

Approximately 700 m north-east of the wind power plant, the front fuselage part, consisting of engine and fire wall including instrument panel, stuck about 30 cm deep in the forest floor. The propeller blades had been torn off and were lying next to the front fuselage part. The middle section of the fuselage, including severed vertical tail, lay approximately 400 m north-east of the wind power plant. Both occupants were found in their seats wearing seat belts.

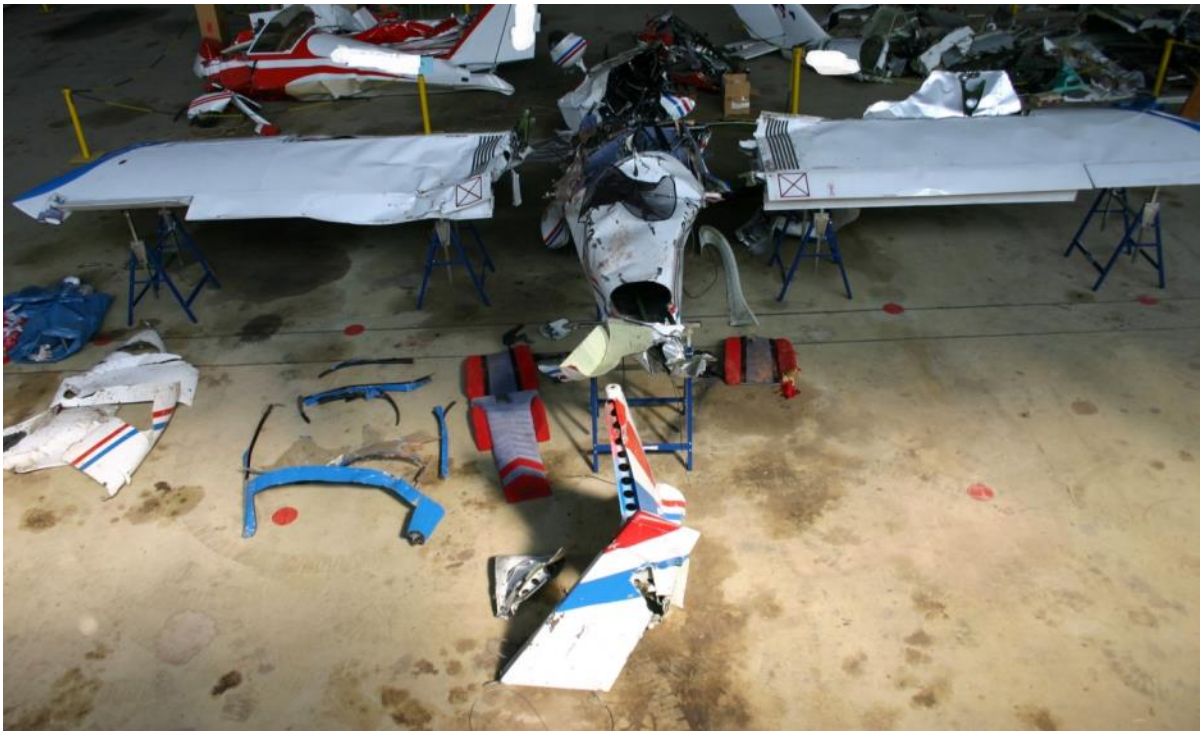
Displayed wreckage parts

The wreckage showed several modifications. An additional tail wheel had been fitted to the vertical tail. The trim lever had been fitted with an extension. Between the landing gear legs a coil spring had been added. Parts of the left wing and wing tip had been repainted. A lock wire on the bolt of the wing did not meet the requirements of the manufacturer. A bolt was secured with a regular safety pin.

Besides the repainting the wings did not show any other signs of repair.

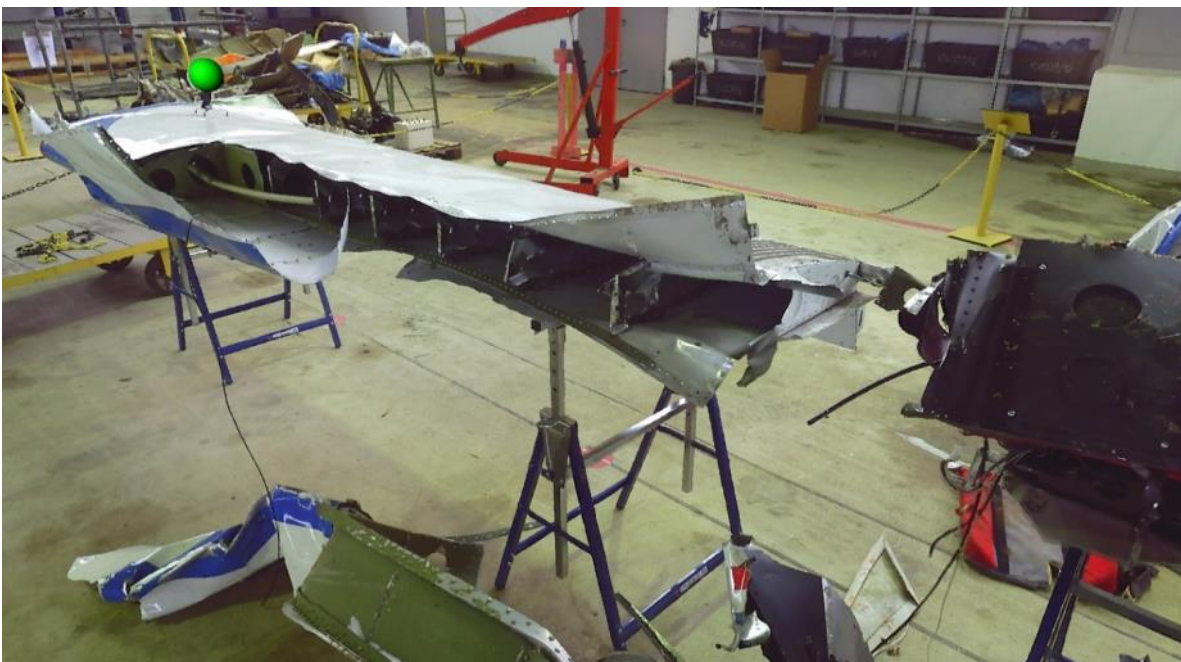
Right wing

A fractured piece of the aft wing spar was attached to the right wing. The right main wing spar was attached to the fuselage and bent like a corkscrew. The leading edge of the wing had ruptured open and was severed from the wing spar. The rivets were torn out. The right wing root section was deformed.

An approximately 10 cm large piece of the aft wing spar cap was attached to the

wing. A torn-out piece of the wing root was attached to the wing spar.

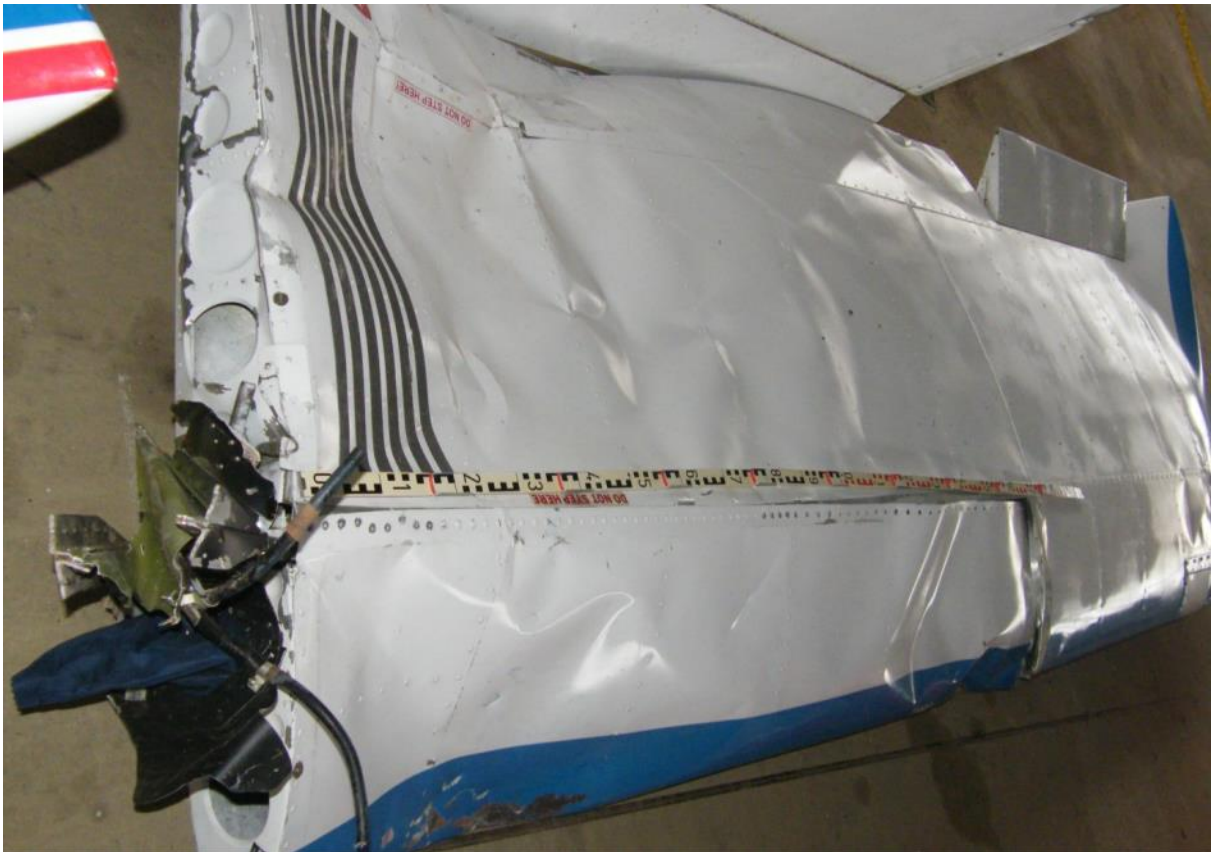
Left wing

The leading edge of the left wing was dented about 30 cm prior to the wing spar web. Blue colour was found on the wing upper surface in the area of the wing spar. The outer area of the wing had been repainted.

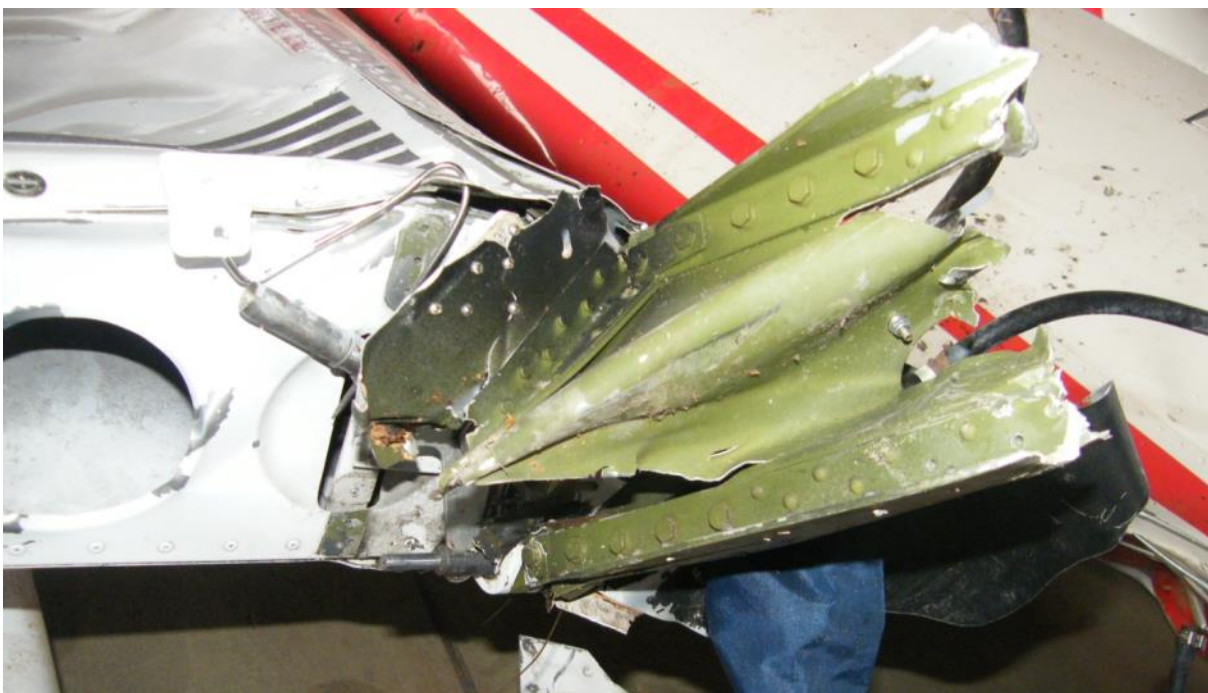
Left wing main wing spar

The wing spar had been shorn off at the fuselage area and its fracture surface was deformed. The aft support wing spar had been torn out of the wing.

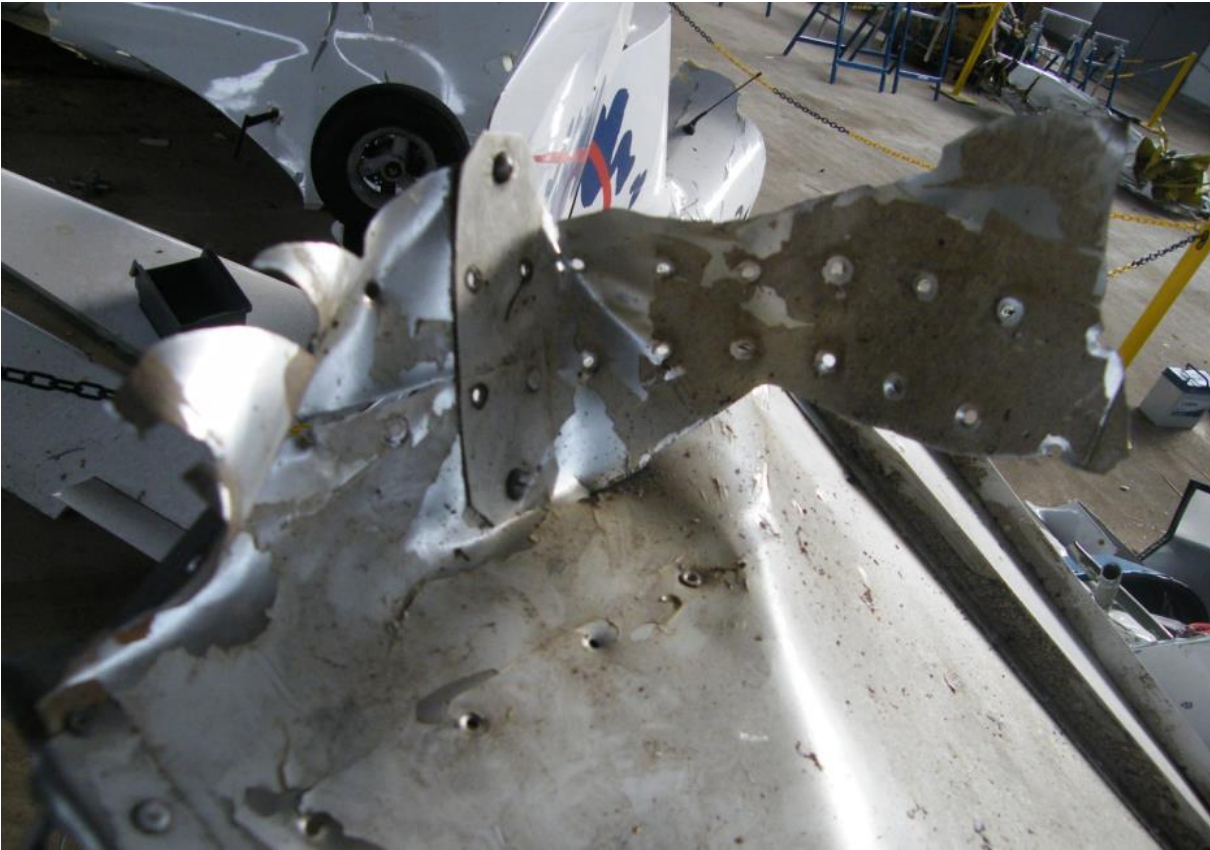
Front fuselage section

The front fuselage section had been torn out of the fuselage. The rivets were torn out also.
