Investigation Report

Type of Occurrence:	Serious incident
Date:	26 June 2014
Location:	Mannheim City Airport
Aircraft:	Helicopter
Manufacturer / Model:	Agusta S.p.A. / AB 412
Injuries to Persons:	None
Damage:	Minor damage to aircraft
Other Damage:	None
Information Source:	Investigation by BFU
State File Number:	BFU 7X002-14

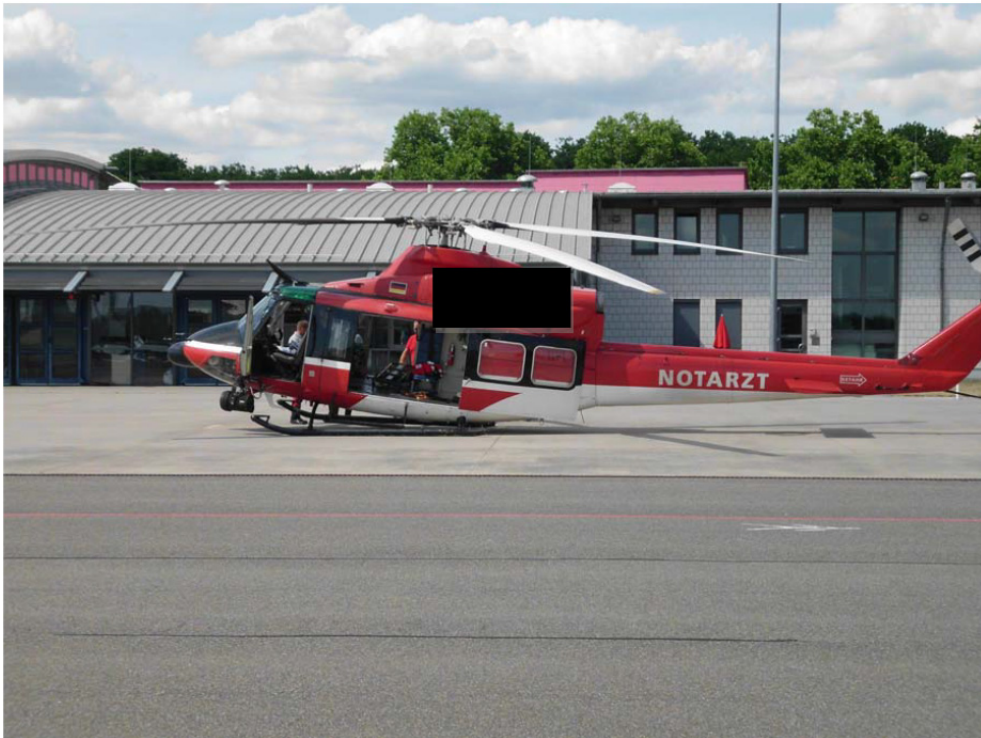
Once the fire brigade arrived, he slowly pulled back the thrust levers and shut off the engines. The helicopter remained in its position resting on the fractured part of the aft cross tube and the tread (see Appendix Images 1 and 2).

The serious accident occurred on the apron in front of the terminal (see Appendix Image 1). The helicopter sacked back to the left and rested on the fractured part of the aft cross tube.

Image 1: Overall view

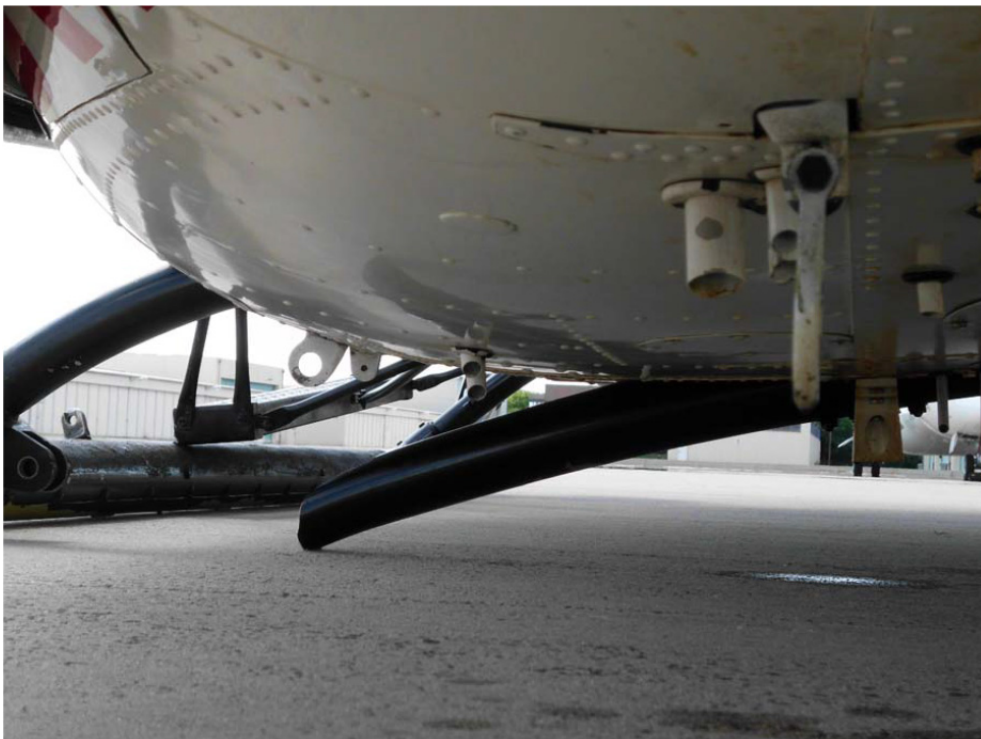
Image 2: Fracture viewed from left rear

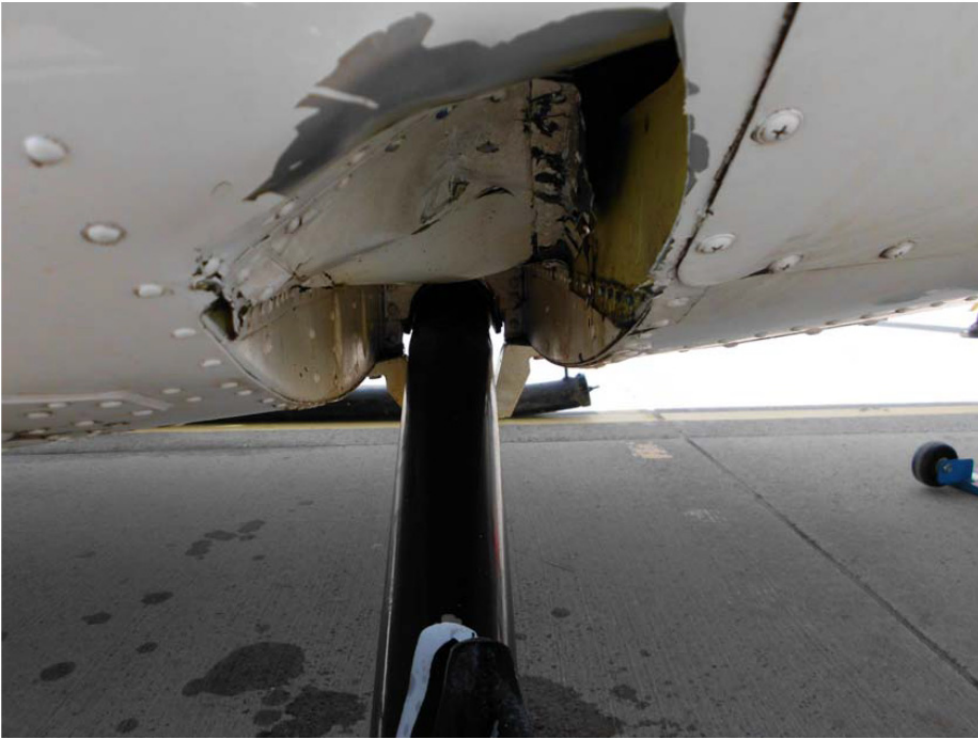
The fracture occurred on the left side in the area of the cross tube with the increased bent. The larger part of the fractured cross tube remained attached to the fuselage. The right fracture face (viewed in the direction of the flight) hit the apron's concrete. The left stub of the cross tube had been pushed into the fuselage and the outer panel in the left area of the cross tube tunnel had been damaged (see Appendix Image 3).

Image 3: Damage on the left side of the fuselage

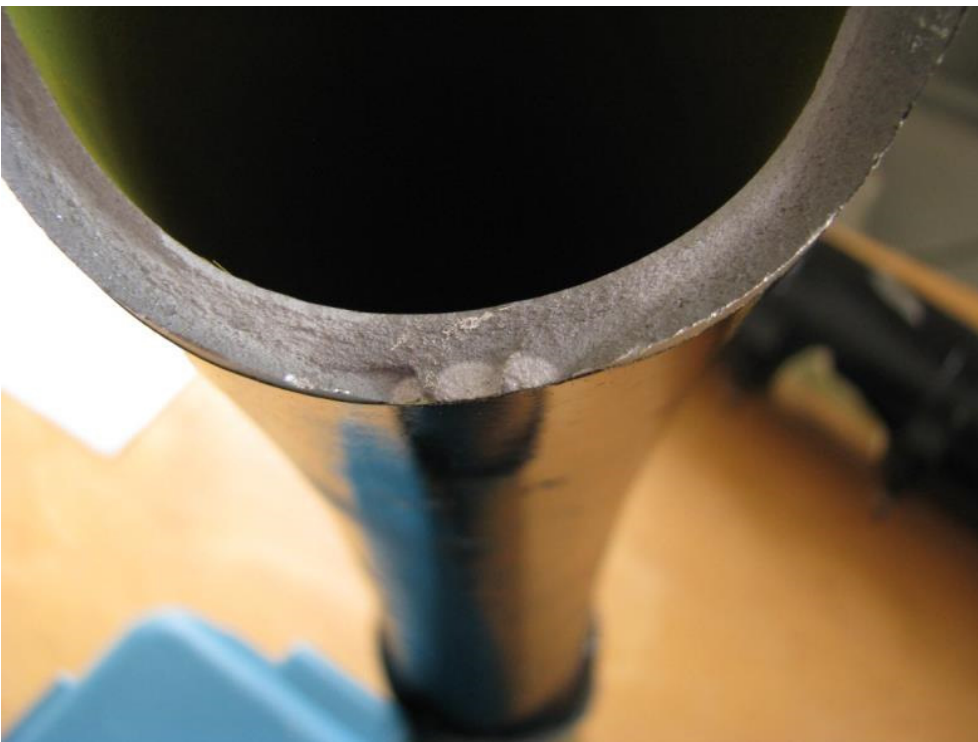
The bottom surface of the larger fragment, which was still connected with the fuselage by way of the brackets, had crashed to the concrete surface of the apron. This had flattened approximately half of the fracture surface of the outer wall. The traces for fracture analysis had been destroyed in that area. The fracture surface of the smaller fragment, which was still connected with the left skid, was undamaged. The fracture analysis was performed on this part (Image 4).

The image shows an overview of the fracture surfaces of the cross tube (aluminium alloy). On the outer tube underside, i.e. in the area of the largest tensile stress, three extended thumbnail initial cracks had formed (Image 4). The cracks were in different levels; the left crack ran into a gap behind the crack in the middle. Unequivocally, the cracks were fatigue cracks. They had progressed to about half of the wall thickness before the forced rupture occurred.

From a constructional point of view the fracture occurred in the area of the largest bent with the largest tensile stress (large bending moment). It was caused by the bending up behaviour as normal reaction of the cross tube to the helicopter's mass.

Image 4: Fracture surface of the smaller fracture piece including cracks

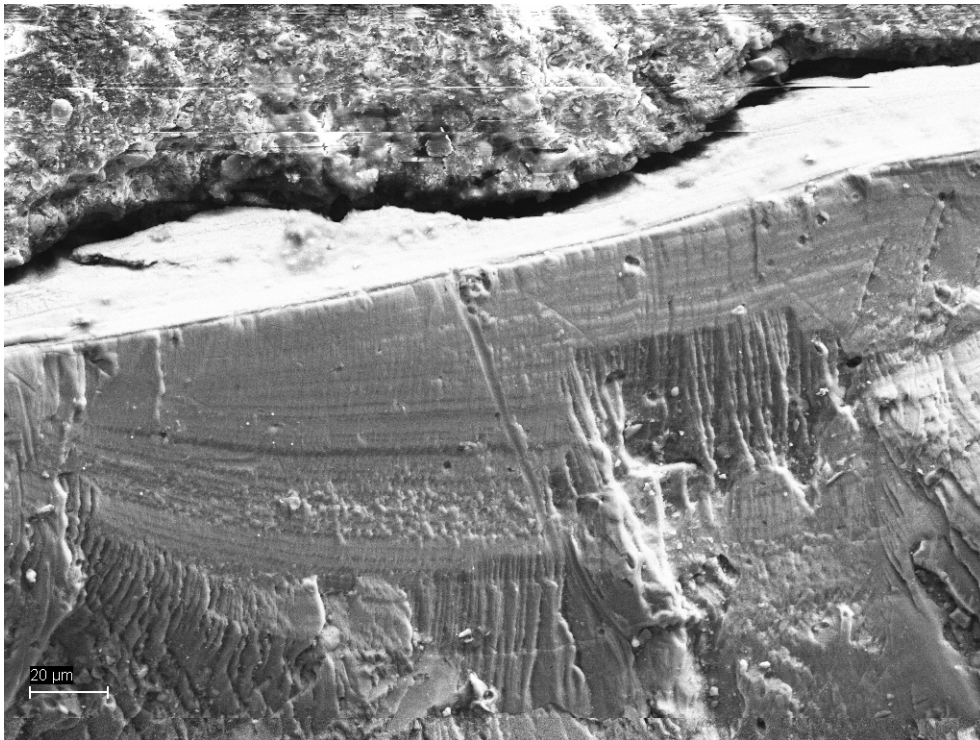
The Fraunhofer Institut für Schicht- und Oberflächentechnik (IST) in Braunschweig provided the scanning electron microscope and technical assistance for the microscopic examination. The characteristic striation micro-topography (Image 5) confirmed the fatigue crack. The image shows the origin of the right fatigue crack. The residual fracture occurred as micro ductile forced rupture.

Image 5: Right fatigue fracture (Image 4) in detail

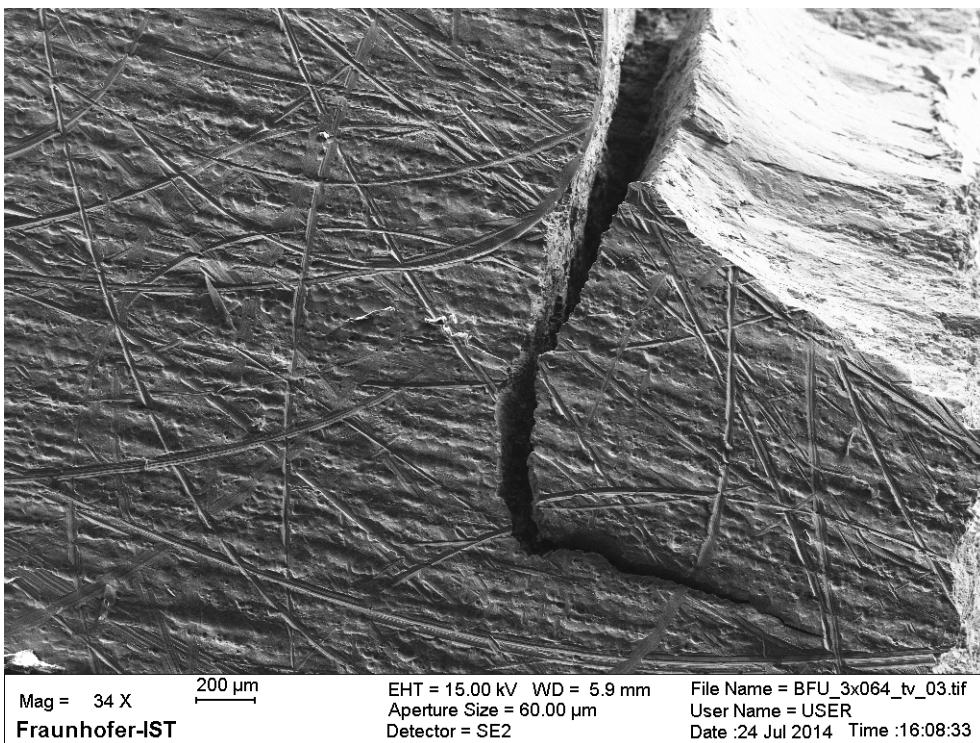
Image 6 shows an overview of the surface topography in the area of the left fatigue fracture. The surface was covered in chrome (EDX Analysis) and its striation ran in longitudinal direction to the component dimension. The surface was covered with irregular, almost concentric, scratches. It seemed they might have originated from some kind of process, such as a rotating steel brush. These scratches were kerfs which served as starting points for fatigue cracks. The gap initially ran crosswise to the longitudinal axis of the component, i.e. crosswise to the stress. Then it spiked 90° toward the fracture surface. Image 7 shows that the fatigue crack originated from one of the scratches. The crack started where the scratch ran in the area of the largest stress, i.e. crosswise to the load direction.

Image 6: Overview crack

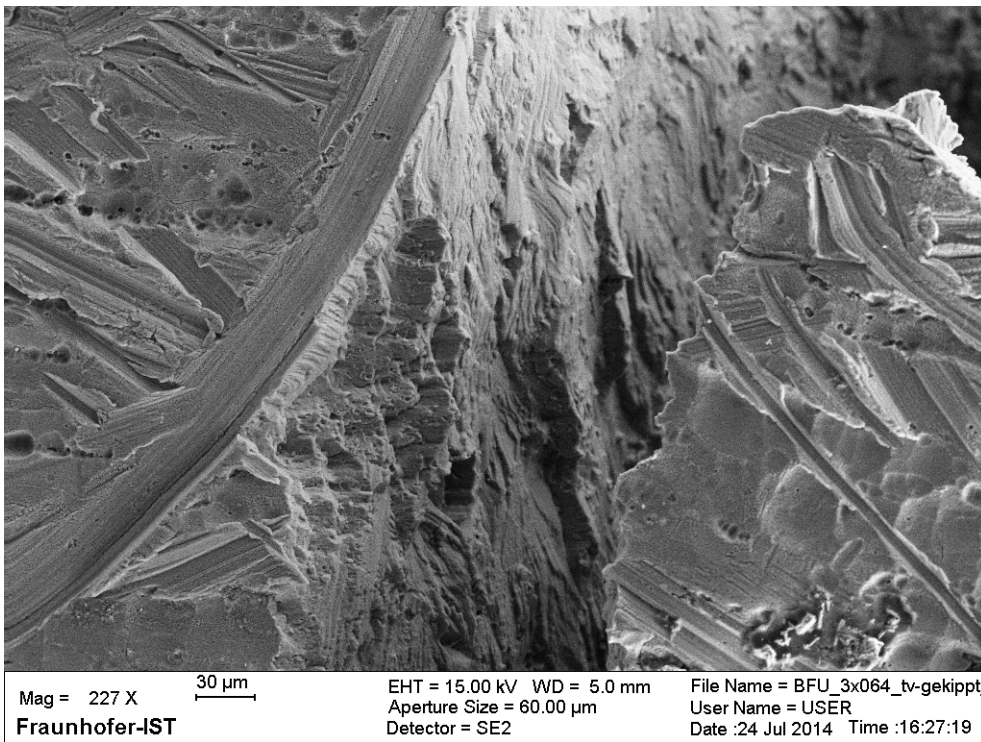
In summary, it can be concluded that during paint work varnish residue was not removed using chemicals, as was recommended by the manufacturer, but with mechanical means, e.g. rotating steel brush or grinding disks. The subsequent scratches facilitated the development of a fatigue fracture in a high tensile stress area of the cross tube.

Image 7: Beginning of the crack at a scratch

When commissioning work on aircraft, the operator's maintenance organisation should inform any contractor about the stipulated and approved procedures of the manufacturer and supervise the work.

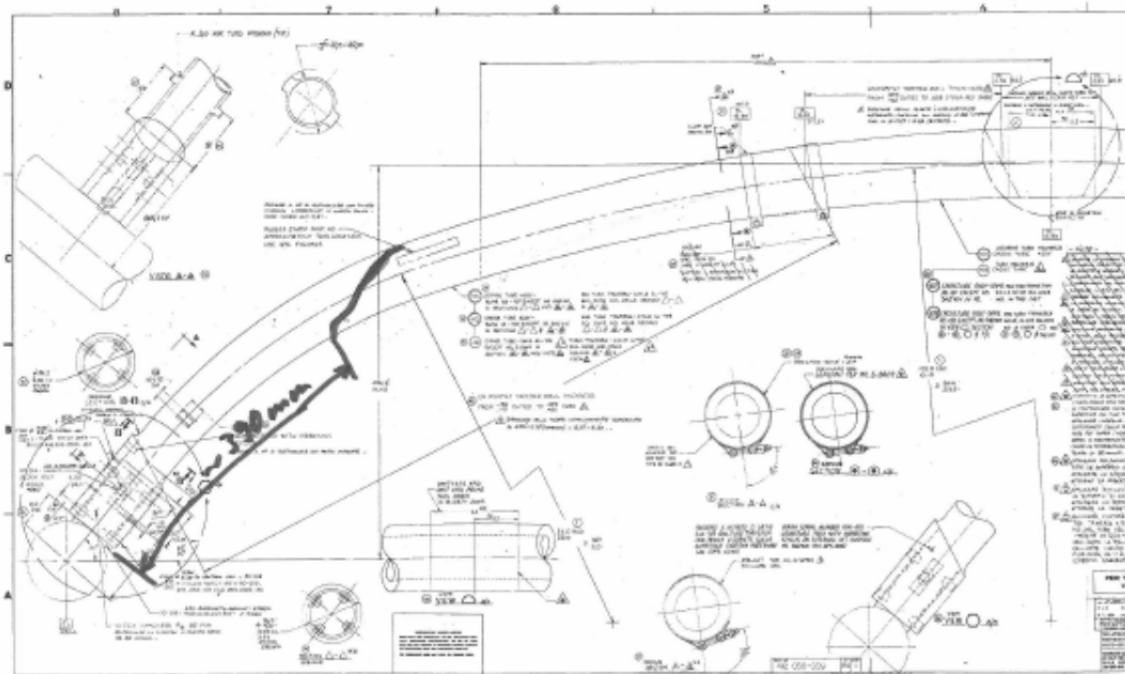
Drawing 1 Cross tube with drawn-in fracture propagation

The crack began on the inside radius of the cross tube approximately 390 mm from the left end (see Appendix, Drawing 1). The fracture then formed a “tongue” and ran upward. In this area the cross tube had an oval section. At the fracture site the height of the outer diameter was 66.4 mm and the inner diameter 54.3 mm. The width of the outer diameter was 70.3 mm and the inner diameter 58.7 mm.

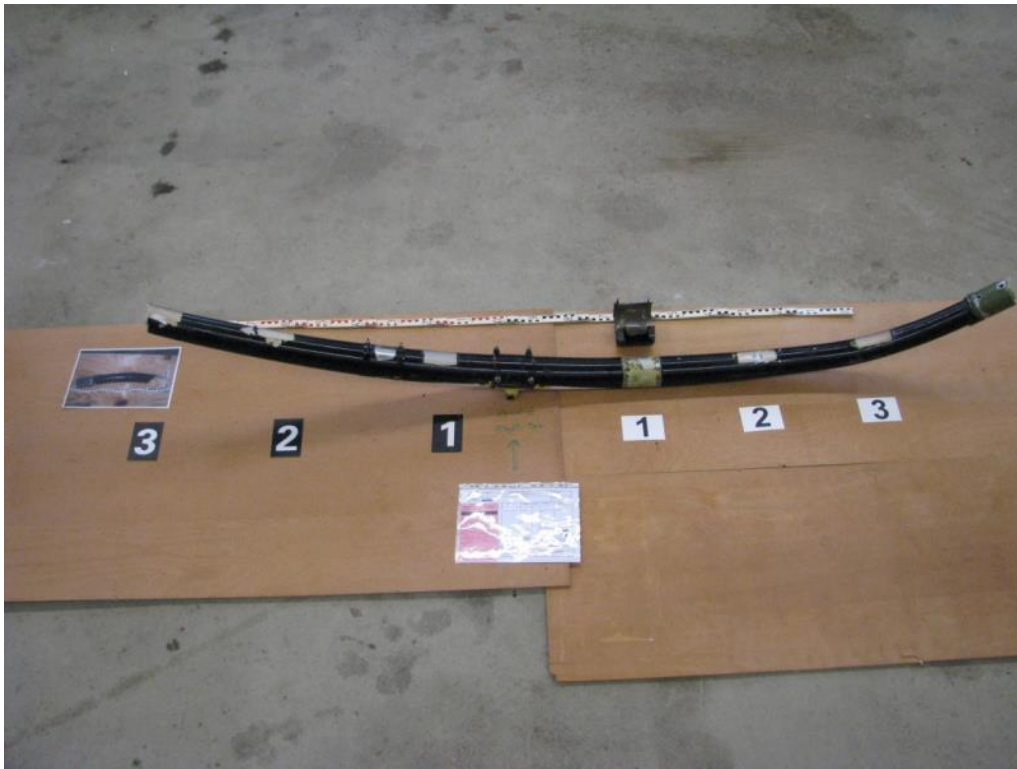
Image 8 shows an overview in flight direction. Numeration occurred from the centre outwards. The white numbers indicate the examined places on the left side; the black ones those of the right side. The underside was the tensile side of the cross tube and therefore mostly places on this side were chosen.

Image 8: Cross tube overview with the six examination areas

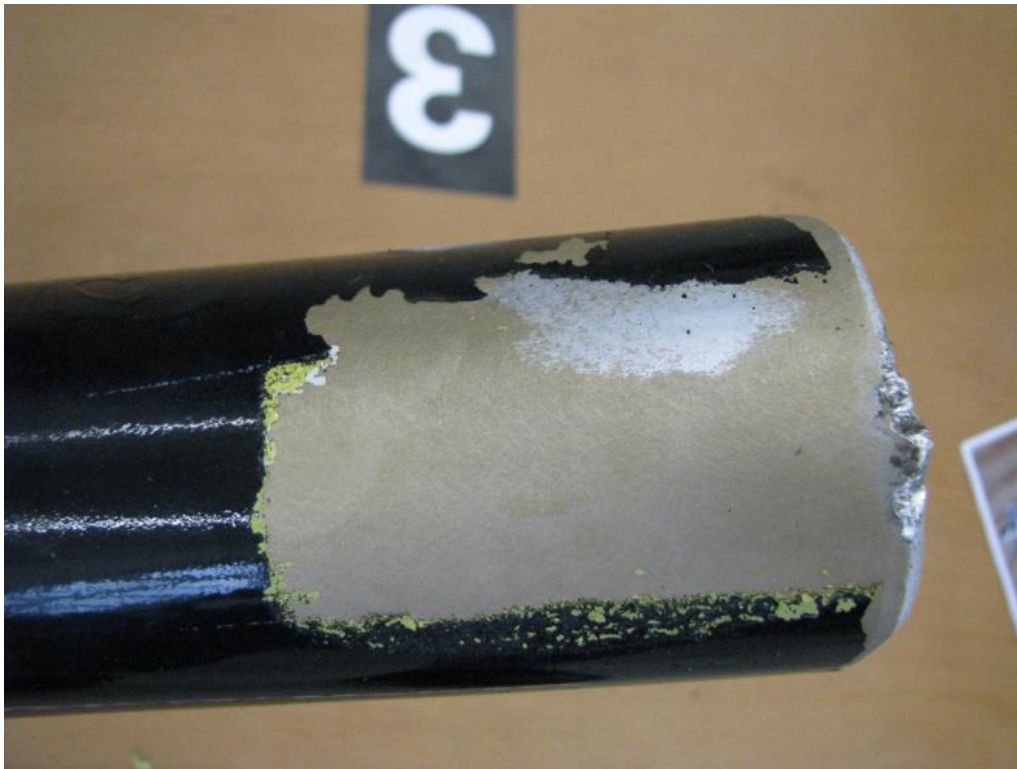
Left side: Area 1 showed a metallic surface; it is highly likely that it had been shot peened. No scratches were found. During the stripping the varnish showed good adhesive force. Area 2 was chosen due to the varnish touch up. Spray was visible on the surface; its appearance was dull. After varnish removal the metallic surface showed scratches. Area 3 (Image 9) shows the area next to the fracture origin. Scratches on the metal surface were found after varnish removal; as was the case during the microscopic examination. The silver-coloured coating visible in this area was not subject to further examination.

Image 9: Detail left cross tube area 3
