# Investigation Report

Type of Occurrence:	Serious incident
Date:	8 October 2014
Location:	Frankfurt/Main
Aircraft:	Cargo airplane
Manufacturer / Model:	The Boeing Company / B 747-400 F
Injuries to Persons:	None
Damage:	Minor damage to aircraft
Other Damage:	None
State File Number:	BFU EX007-14

During the approach to Frankfurt/Main Airport parts of the left wing flap detached from the airplane.

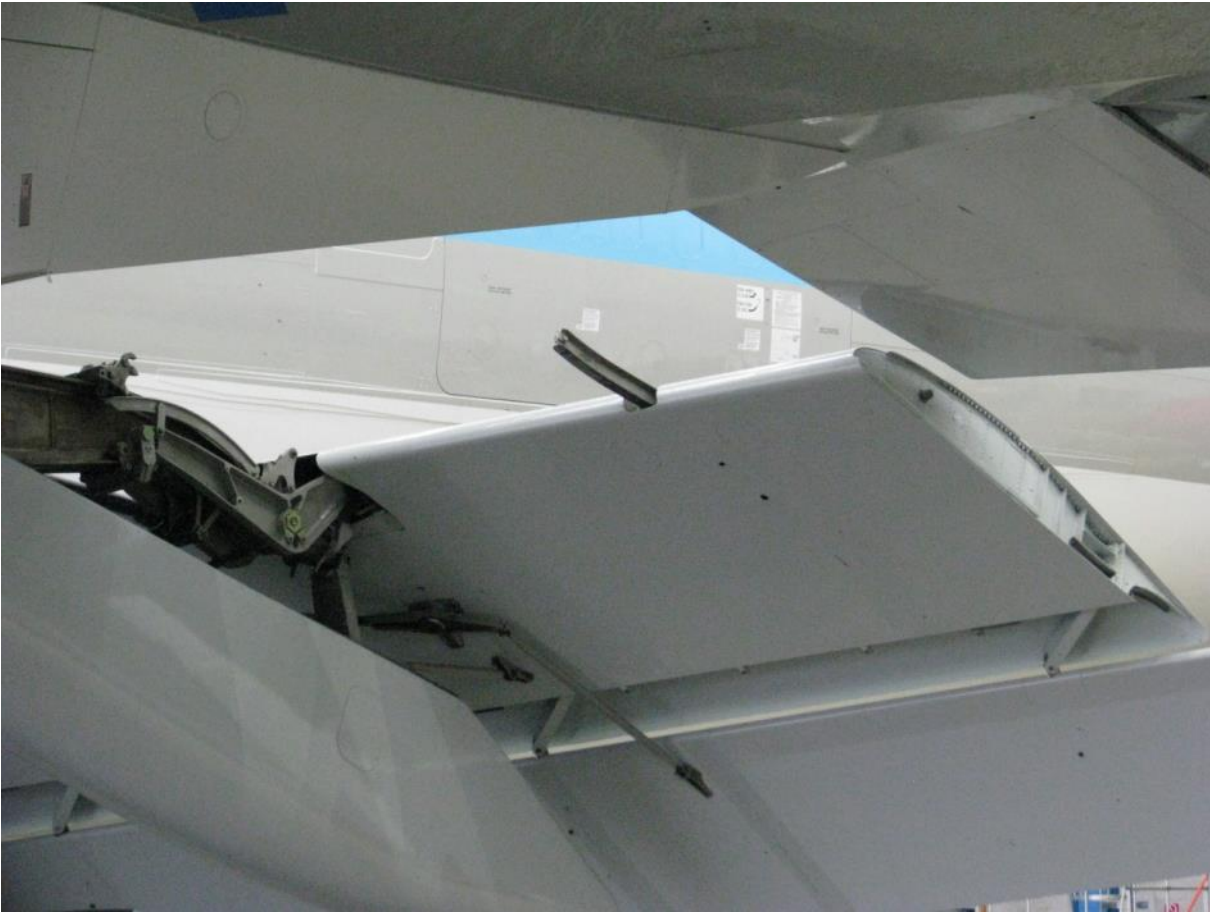
On the airplane part of the left wing inboard fore flap (approximately 4.5 x 1 m) was missing. The fracture had occurred approximately one metre left of the inner flap attach fitting (Images 1 - 3). The two outer fore-flap tracks, connecting the fore and middle inboard flap, were fractured or damaged. The cover panels of the fore-flap track's mountings showed damages. In the area of the carriage, which moves the outer bearing of the flap, a fracture piece of the bearing seat got jammed (Image 8). The bronze bushing was still connected with the carriage through the bolt (Image 9). Image 5 shows a drawing of the flap arrangement and the fractured attach fitting. The

Image 1: The fractured flap viewed from below

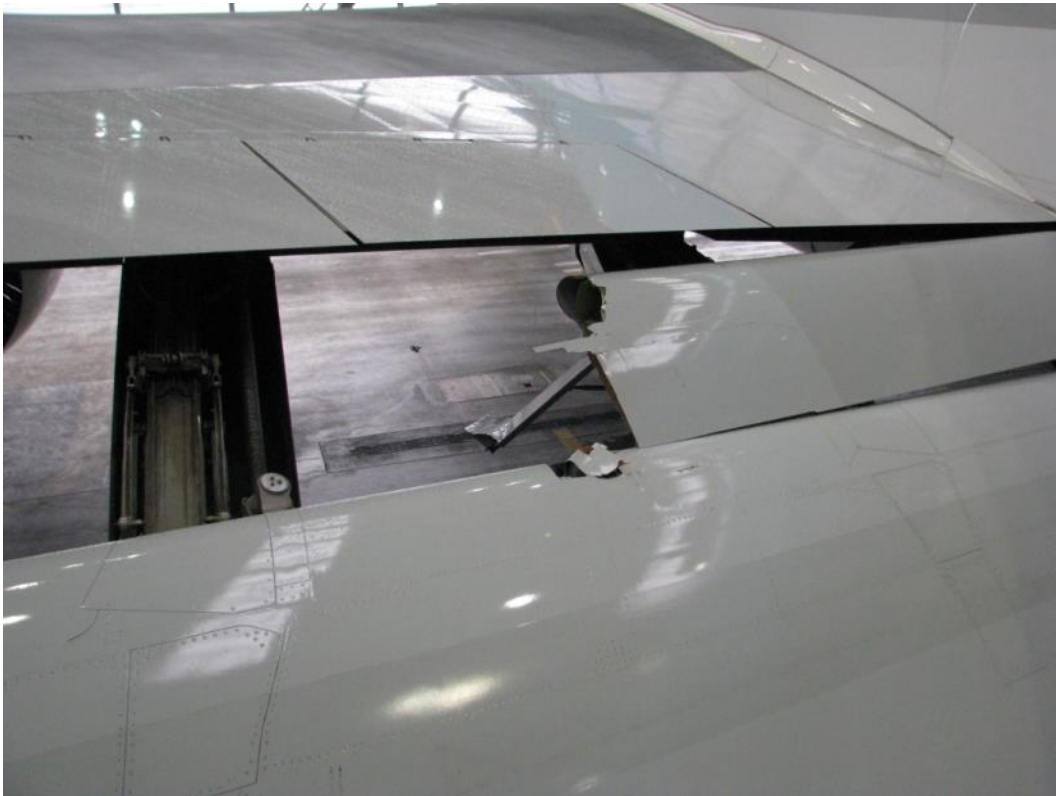
Image 2: The fractured flap viewed from above

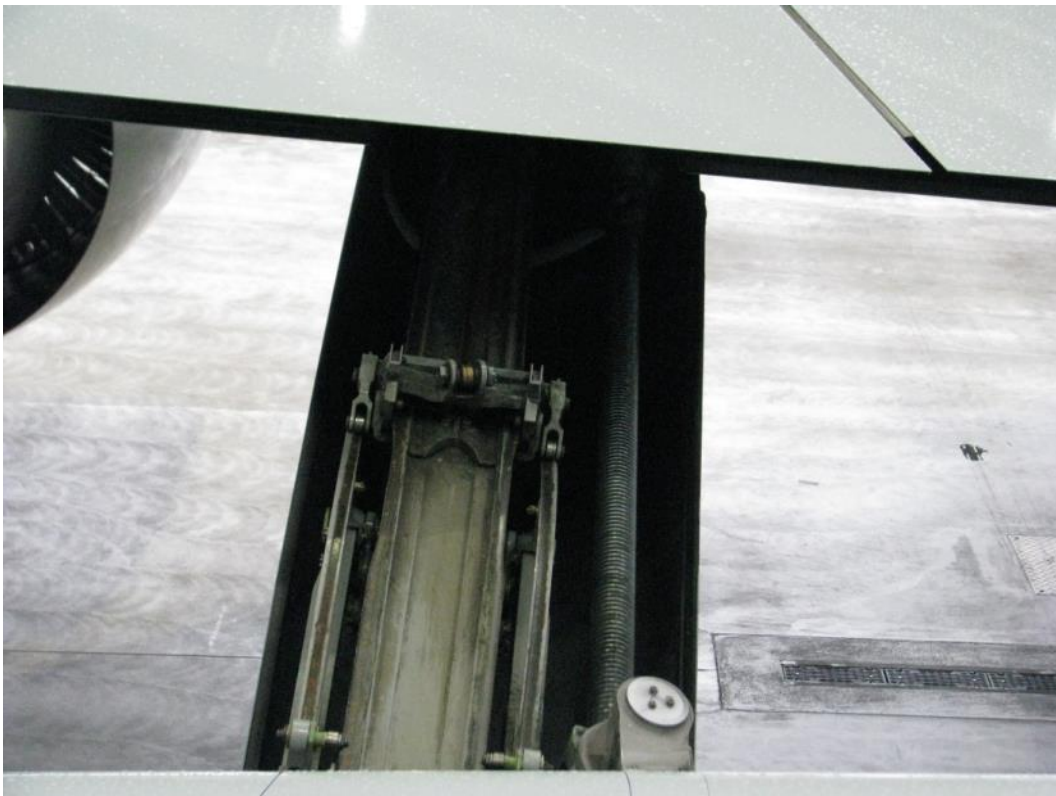
Image 3: Outer mounting point of the flap

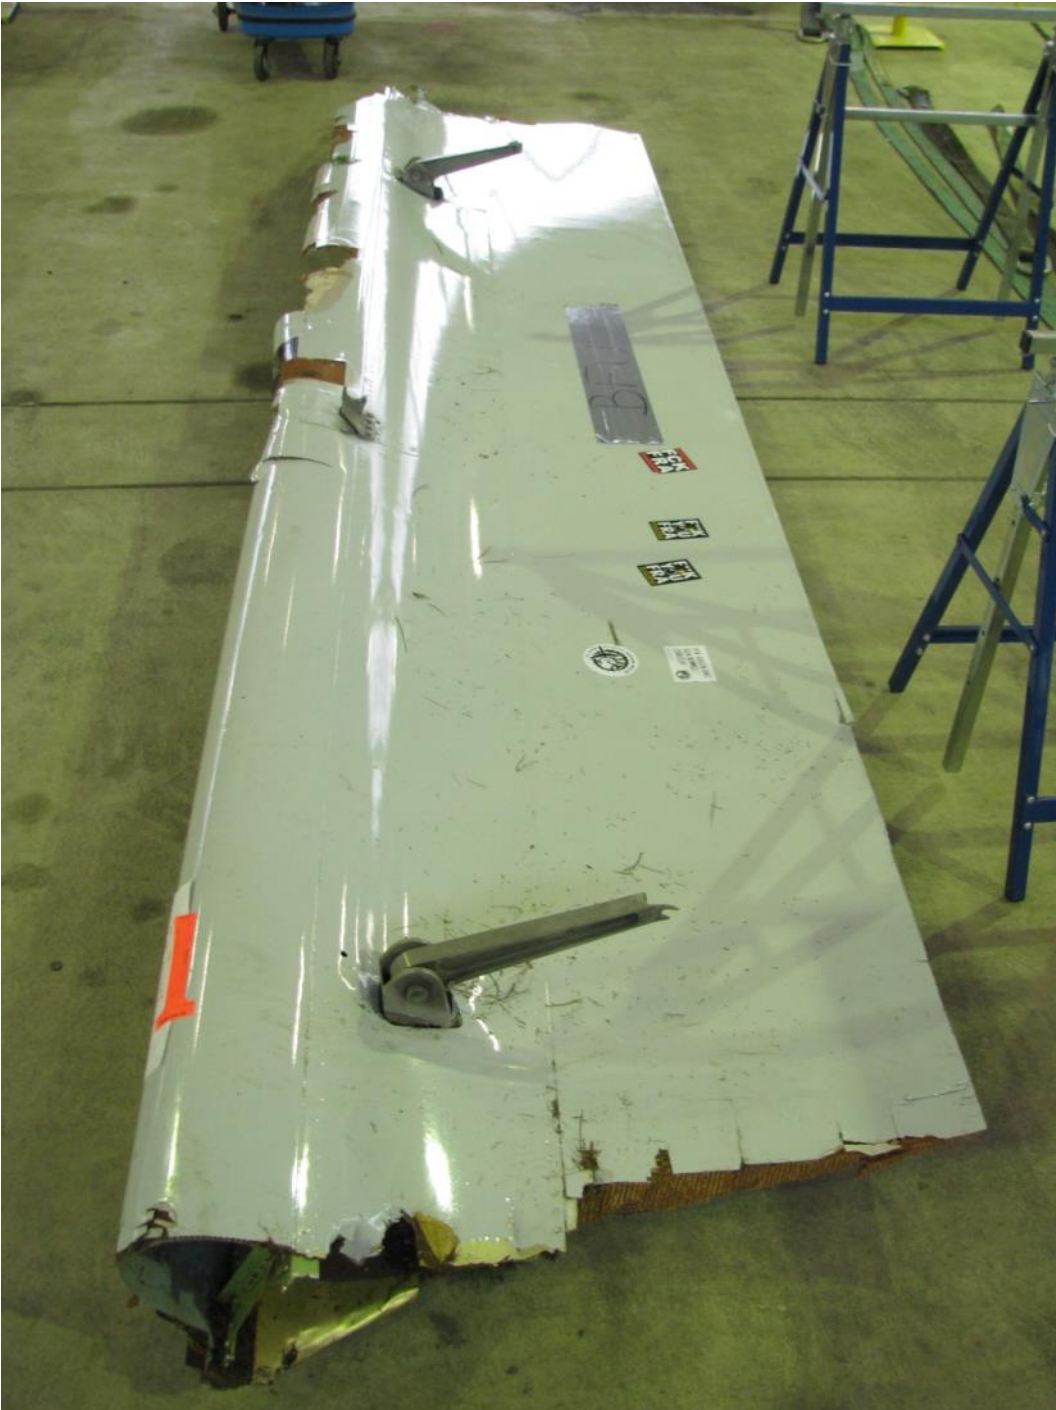
The severed flap part was found in a forest close to Frankfurt/Main and transported to the BFU for further examination (Image 4).

Image 4: Fractured flap part

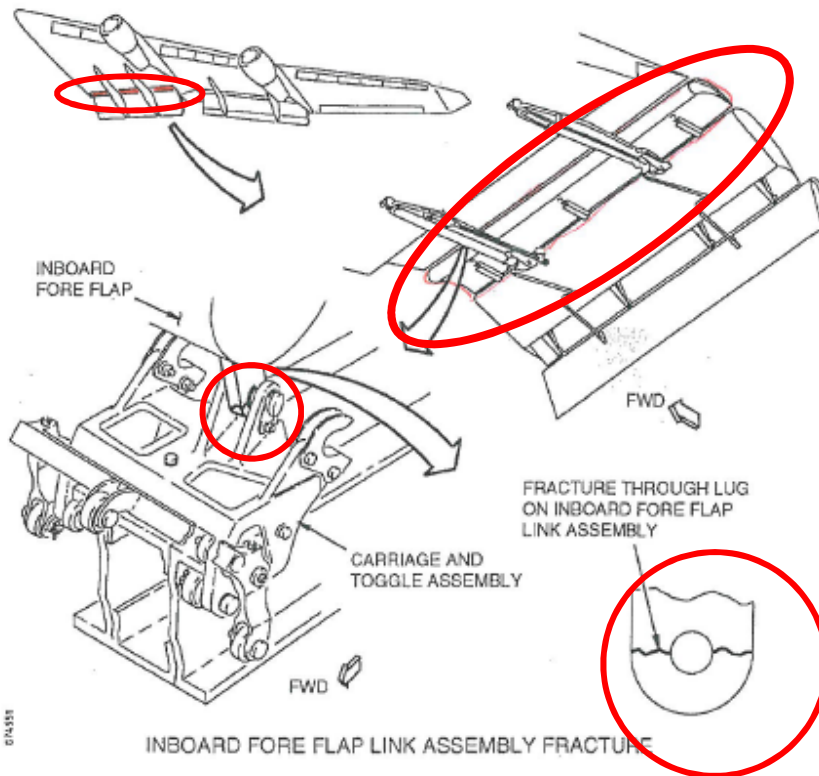
Image 5: Assembly and position of the inboard fore flap with fracture on the attach fitting

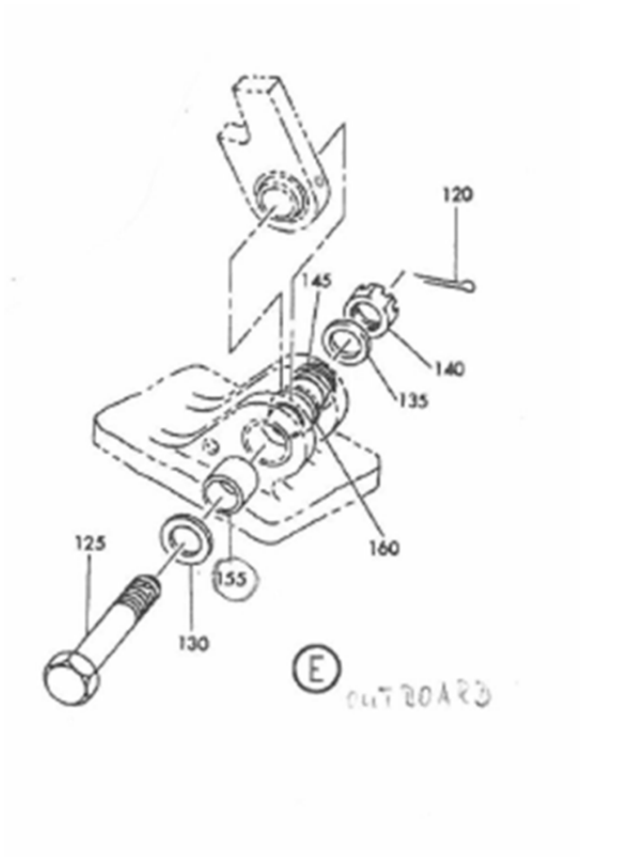
A bolt, which led through the drill hole to the ball, connected the attach fitting with the carriage, which moved the flap (Image 6a).

Image 6a: Detail link between inboard fore flap and carriage

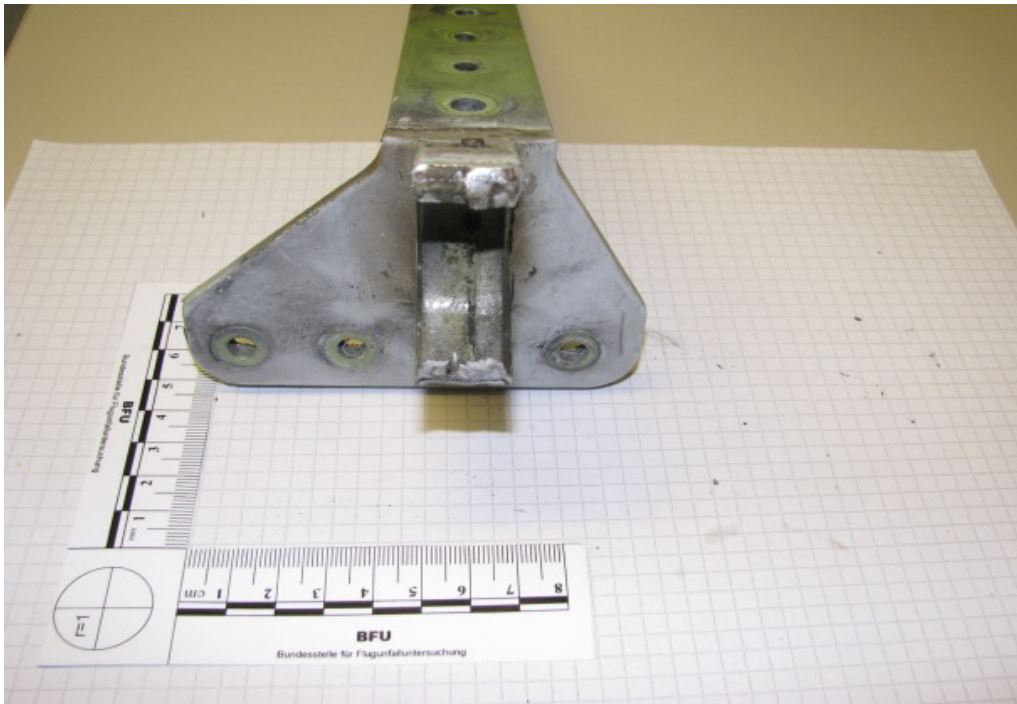
left outer inboard fore flap attach fitting (Image 7) with the Part Number ASSY 65B39025-29 /-31 had fractured.

Image 7: Flap attach fitting with lower bearing seat, fracture surfaces severely damaged

The aircraft manufacturer, as type certificate holder of aircraft type Boeing B 747-400, should enhance the corrosion resistance of the flap attach fitting, especially in the bearing seat area.

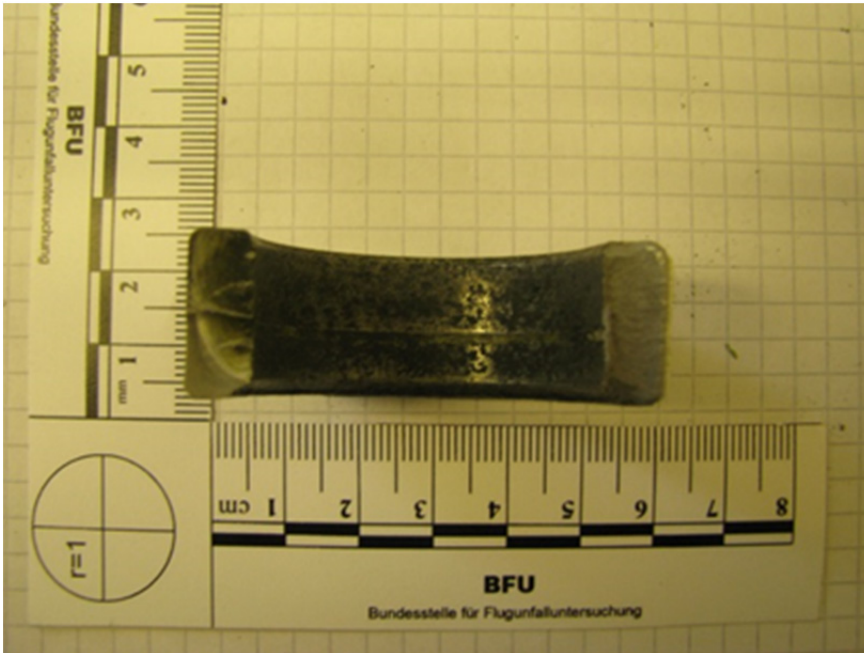
Image 8: Upper part of the bearing seat with well-preserved fracture surfaces Source: BFU

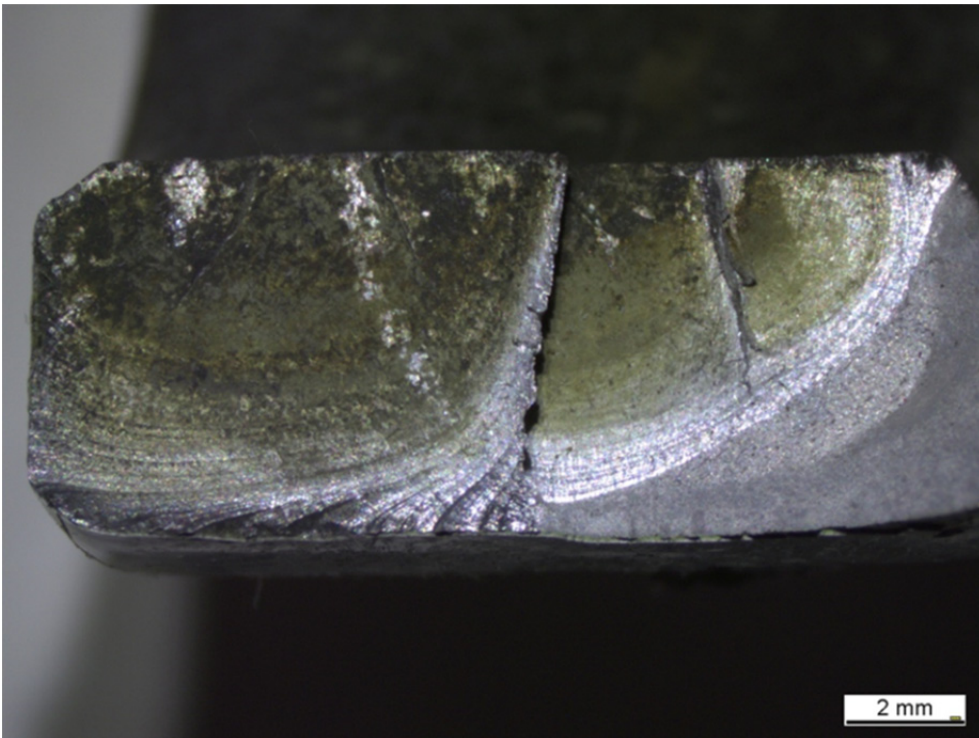
During macroscopic examination clear characteristics of fatigue fracture were visible (Image 10). These lines of rest indicated fracture propagation from inside to outside (Image 11). The examination with the scanning electron microscope (REM), Jeol JSM-6480, showed clear striations (Images 12 and 14) and confirmed the fatigue crack. The crack origins on the inside of the fracture piece showed holes and depressions which indicated corrosion (Image 13). Further examination of the drill hole surface clearly showed corroded areas. It was noted that the area of the lubrication groove showed significantly less corrosion (Image 16) than the larger area of the drill hole surface. They looked like holes or depressions. Another crack was found there (Image 16). The fatigue cracks, which ultimately resulted in the fracture of the component, originated in just such an area. The residual fracture showed a ductile fracture structure (Image 15).

Image 10: Fracture surface on the upper bearing seat (at delivery)

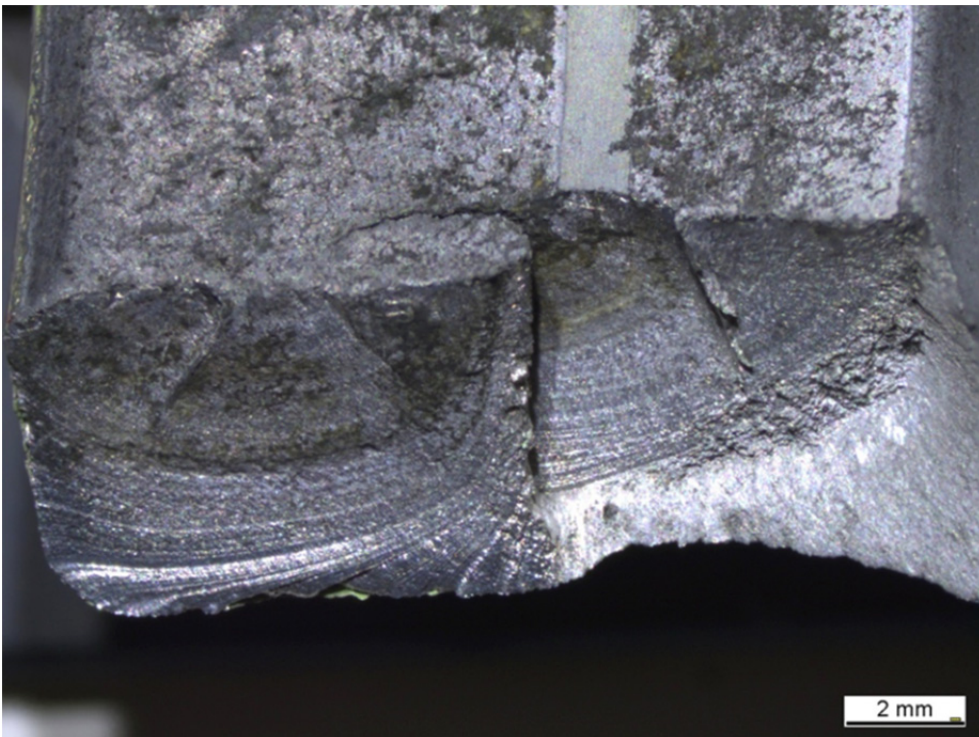
Image 11: Fracture surface on the upper bearing seat (cleaned)

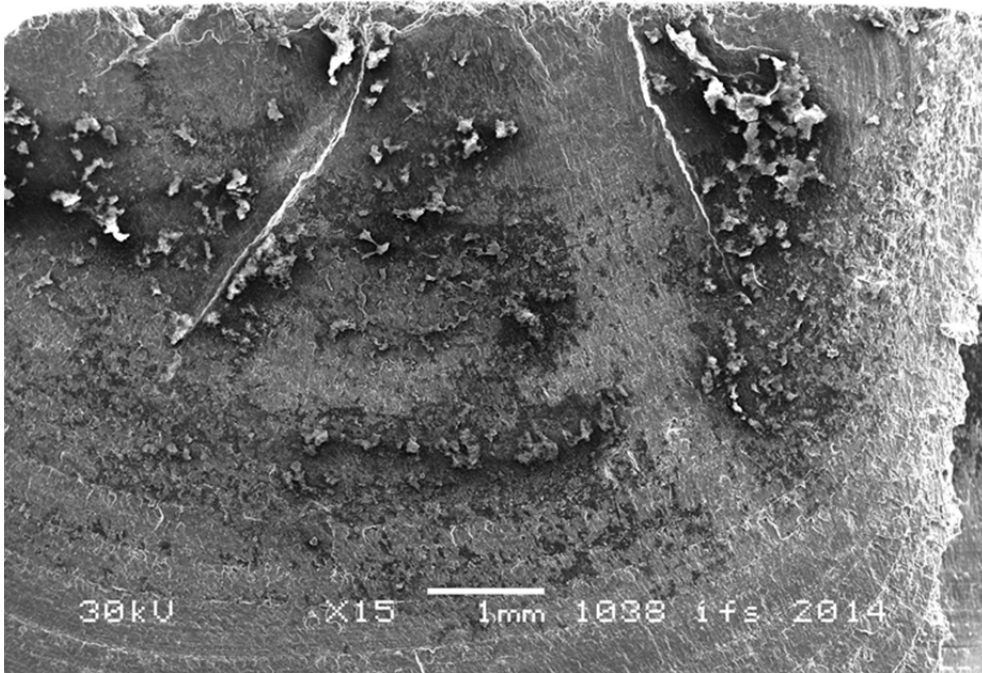
The fracture of the attach fitting was due to fatigue corrosion. The corrosion, in consequence of the used material, resulted in kerfs which, in correlation with stress, served as crack origin for fatigue fracture. The fatigue fracture propagated until the remaining section was destroyed by ductile forced rupture. Because of a well-preserved fracture surface of the attach fitting the fracture origin and the fracture propagation could be established conclusively. Trigger for the fracture of the remaining section was the extension of the flap and the corresponding stress increase, which the section could no longer tolerate.

Image 12: Fracture origin

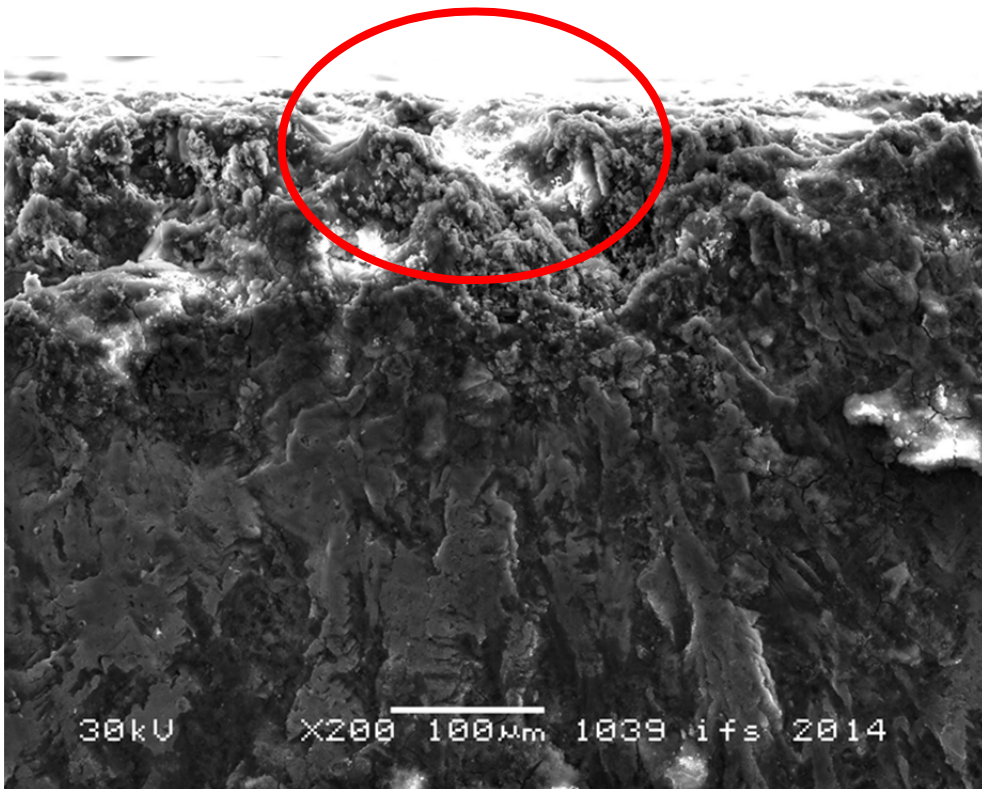
The flap attach fitting was destroyed by an extended fatigue fracture. It is highly likely that it started with a corrosion depression.

Image 13: Fracture origin with corrosion

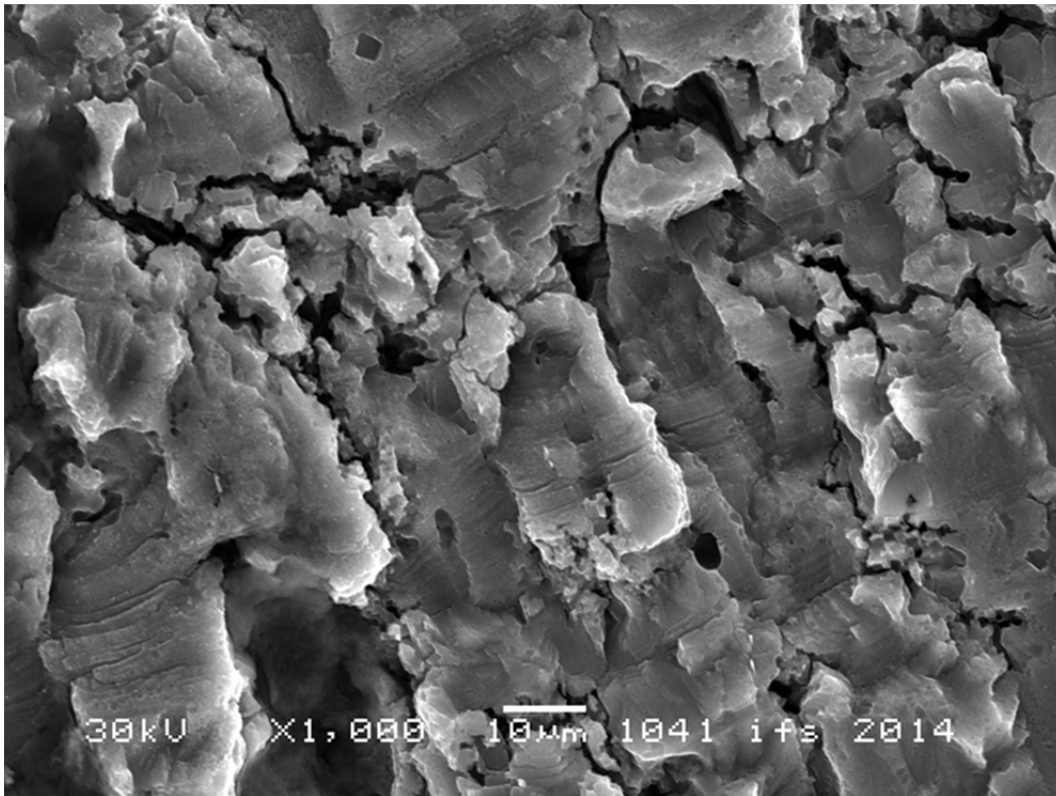
Image 14: Detail enlargement of the fracture surface with striations

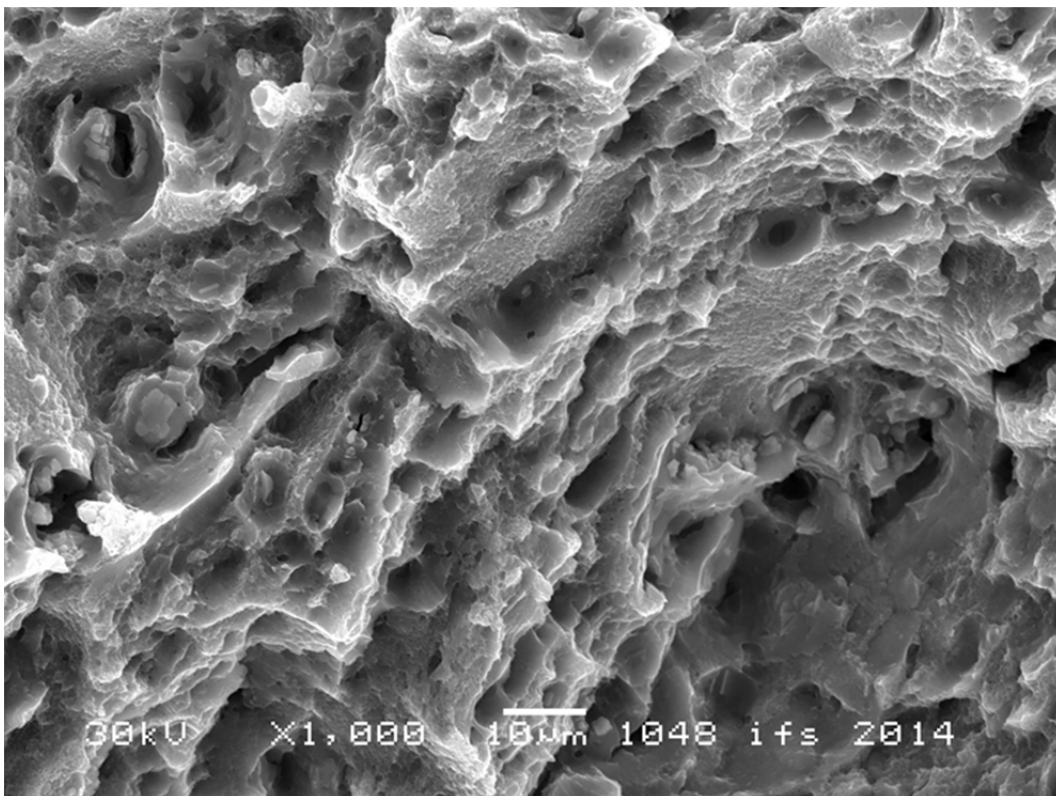
Image 15: Detail enlargement of the residual fracture, ductile forced rupture

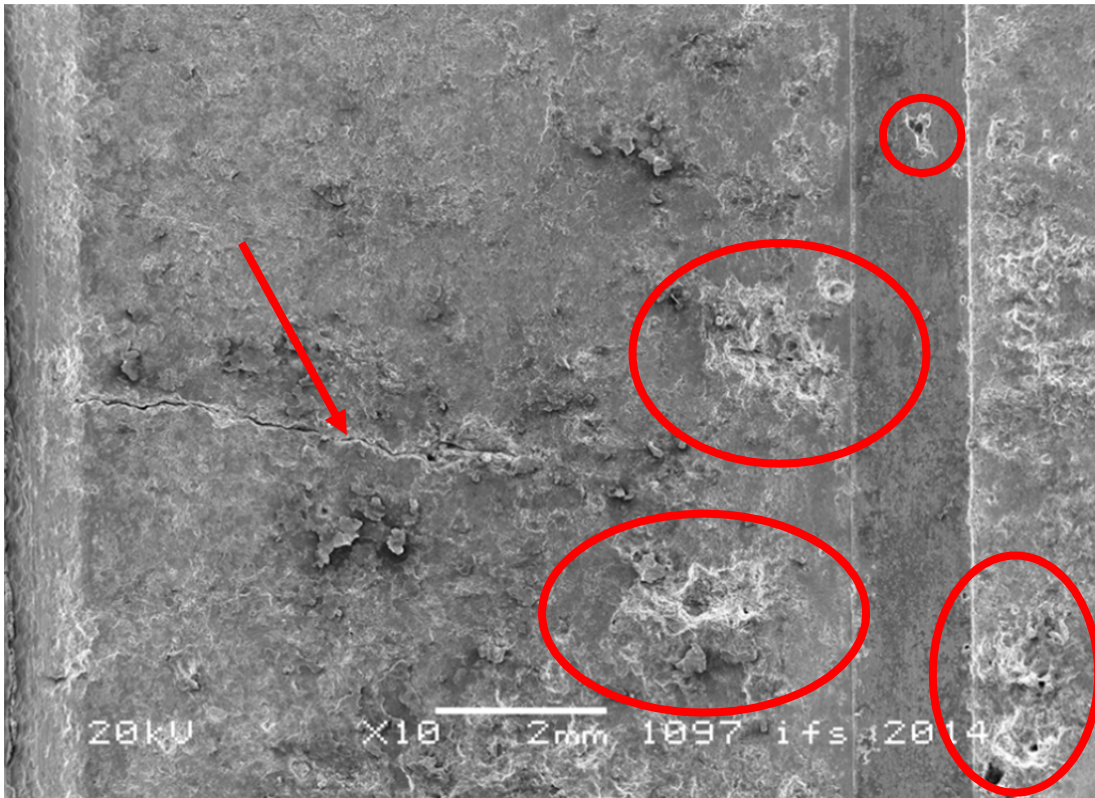
Image 16: Surface structure of the inside of the bearing seat, corrosive area (encircled) another crack (arrow), lubrication groove (right)

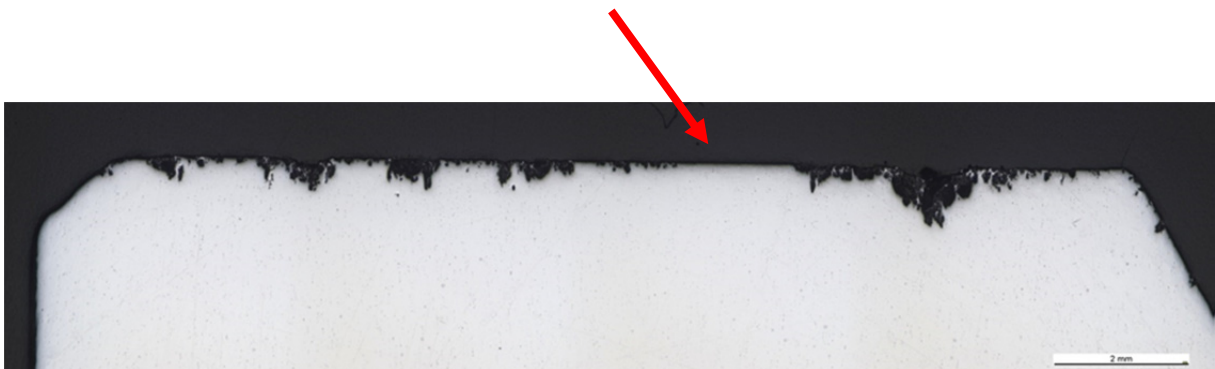
The metallographic cross specimen showed clearly strong corrosion on the entire inside of the fracture part. The base metal seemed to dissolve. It was also clearly visible that the areas outside the lubrication groove were significantly more affected. The metallographic examination also revealed that the groove of the drill hole surface had a different mechanical quality (Image 17).

Image 17: Metallographic overview of the heavily corroded inside with lubrication groove (arrow)

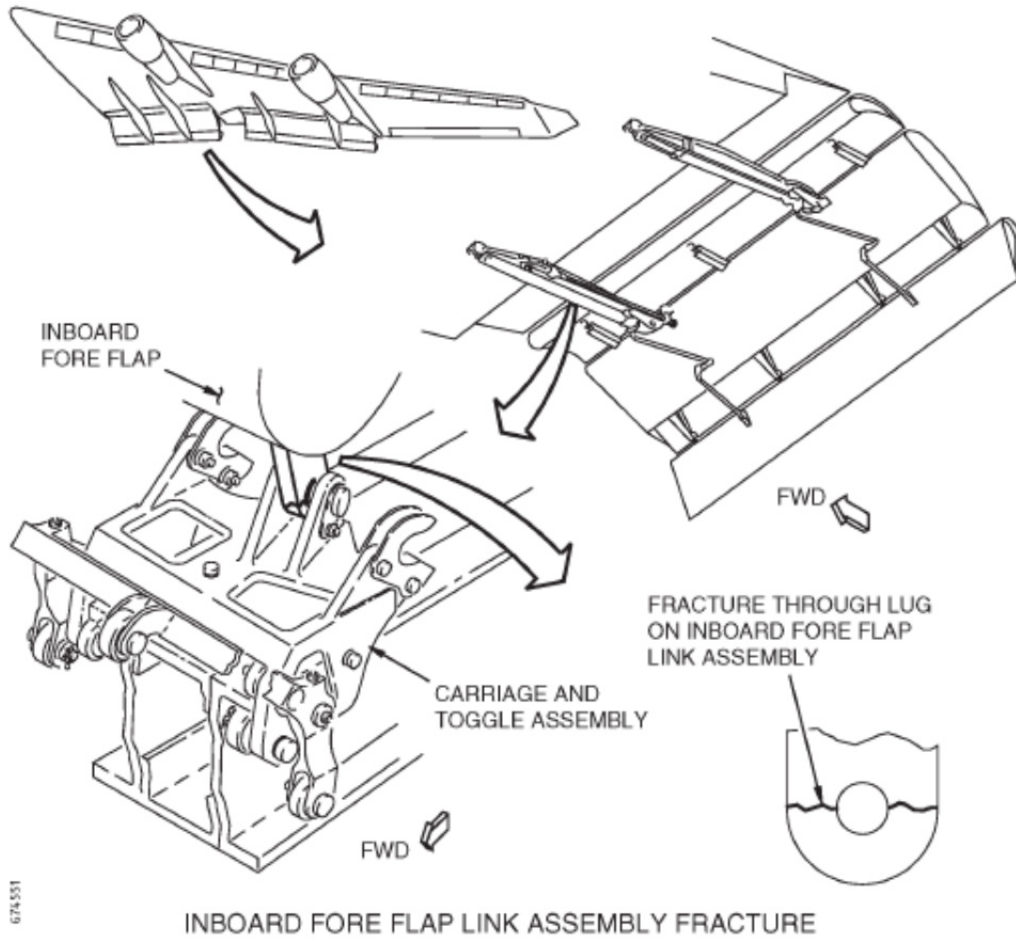
Attachment: Inboard Fore Flap Link Assembly Fracture

The inboard (P/N 65B17540-3) of the two fore flap attach fittings was found fractured and is considered the cause of the partial fore flap loss. Refer to Reference c) or d).

Boeing conducted a metallurgical analysis of the fractured fittings from the three prior events and found indications of Stress Corrosion Cracking (SCC) at the bore surface for each of the fittings.

Boeing recommends operators replace existing P/N 65B17540-3 with P/N 65B17540-5 link assemblies at a convenient maintenance opportunity such as during flap overhaul per Reference b).
