Investigation Report

Type of Occurrence:	Accident
Date:	21 July 2015
Location:	Gardelegen Special Airfield
Aircraft:	Glider
Manufacturer / Model:	Scheibe Flugzeugbau / Bergfalke IV
Injuries to Persons:	Two persons severely injured
Damage:	Aircraft severely damaged
Other Damage:	None
Information Source:	Investigation by BFU external experts for field investigation
State File Number:	BFU 15-0914-CX

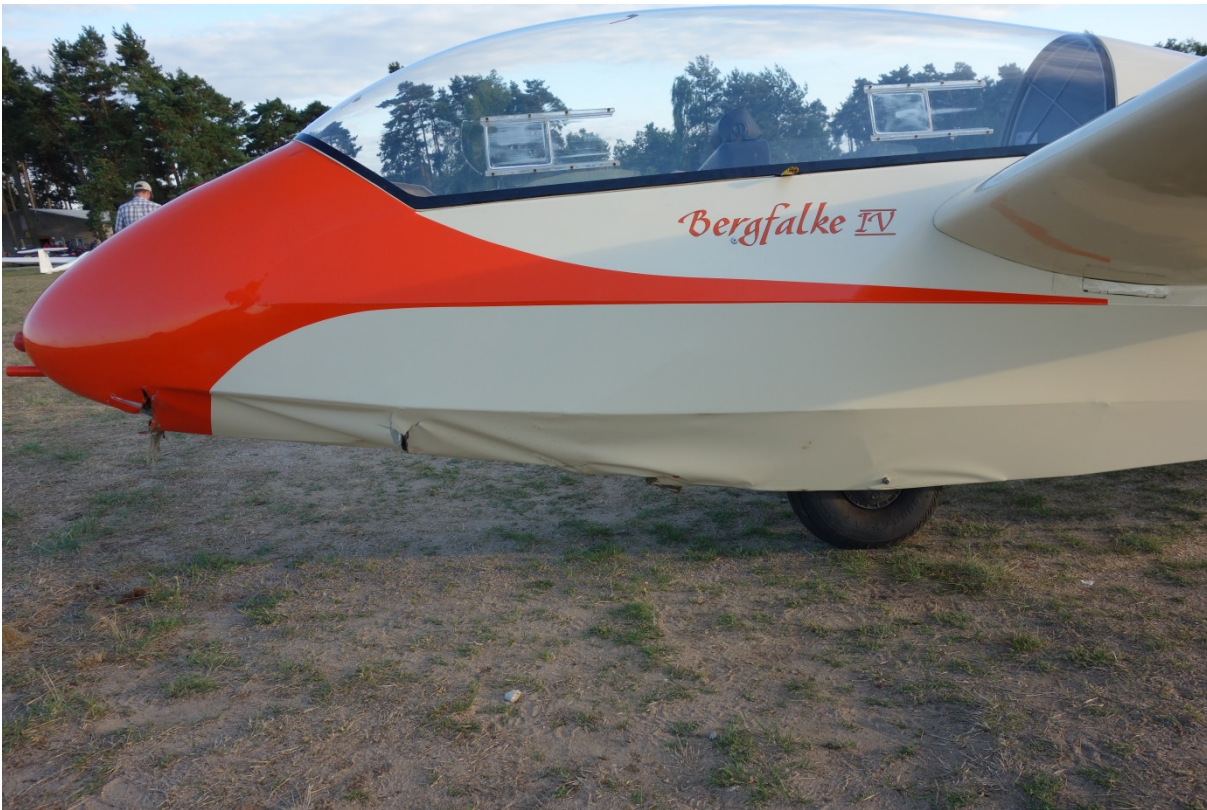
The bottom side of the front fuselage was bent inward up to the main wheel.

Damaged bottom fuselage

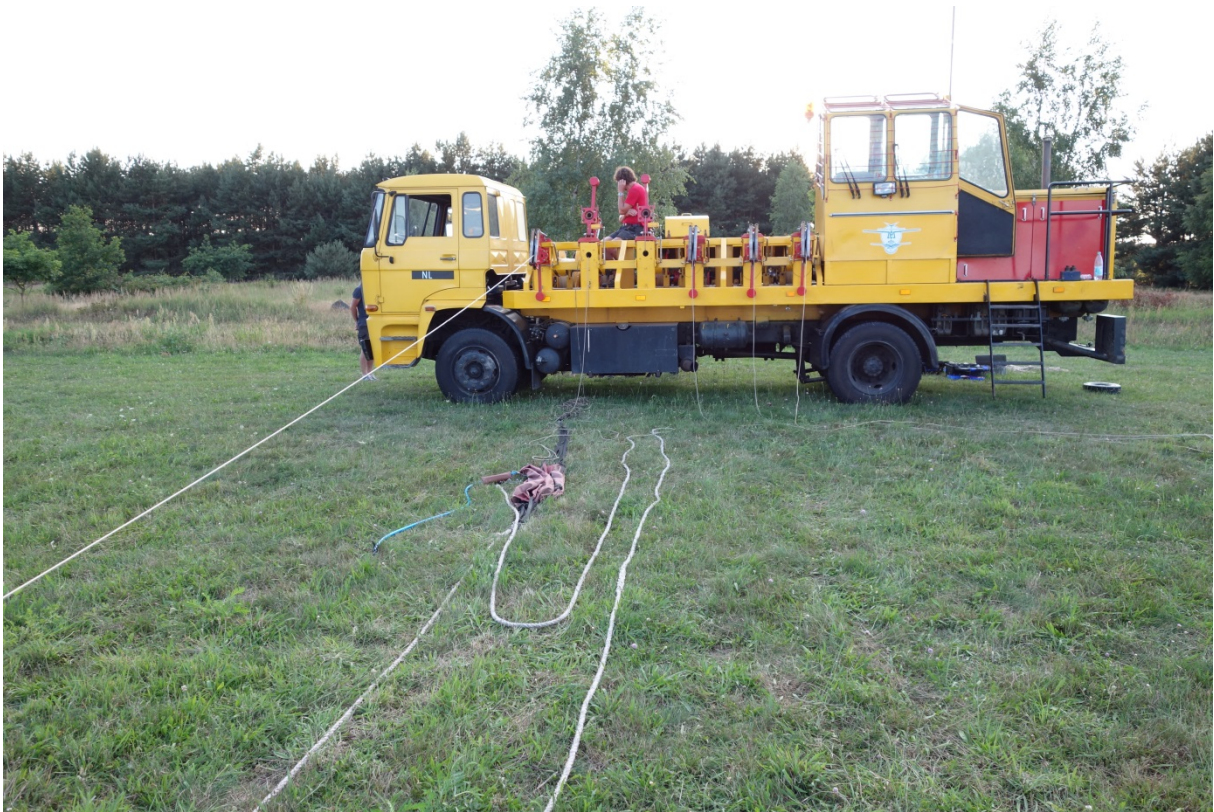
The examination of the winch determined that one loop of the towline used before had slipped over the side of the cable drum. All cable drums were driven by one axis which the towline had blocked. The towline consisted of Ultra-High Molecular Weight Polyethylene (UHMWPE) fibres (Dyneema).

Six cable drum launch winch Busio
