Investigation Report

Type of Occurrence:	Serious incident
Date:	31 March 2015
Location:	Wangerooge
Aircraft:	Airplane
Manufacturer / Model:	Britten Norman Limited / BN-2B-26
Injuries to Persons:	None
Damage:	Minor damage to aircraft
Other Damage:	None
State File Number:	BFU 7X004-15

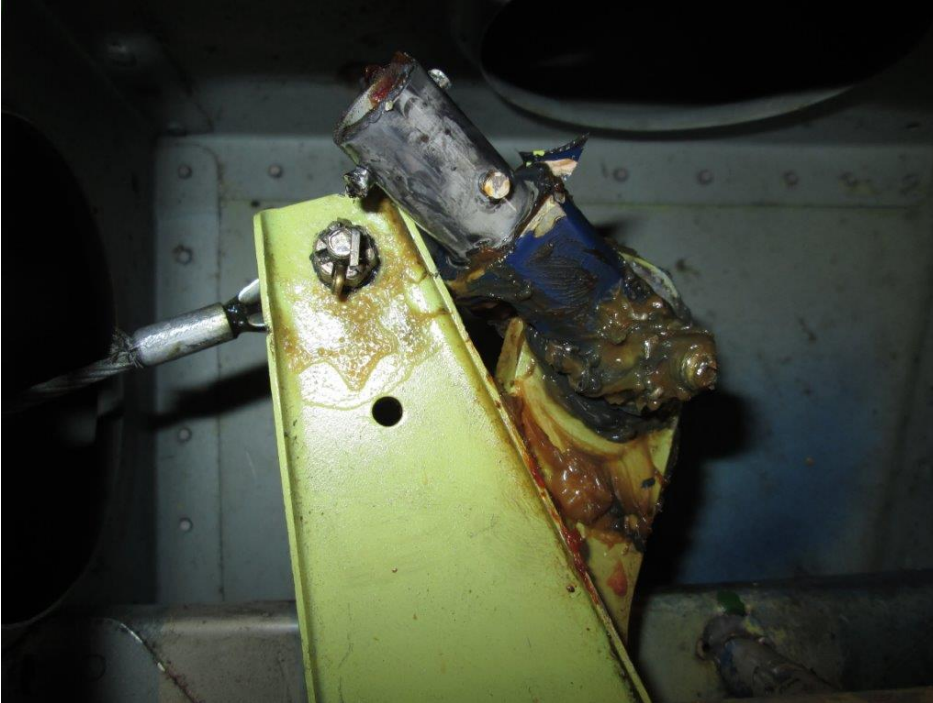
The rudder control rod was torn off the clevis, which was mounted to the rudder lever (Appendix Image 1). Two thirds of the part of the control rod mounted to the clevis were missing. The remaining third was bent backward (Appendix Image 2). The three rudder hinges were damaged. Image 3 (Appendix) shows the centre hinge.

Image 1: Rudder lever including clevis

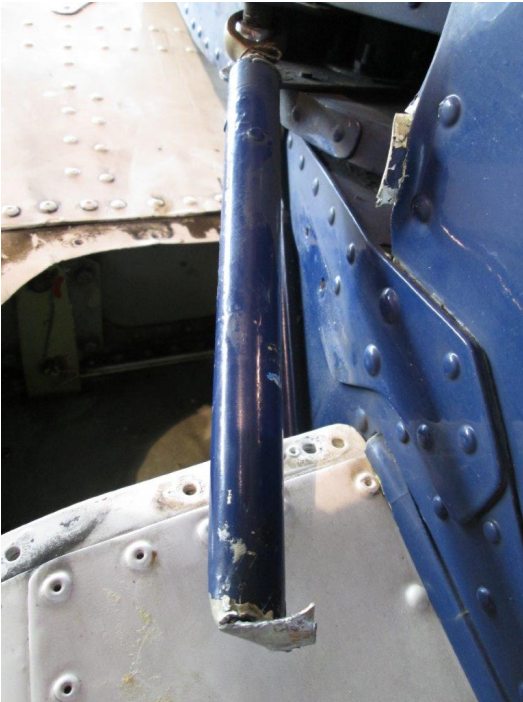
The rudder control rod failed due to ductile forced rupture in the form of a fracture by shear stress. The increased hardness of the fracture area was due to deformation hardening.

It is highly likely that the forced rupture occurred due to the high wind stress the rudder had transferred to the rod during taxiing in strong and gusty crosswind and tailwind. The wind stress occurred because of the strong and gusty west wind prevailing at the time of the serious incident. The gusty wind resulted in wind stress changes on the rudder during taxiing which was the critical factor.

Image 2: Torn-out control rod

The aircraft manufacturer should subject possible wind loads affecting the vertical tail, which are the result of wind speeds and air impingement angle during taxiing, to differentiated consideration and counteract resulting negative effects.

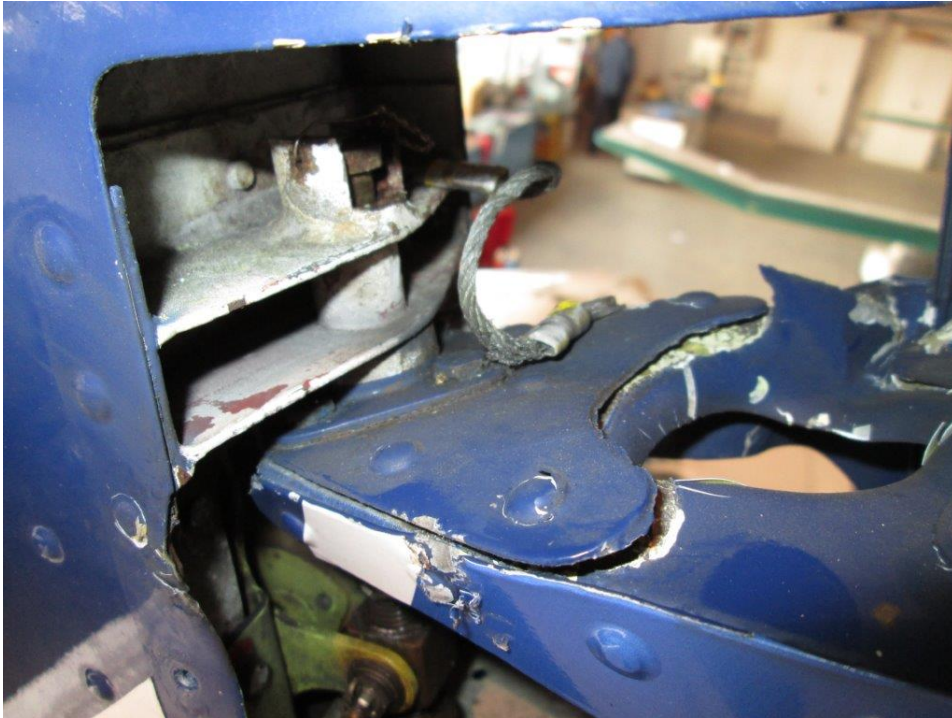
Image 3: Damaged centre rudder hinge

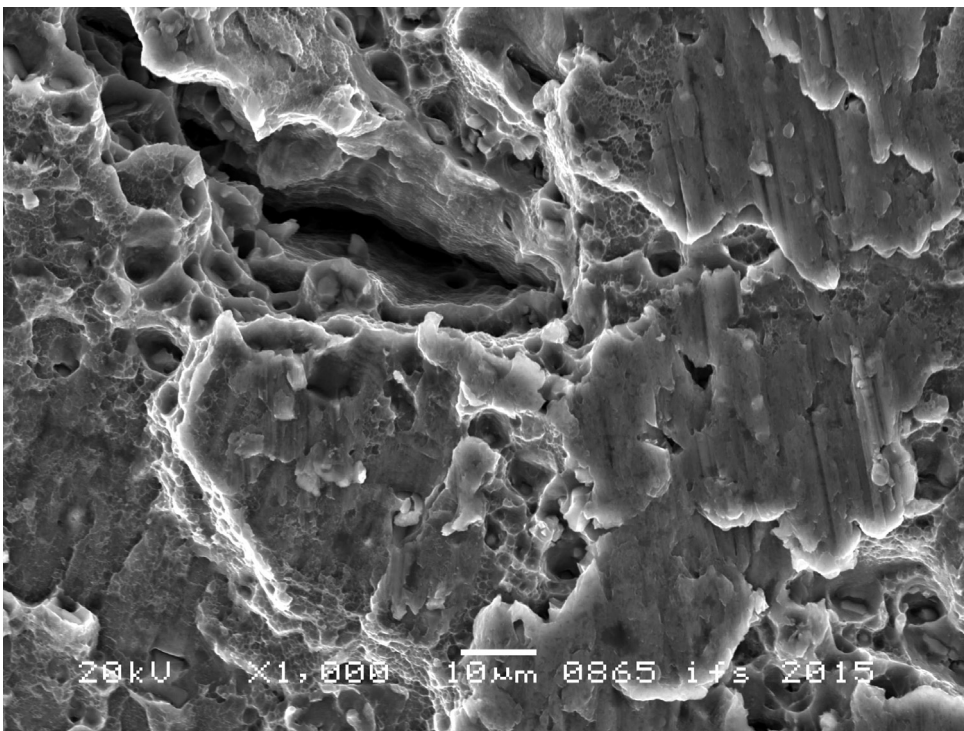
The examination of the fracture surface with a scanning electron microscope showed destroyed fracture structures. But there were enough intact fracture structures left. These showed repeated evidence of fracture by shear stress consisting of slip lines and shear dimples (Appendix Images 4 and 5). The residual fracture occurred as ductile forced rupture (Appendix Image 6).

Image 4: Ductile fracture surface with shear lines

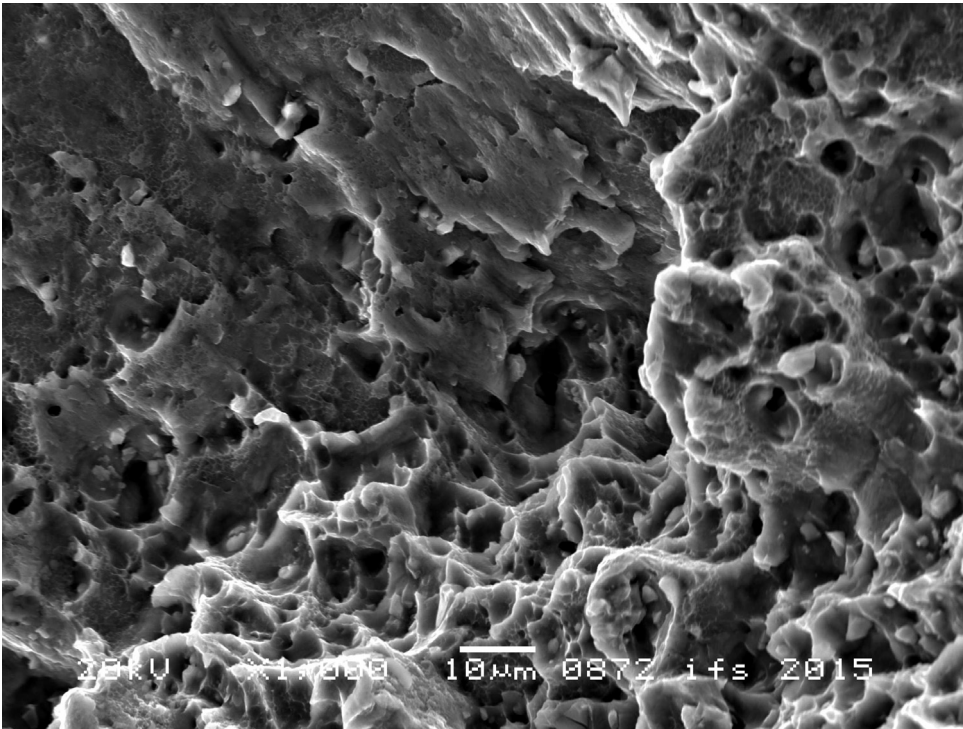
Image 5: Ductile forced fracture structure with shear dimples

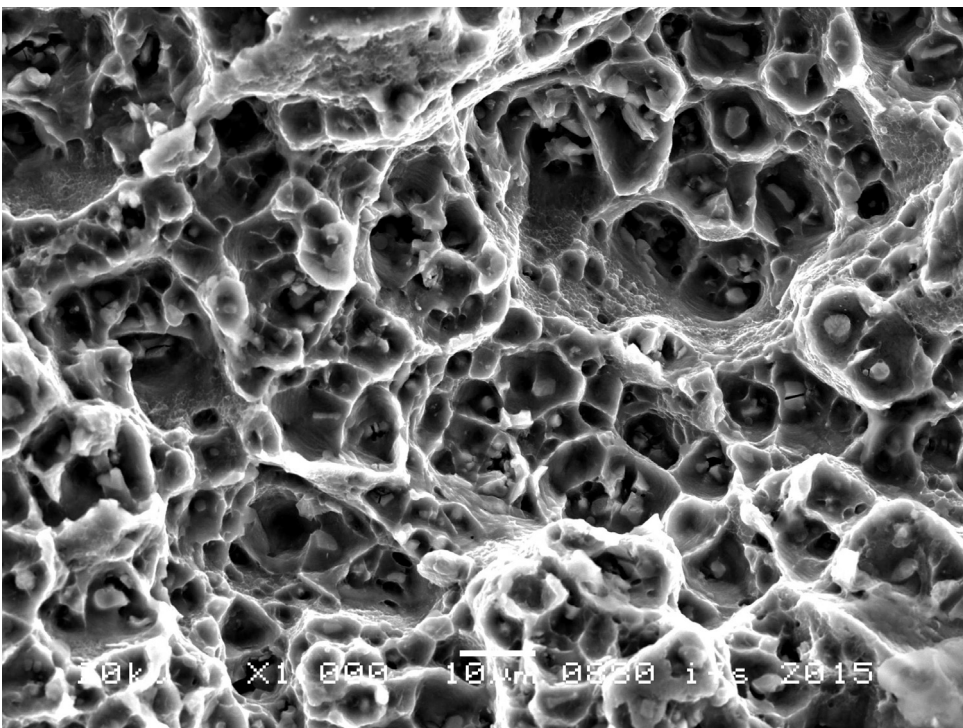
Image 6: Ductile forced rupture and residual fracture structure
