Investigation Report

Type of Occurrence:	Accident
Date:	8 May 2016
Location:	Teising
Aircraft:	Ultralight aircraft
Manufacturer / Model:	JMB Aircraft s.r.o. / Aveko VL-3 E
Injuries to Persons:	Two persons fatally injured
Damage:	Aircraft destroyed
Other Damage:	Crop damage
State File Number:	BFU16-0524-3X

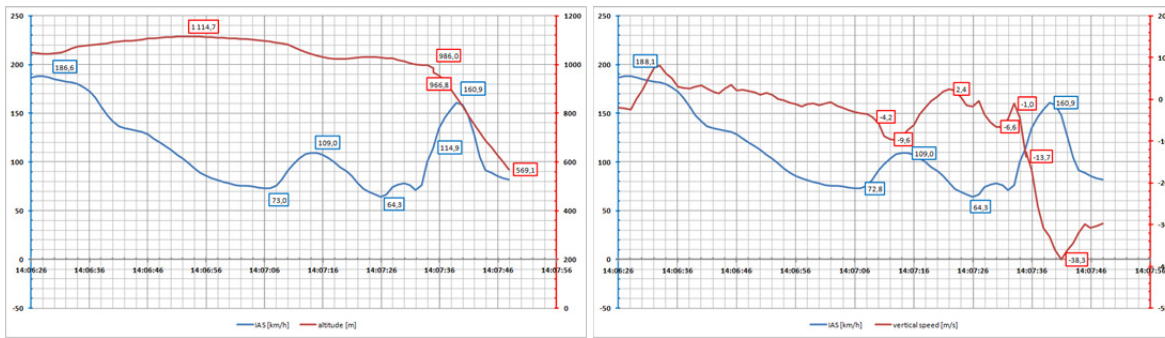
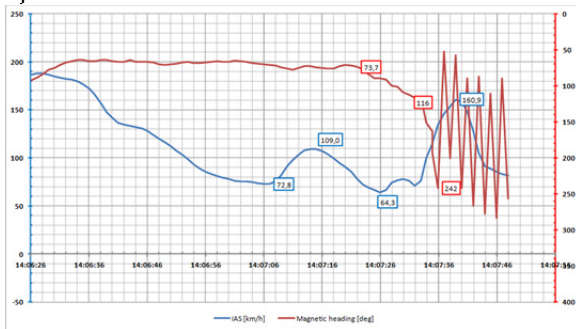
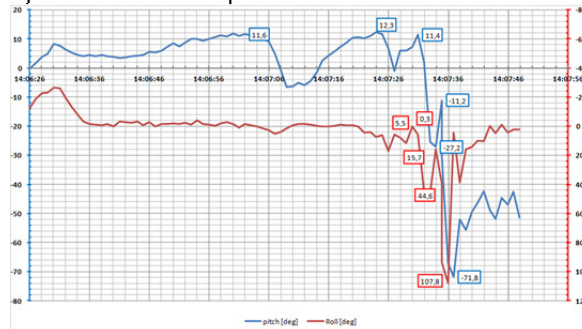
Selected parameters of the analysed Garmin data

According to this analysed data take-off occurred at 1602 hrs. The ultralight climbed to 1,080 m AMSL. During cruise flight a maximum ground speed of 200 km/h was reached. At 1606 hrs engine thrust was selected to idle and ground speed reduced to 76 km/h. A pitch of 11.6 degrees and no bank angle were recorded. After a stall warning speed increased to 109 km/h with a rate of descent of -9.6 m/s. Engine thrust was increased to 2,670 revolutions per Minute (RPM). This was followed by climb with a rate of 2.44 m/s and subsequent speed reduction to 79 km/h and engine thrust at idle. The angle of attack was increased and the flight continued with a pitch of 11 to 12 degrees. The rate of descent was -1.7 m/s and the bank angle 5 to 6 degrees. With this configuration the speed was further decreased to 64 to 72 km/h. The rate of descent increased to -6.6 m/s. At 1407 hrs the pitch angle changed within 0.5 seconds from 12° to -1° and the bank angle increased from 5° to 16°. Then the pitch angle was 11.5° and the bank angle 5° to 6°. The speed was between 64 and 72 km/h. The rate of descent was 6.6 m/s. For six seconds this configuration was maintained until stall occurred at 1607:32 hrs. The ultralight entered a right spiral. At 1607:32 for 0.3 seconds engine thrust was increased to 4,040 rpm and then selected to idle. At 1607:48 hrs the recording ended.

The investigation revealed that after take-off in Mühldorf the aircraft initially climbed to 918 m AMSL and then turns with bank angles of 45° to 60° were flown. At 1,080 m AMSL at 1606:33 hrs the engine thrust was selected to idle. Almost with stall speed the ultralight turned right with slight bank angle and large angle of attack. During the manoeuvre the rate of descent was -6.6 m/s. During the time period between the engine thrust "idle" and the manoeuvre with a rate of descent of -6.6 m/s the engine thrust was at least once increased to 2,670 rpm/m and again reduced to idle. This configuration resulted in stall on the right wing. During the attempt to

recover a stabilised flight attitude the pitch and bank angle and the engine performance were changed speedily. This resulted in a significant increase in angle of attack and stall at the wings.

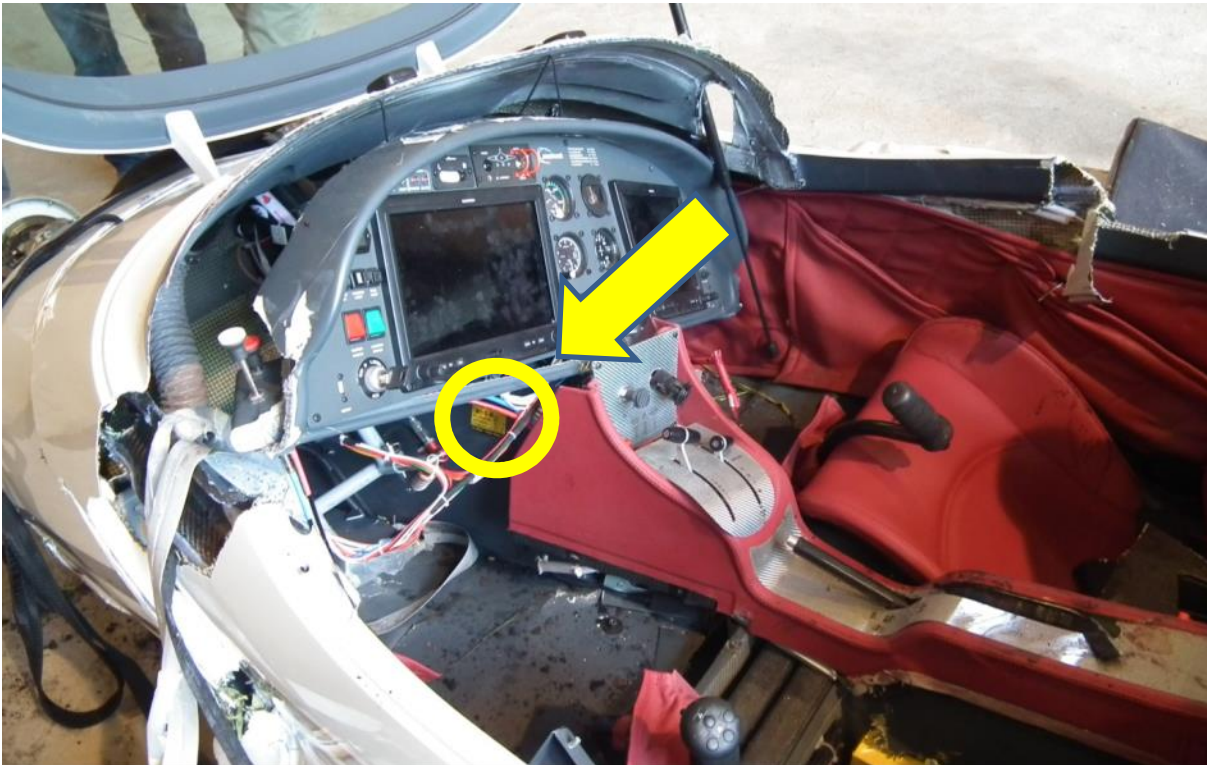
Interior with load label

A weight label was located below the instrument panel in the pilot's leg area of the ultralight. Payload was listed with 125.1 kg.

The loading label with the maximum allowable payload had been mounted in the leg area below the instrument panel. The BFU is of the opinion that the requirement according to the Airworthiness Directive (AD) No: LSG 05-004, which states that the loading label should be mounted in the field of vision of the pilot, was not properly executed. The requirement's purpose was to visibly inform the occupant of an ultralight about the limited payload and a possible overloading of the ultralight.

The maximum take-off mass of the ultralight was exceeded. The BFU is of the opinion that both pilots should have been aware that they were flying an overloaded ultralight. A corresponding label with the maximum allowable payload (125.1 kg) was installed in the cockpit, but not in the in direct visual range of the occupants.
