# Investigation Report

Type of Occurrence:	Accident
Date:	26 June 2016
Location:	Near Hofgeismar
Aircraft:	Helicopter
Manufacturer / Model:	Bell Helicopter Textron / Bell 407
Injuries to Persons:	None
Damage:	Aircraft severely damaged
Other Damage:	None
State File Number:	BFU16-0848-3X

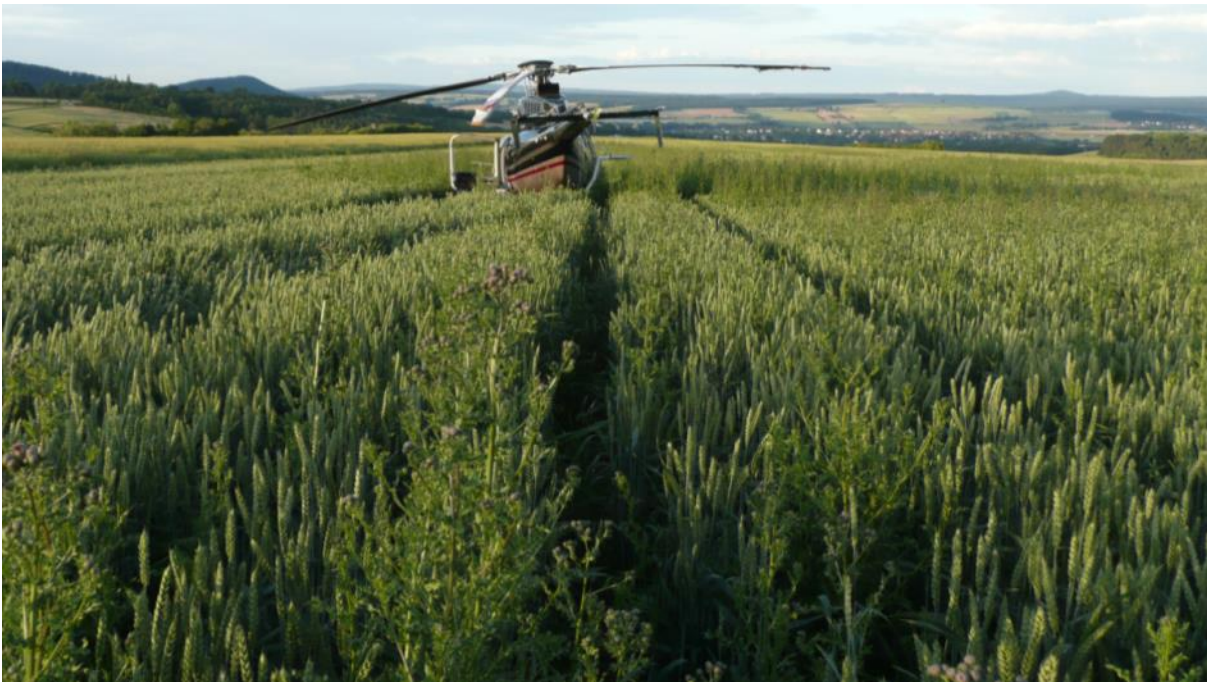
The accident site was located between the townships Friedrichsdorf and Hofgeismar approximately in the middle of a slightly downward sloping grain field. The helicopter stood upright at the end of skid marks, which were about 24 m long, pointing to about 30°.

Overview accident site

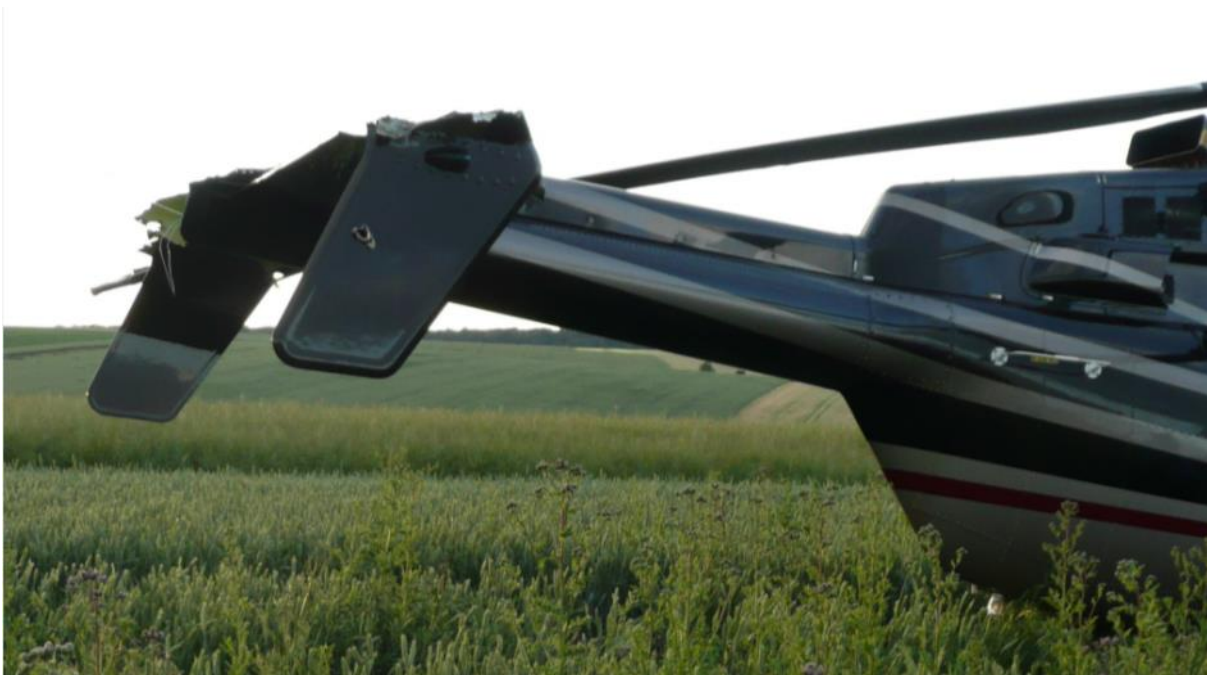
All four main rotor blades and the rotor head were damaged. The tail boom had been severed abeam of the horizontal stabilizer. The outer vertical fins had been severed above the horizontal stabilizer. The vertical fin together with the tail rotor including the fractured tail rotor gear box were found in the field south-east of the helicopter. The aft crosstubes of the skids were bent outwards.

Damaged tail of the helicopter

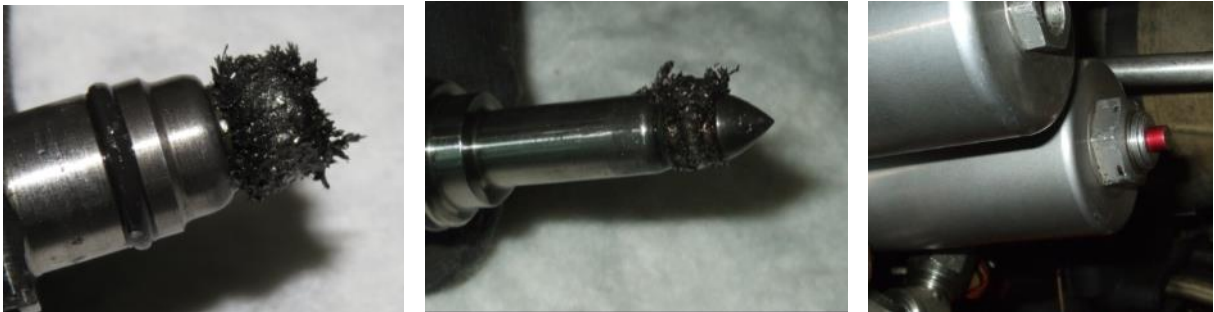
After the helicopter had been salvaged the engine was examined in the presence of an expert of the engine manufacturer. It was determined that the engine was still mounted correctly and did not show any external damage. All air pressure, oil, and fuel pipes seemed to be undamaged and without leakages. The compressor did not show any foreign object damages. The N1 and N2 power train could manually be turned and power transmission was possible. In the N2 power train strong friction and grinding noises were observed. The examination of the two chip detectors revealed numerous metal chips. The bypass-pop-out of the oil filter at the engine had also been triggered.

Metal chips in the engine oil circulation

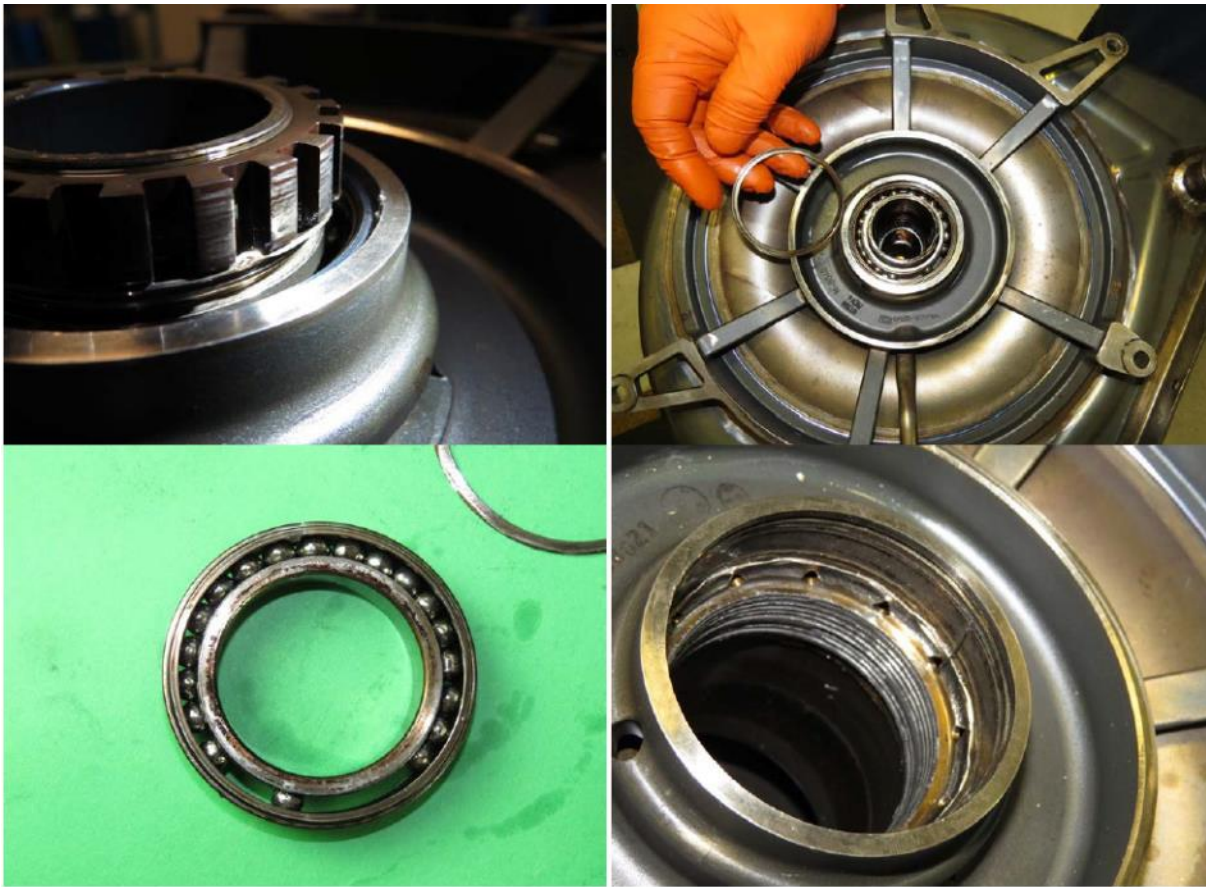
The examination at the engine manufacturer occurred on 11 November 2016. The engine disassembly showed damage of the No 5 bearing (Version Part Number 6871505, operating time of about 1,341 hours and 1,479 cycles) and a damaged N2 sensor.

The No 5 bearing at the time of the engine disassembly

The examination of the engine at the manufacturer's in the USA showed that the No 5 bearing was the cause for the power loss which was recognised by the pilot, the

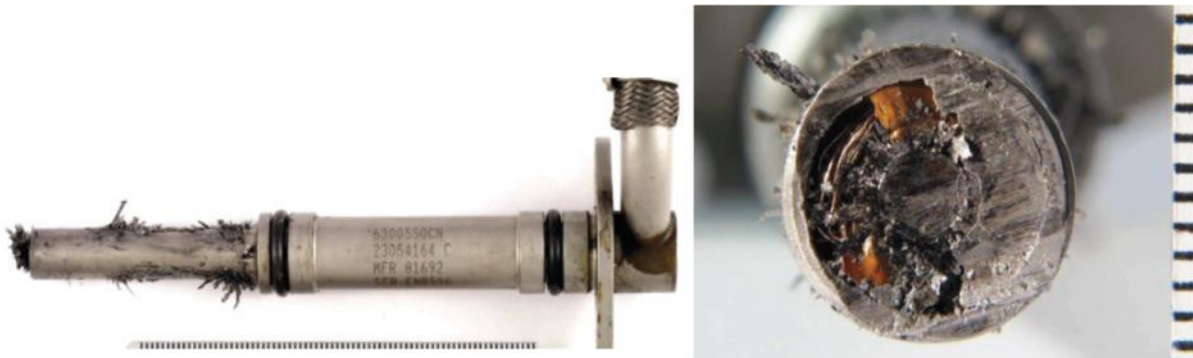
Damages at the N2 Sensor

- No ECU hard faults were recorded during the event which would have triggered the incident recorder. The N2 sensor fault recorded is consistent with the damage discovered resulting from the #5 bearing retaining nut contacted and damaging the N2 speed pick up sensor.*

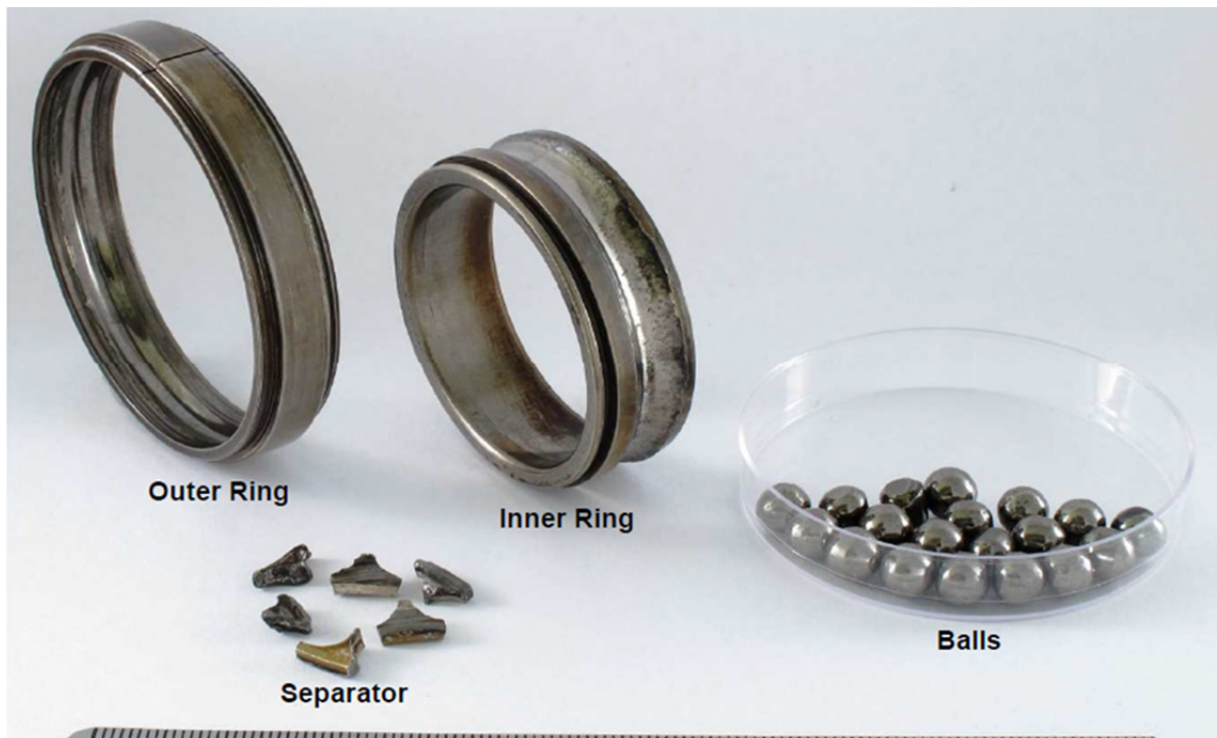
- *The No. 5 bearing separator fractured into several fragments and the outer diameter surface exhibited rub damage from rubbing against the inner diameter surfaces of the outer ring. Smearing of the fracture surfaces precluded the identification of a fracture mode.*

- *The No. 5 bearing outer ring shoulders exhibited fretting from contact with the four holding rings. The inner diameter of the outer ring exhibited re-deposited material rolled over the full circumference of the forward edge of the raceway. The outer ring shoulders also exhibited rub damage from the separator around the full circumference of the outer ring; the rub damage pattern forward of the raceway was different than the rub damage pattern aft of the raceway. The forward outer ring raceway surface exhibited evidence of thermal distress. The manufactured split in the outer ring exhibited damage consistent with heavy hammering between the two mating surfaces.*

- *The No. 5 bearing inner ring exhibited re-deposited material around the full circumference of the raceway. The forward shoulder of the raceway exhibited a rolled edge continuously for approximately 90° and discontinuously around the rest of the circumference while the aft shoulder exhibited a rolled edge around the full circumference. More material rolled over the aft shoulder of the inner raceway than*

*the forward shoulder. The aft inner ring raceway surface exhibited evidence of thermal distress.*

- All of the No. 5 bearing balls exhibited thermal distress and varying degrees of re-deposited material. Twelve (12) of the nineteen (19) balls were barrel shaped.*

- The No. 5 bearing aft holding rings fractured from fatigue crack initiation and propagation that transitioned to overload. Fatigue initiated on the outer diameter surface and then on the inner diameter surface of aft holding ring A, while fatigue only initiated on the outer diameter surface of aft holding ring B. The No. 5 bearing forward holding rings fractured from overload. The faces of all the holding rings were fretted and worn. The inner diameter surfaces of all the holding rings were not flat, indicating the inner diameter surfaces of the holding rings were not completely flush with the No. 5 bearing outer ring.*

- The No. 5 bearing lost the ability to axially and radially position the power turbine and related shafting due to the failure of the separator and holding rings. The sequence of failure between the separator and the holding rings could not be determined.*
