Investigation Report

Type of Occurrence:	Accident
Date:	26 July 2016
Location:	Senheim
Aircraft:	Helicopter
Manufacturer / Model:	MD Helicopters Inc. / HU 369E
Injuries to Persons:	Pilot slightly injured
Damage:	Aircraft severely damaged
Other Damage:	None
State File Number:	BFU16-1037-3X

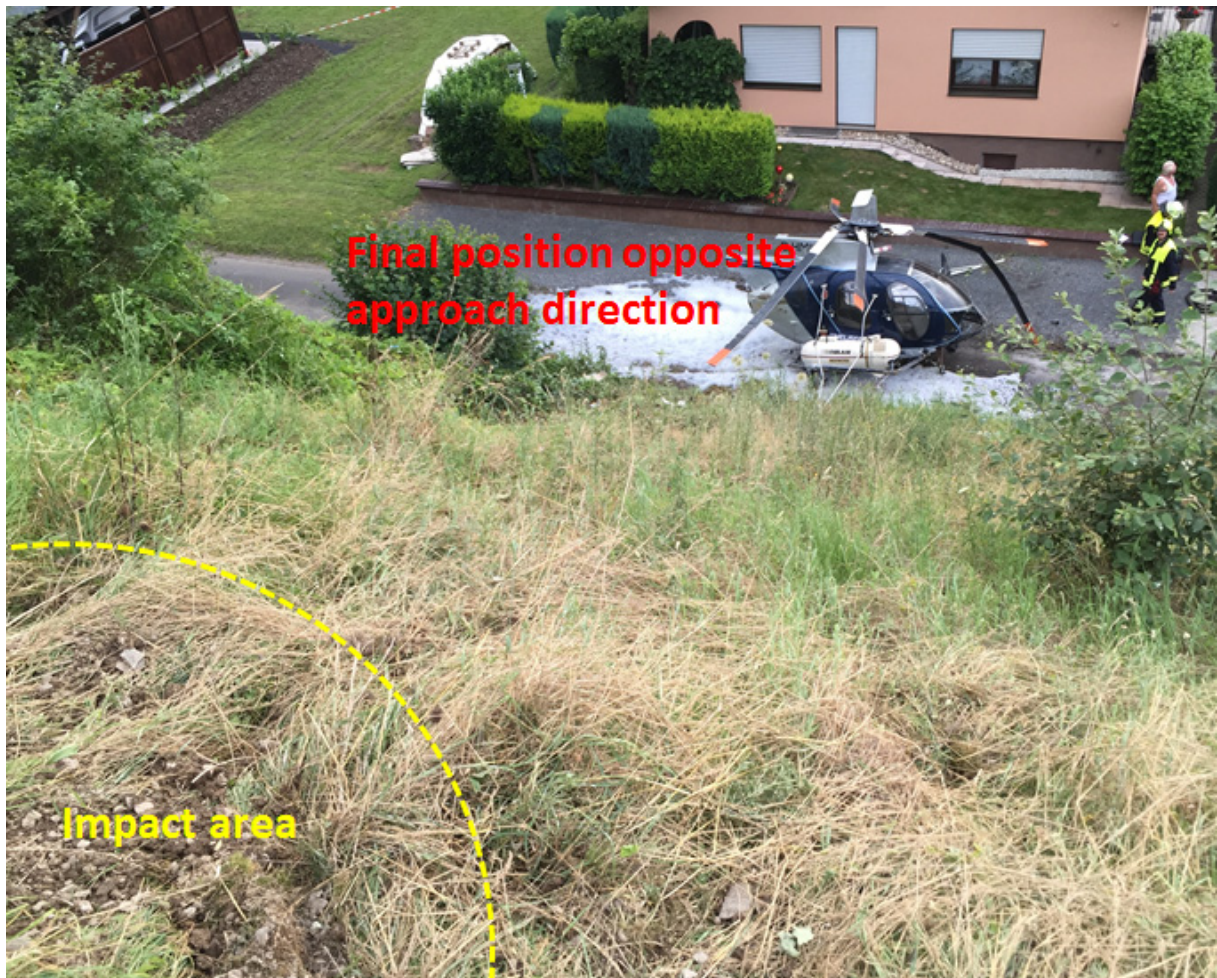
With low horizontal velocity he touched down on the slope, which declined by about 40°. The helicopter slid down the slope by about 20 m and came severely damaged to a stop standing upright on a street opposite the flight direction.

Overview accident site and final position of the helicopter

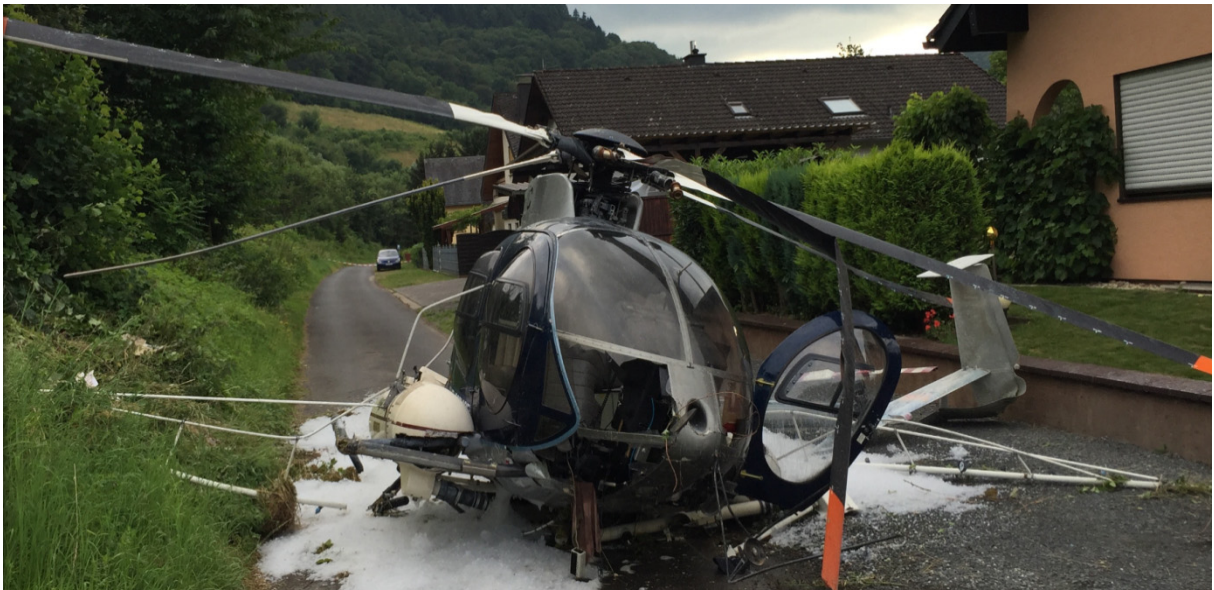
The left skid was found at the slope at the impact site. Between the impact site at the slope and the final position of the wreckage the tail skid, fairing pieces and fracture pieces of the cockpit were found. The tail boom had been torn off and was lying in the street next to the fuselage. The right skid had fractured and its front part penetrated the cockpit. The rotor blades were bent. The spraying agent tanks had burst open and the spraying beams were bent. Fuel and spraying agent were leaking on to the accident site.

Accident site and helicopter damages

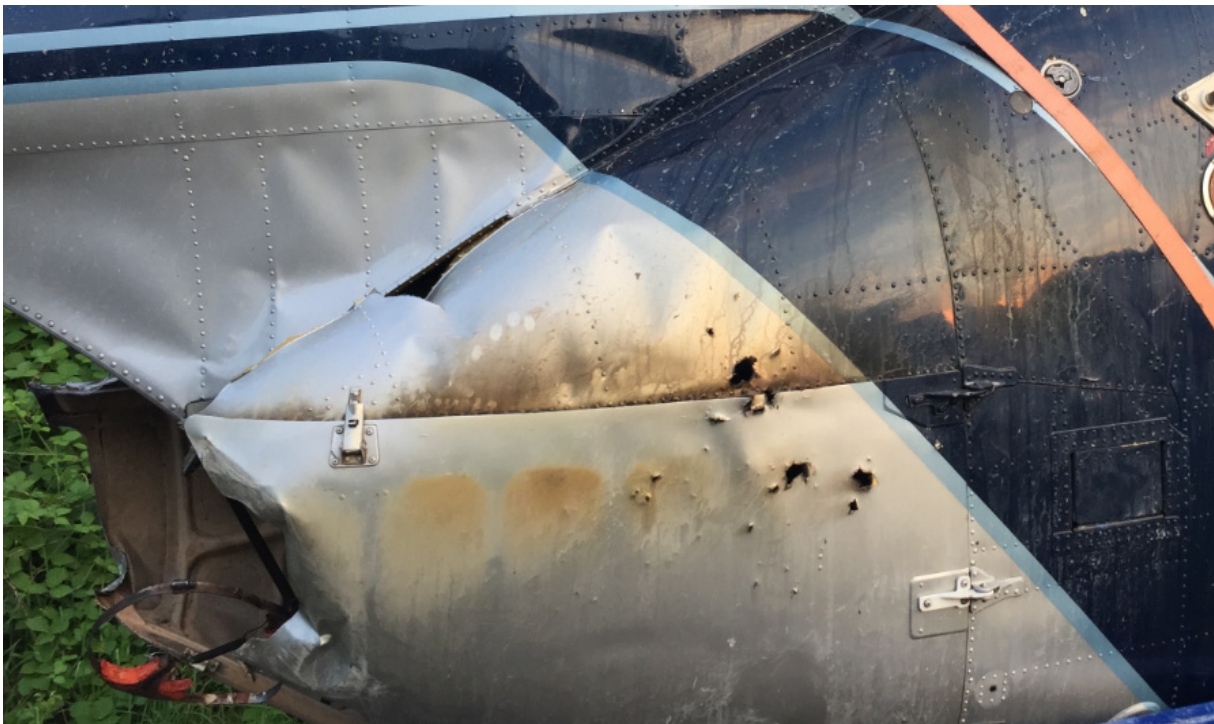
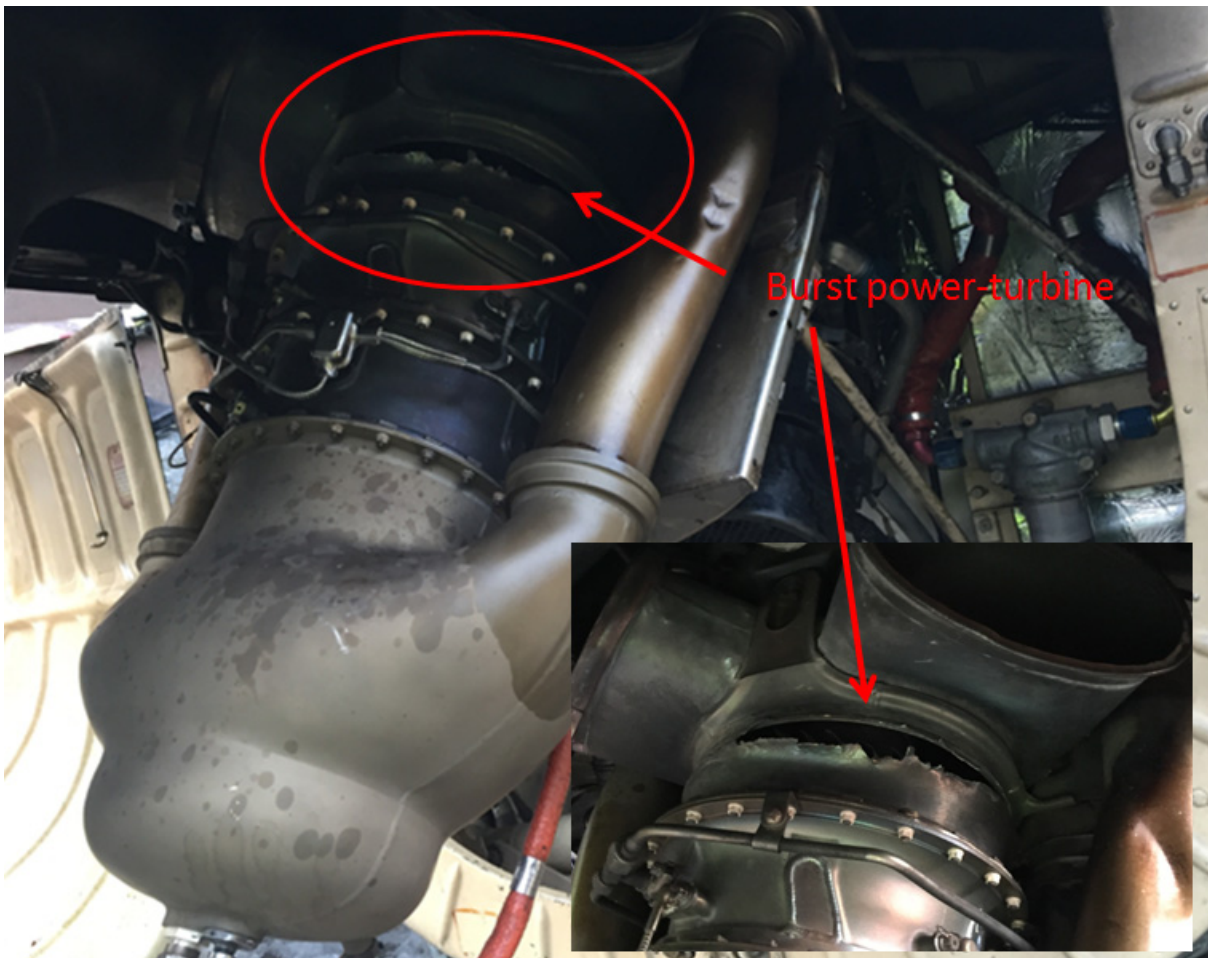
The external surface of the right fuselage side above the engine was coated with a brown film (soot). The paint of the engine bay doors was discoloured which is consistent with contact by hot exhaust gases. The right side of the fuselage by the engine bay exhibited multiple holes in the plane of the engine power turbine, the edges of which were 'petalled' outwards. The engine had sustained an uncontained internal failure in the plane of the power turbine.

Damages in the area of the engine doors and on the turbine

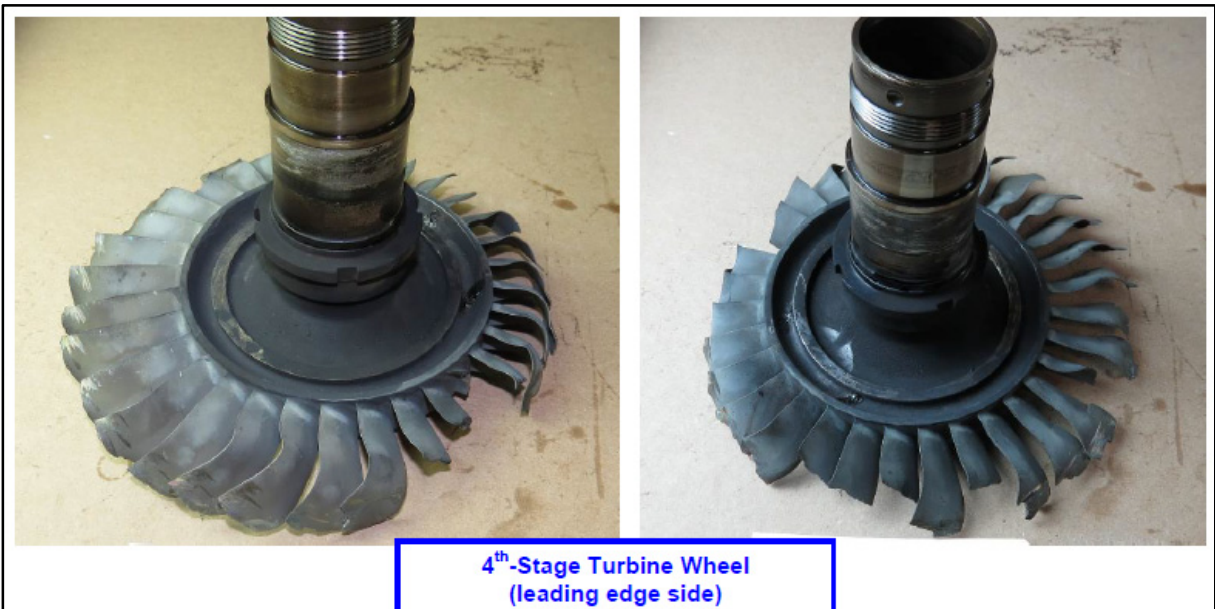
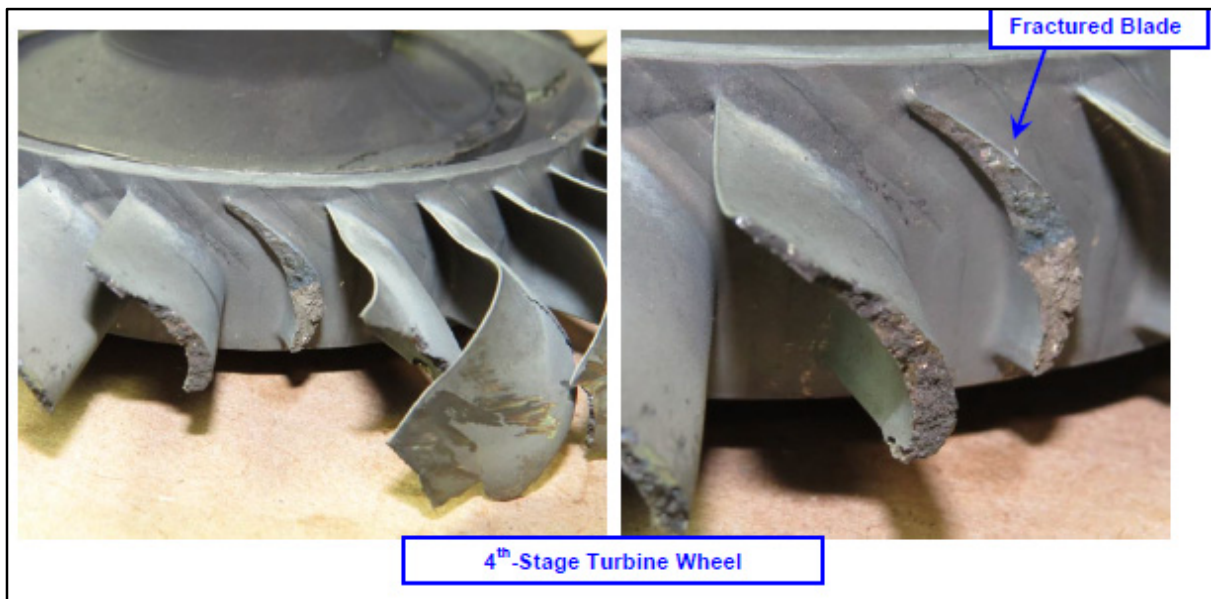
The disassembly of the engine occurred on 20 October 2016 at the engine manufacturer's facilities under supervision of the National Transportation Safety Board (NTSB). The examination revealed that the cause for the engine failure was a high-cycle fatigue fracture of one blade of the 2nd stage power turbine (or 4th stage turbine) wheel.

- A single blade on the 4th-stage turbine wheel fractured in fatigue from an origin at the trailing edge approximately 0.036 inch above the rim of the wheel. The fatigue initiated and progressed approximately 0.511 inch in high cycle fatigue before separating in overload. No material anomalies were present at the origin area and no additional fatigue cracks were present in the other blades.

- Damage to the other components received by the laboratory was consistent with secondary damage as a result of liberated blade and/or the imbalance condition caused by the liberation of a fourth stage turbine wheel blade.

- According to the metallurgical evaluation, the pattern and appearance of the fracture on the subject accident 4th-stage turbine wheel was similar to other post-SB CEB-1365 failures.

Damages on the fourth turbine stage

The examination of the engine determined that in this case a high-cycle fatigue fracture of one blade of the fourth turbine stage was the cause of the power turbine failure and therefore the engine failure. According to the statements of the engine manufacturer and the NTSB the damage pattern and the development of fatigue fracture correspond with the findings of past investigation of engine failures of the M250-C20 engine series with CEB-1365-enhanced power turbine.

In the experience of the engine manufacturer, such a high-cycle fatigue fracture is caused by temporary operation of the engine in the area of 71% to 88% N2 rpm. According to the Alert SB CEB-A-1400 Rev. 4 of 16 March 2016 and the flight manual (CSP-E-1 Limitations, Pages 2-7) this should explicitly be avoided. Currently the helicopter manufacturer does not intend to add a corresponding colour-coded marking of the rpm area to the N2 indicator.

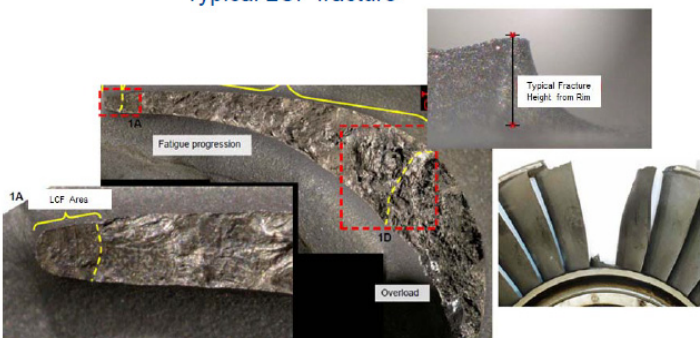
- Fractures initiate outboard of the rim at the Trailing Edge (TE)
 - Eight (8)* Low Cycle Fatigue (LCF) initiated events driven by engine start combined with high speed and thermal gradients; material experiences large stress-strain yield at TE hub (failure location)
 - Two (2) High Cycle Fatigue (HCF) initiated events due to operation on an airfoil natural frequency (reason for expanded speed avoidance range)
- * Eighth event based on preliminary findings
- Cracks then propagate in HCF before the airfoil separates in overload

Typical LCF fracture

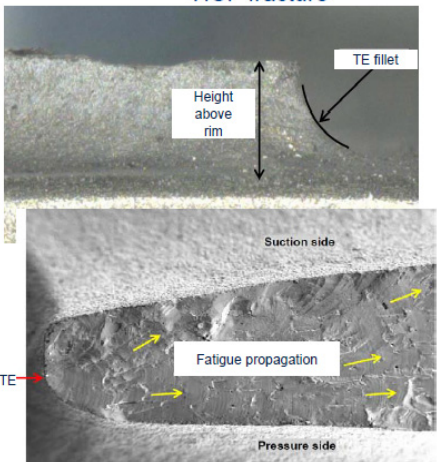
Affected turbine HCF fracture

Origin area at TE of blade
