Aviation Short Investigation Bulletin

Issue 11

ATSB Transport Safety Report
Aviation Short Investigations
AB-2012-088
Final

Report No. AB-2012-088

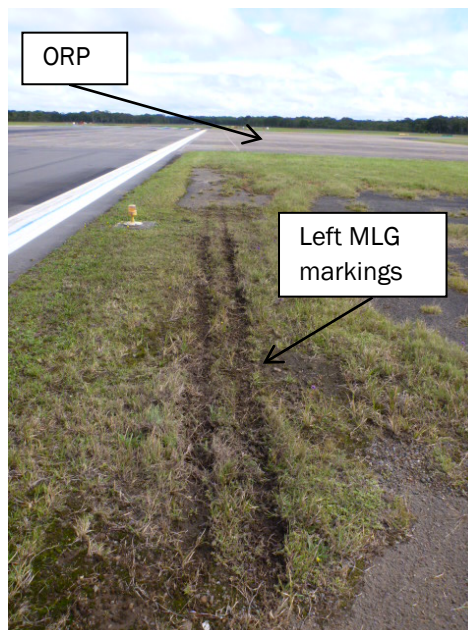
Figure 1: Wheel markings (looking back in direction of threshold runway 12)

An inspection of the wheel markings showed that the left main landing gear departed the ORP adjacent to runway 12, 145 metres from the threshold, tracking straight (Figure 1).

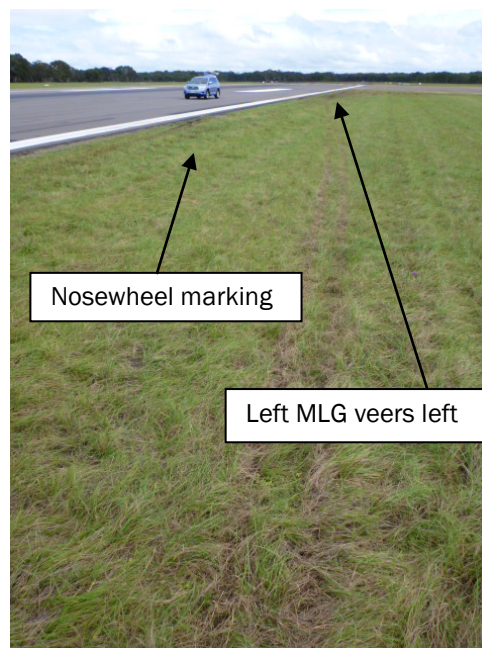
Figure 2: Wheel markings, left MLG and nosewheel

The aircraft then veered left and the nosewheel entered the grass at about 180 metres (Figure 2).

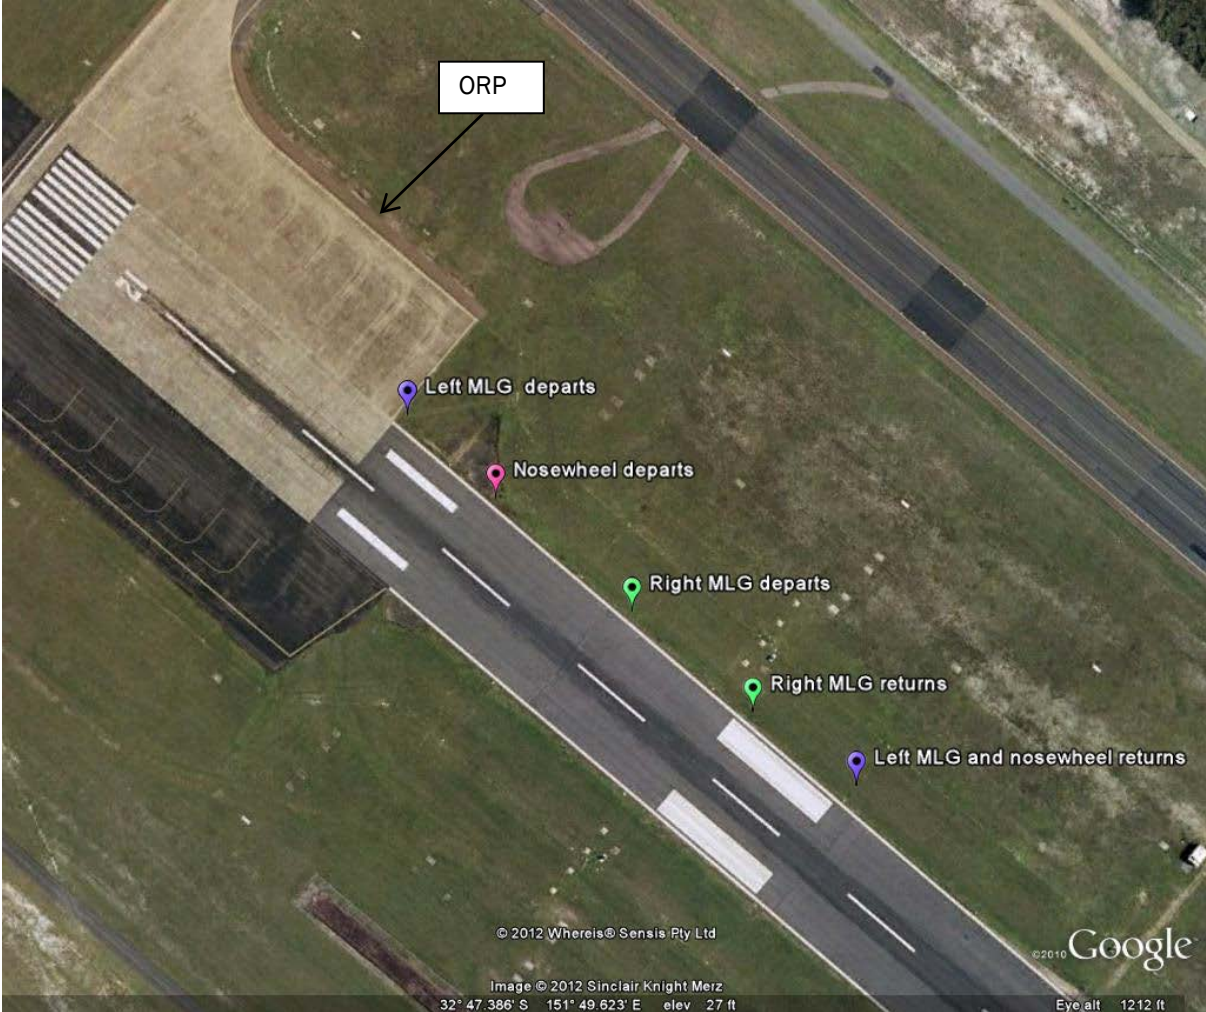
Figure 3: ORP and approximate location of runway excursion wheel markings

The right main landing gear contacted the grass at about 240 metres after impacting a runway edge light. The right main landing gear re-entered the runway at about 300 metres, with the nose wheel and left main landing returning to the sealed runway surface at about 330 metres (Figure 3).

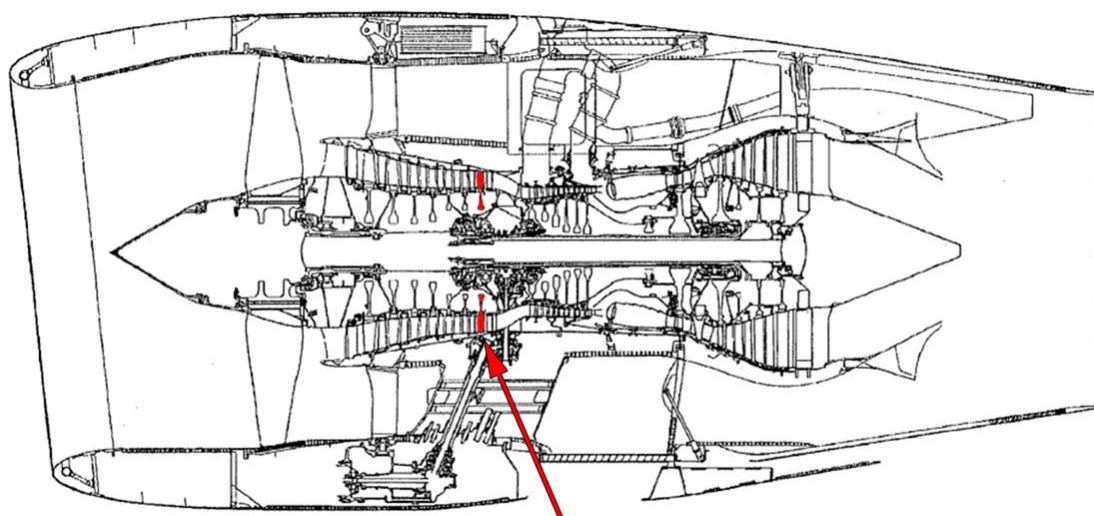
Figure 1: RB211-524 engine with stage 7 IPC rotor highlighted

The initial inspection showed that a single, stage 7 intermediate pressure compressor (IPC) blade had separated from its slot in the compressor disc (Figure 1). Disassembly of the engine confirmed the blade release and revealed significant damage to the remaining IPC blades as well as to the surrounding components.

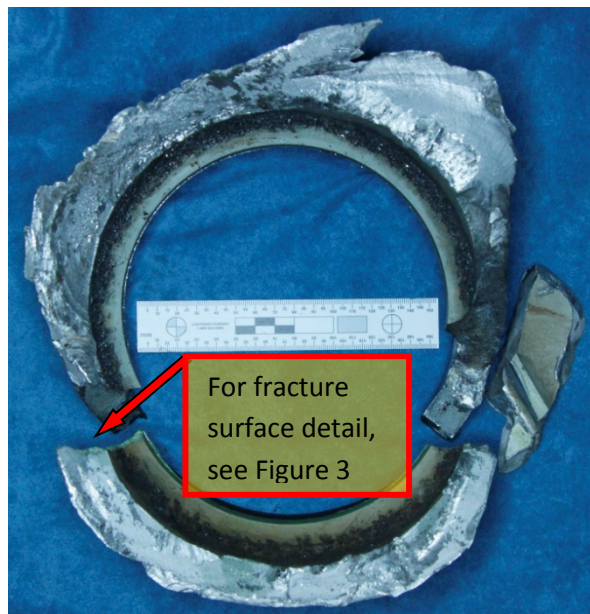
Figure 2: Principal pieces of the wheel hub

The wheel's hub had separated from its rim and had broken into three principal (Figure 2) and three sub-60mm pieces.

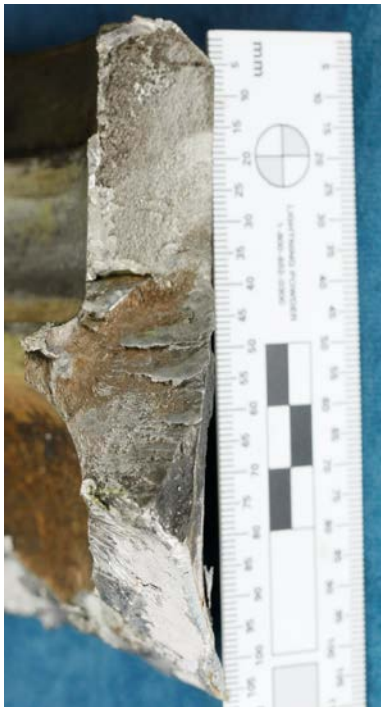
Figure 3: Discoloured and grey fracture zones

Examination of the fracture surfaces showed two zones: a discoloured zone concentrated around the bearing shoulder and the remaining, bright, metallic-grey zone (Figure 3).

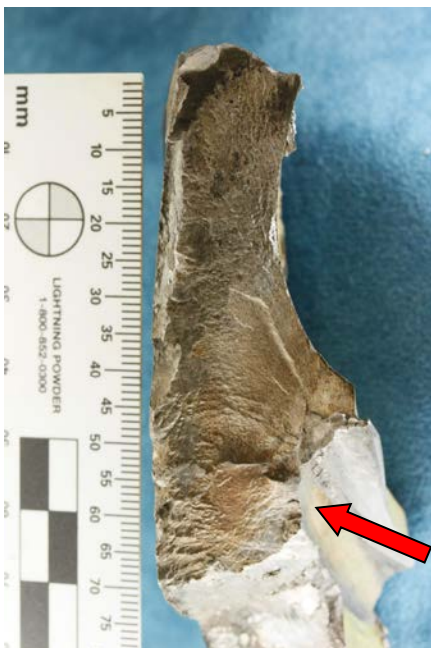
Oblique lighting showed chevrons emanating from the bearing shoulder radius (Figure 4). Microscopic examinations of the radius showed fatigue cracks adjacent to the shot-peened area (Figure 5). Their presence was confirmed with fluorescent dye penetrant.

Figure 4: Fracture surface of the small piece; note the chevron origin at the bearing shoulder radius (arrowed).

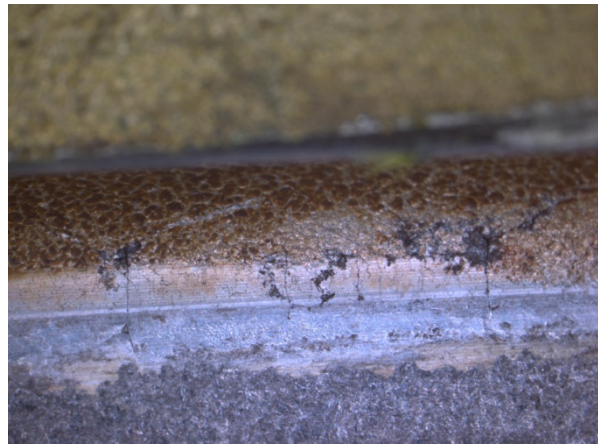
Figure 5: Axial cracks adjacent to the peened radius

The wheel manufacturer made a change to the design of new production wheel components, incorporating shot peening of the entire bearing bore area to help prevent the fatigue cracks from developing. This change was introduced at wheel assembly serial number B15419. The improved wheels were intended for delivery on new aircraft at line number 3099; scheduled for November 2009 (extract from AO-2009-062).

Virgin Australia issued Technical Advisory B737-TA-32-005 on 28 November 2011. It specified that, if abnormal ultrasonic indications were detected in the hub-bearing bore of the wheel inner-half, then an eddy current inspection is required. If that inspection detects cracks, the wheel half shall be quarantined, awaiting disposition.
