# Aviation Short Investigation Bulletin

Issue 24

**ATSB Transport Safety Report**  
Aviation Short Investigations  
AB-2013-202  
Final – 10 December 2013

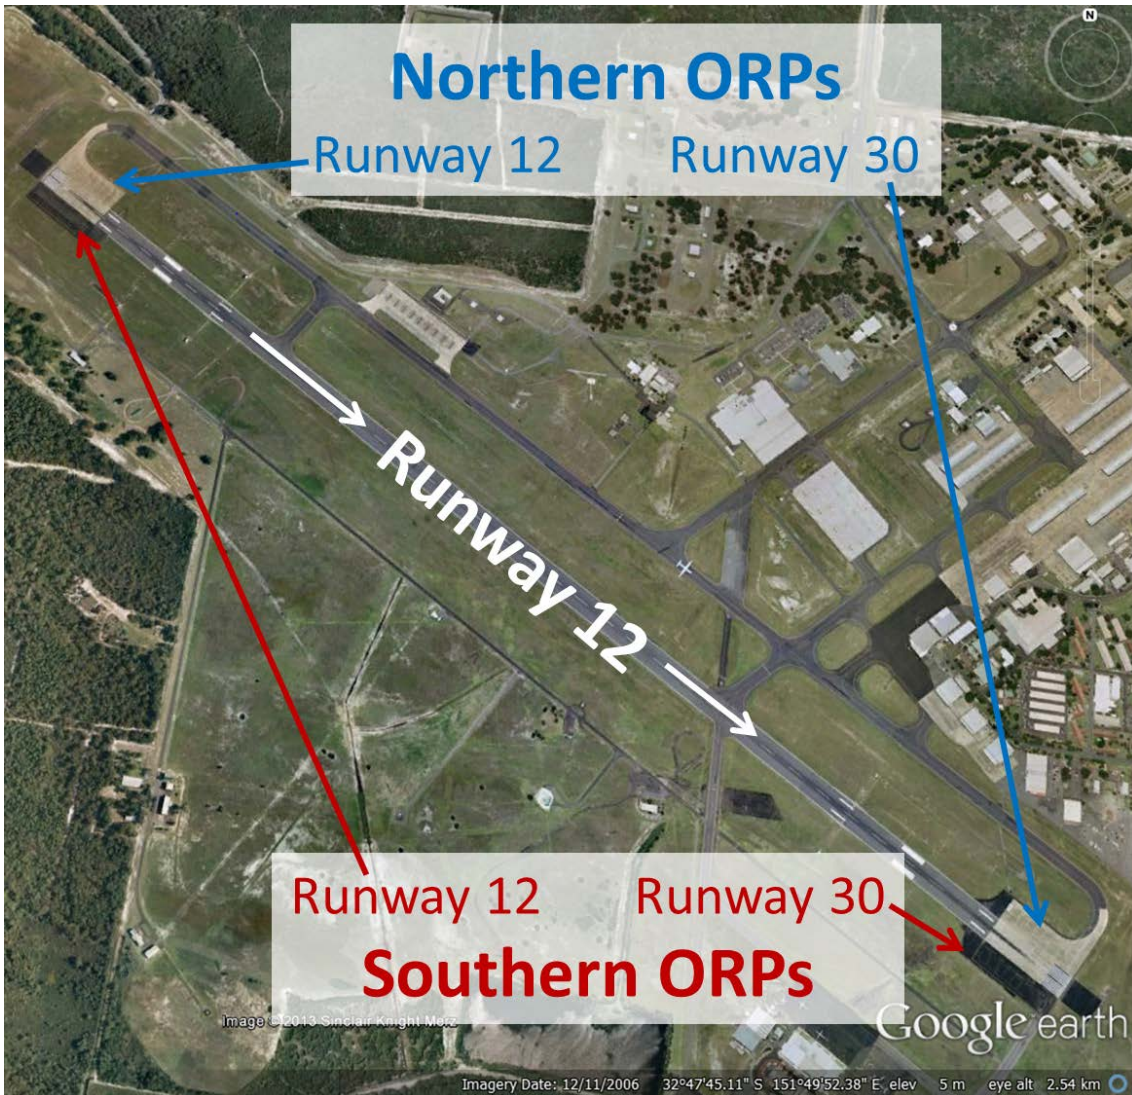
Figure 1: Williamstown Airport showing location and colour of ORPs and runway 12

Williamstown Airport was owned and operated by the Department of Defence, and had one runway aligned 12/30. The runway had an operational readiness platform (ORP) at each end of runway 12/30, on both sides (Figure 1). The ORP was a wide section of tarmac adjacent to the runway threshold, used by military aircraft. The ORPs on the northern side of the runway and both thresholds were concrete; an uneven grey colour. The ORPs on the southern side and the majority of the runway were tarmac, black in colour.

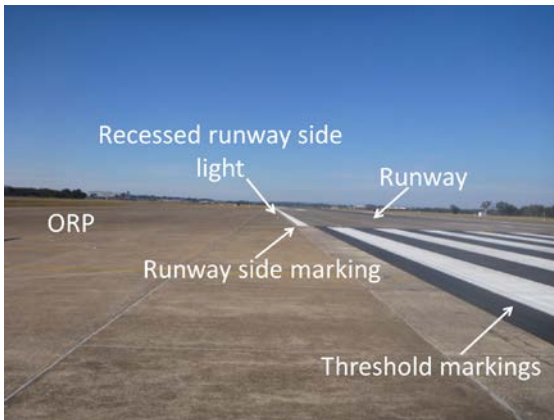
**Figure 2: Runway edge in daylight**

The runway had white runway edge lighting, but was not fitted with runway centreline lighting. For the portion of the runway adjacent to the ORPs, the runway edge lighting was recessed.

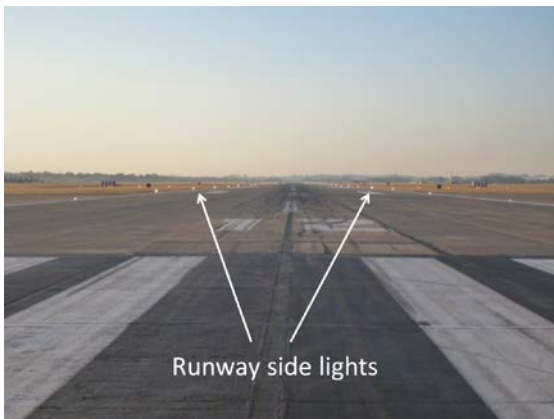
**Figure 4: Runway centreline in daylight**

An internal investigation conducted by Alliance Airlines found that the design of the ORP recessed lighting and obscured centreline markings caused visual confusion during the line-up procedure. This was further compounded by an unserviceable aircraft taxi light and the distraction caused by the requirement for the crew to enter the heading issued by ATC as part of the departure instructions at a critical time.

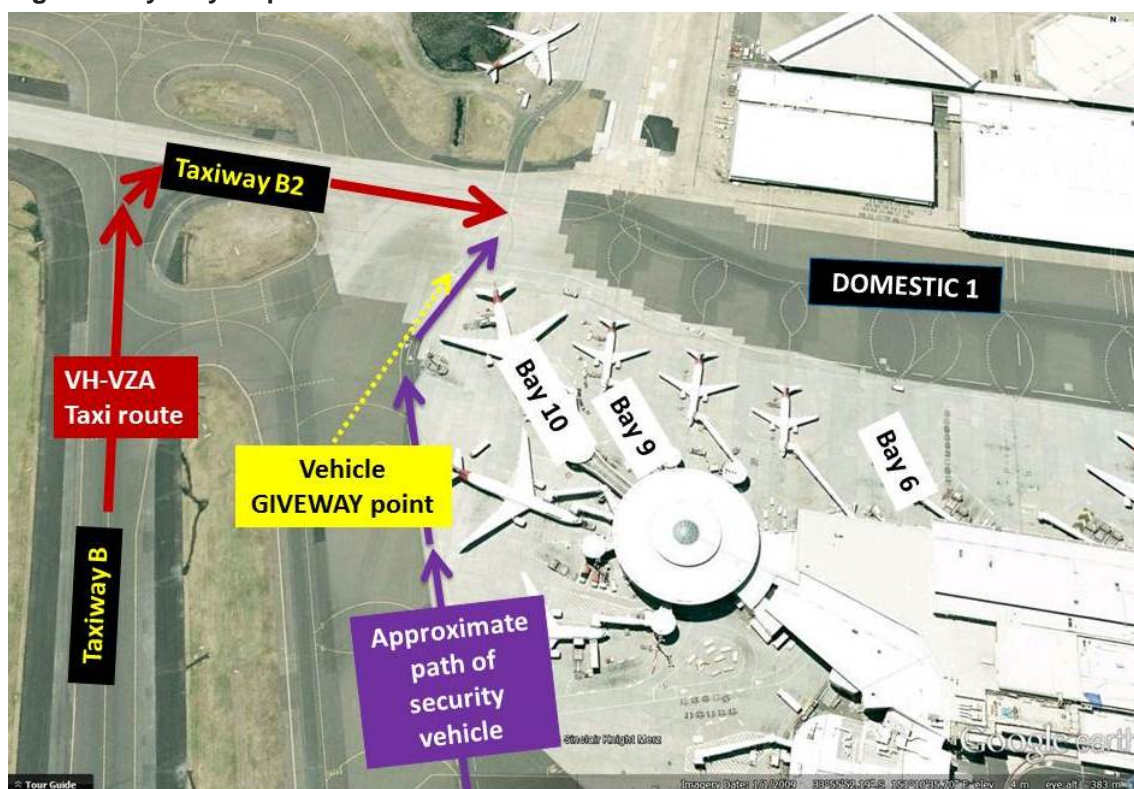
**Figure 3: Sydney Airport Domestic 1**

He further stated that the DOM 1 entry and exit area, where the airside road crosses, was busy, but well lit. He was surprised that the driver of the security vehicle did not see the aircraft.

The driver also reported that, once a vehicle on the airside road passes the give way point (Figure 2 and 3), the vehicle is angled to the right. This restricts sighting aircraft taxiing from the left, especially at night.

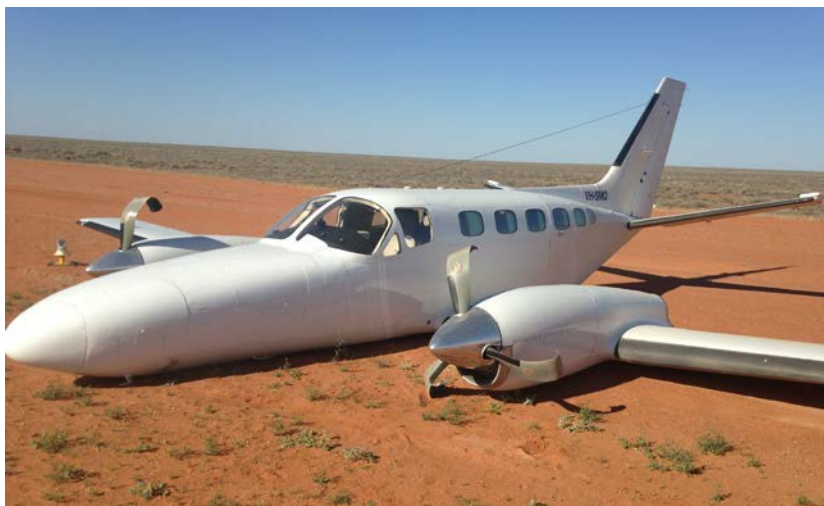
When about 500 ft above ground level (AGL), the pilot commenced his pre-landing checklist. After selecting full flap, the first item on the checklist, the pilot looked at the windsock to confirm the wind and observed 4-5 emus on the right side of the airstrip. He watched them run away from the airstrip and then continued the approach, but inadvertently omitted to complete the remaining checklist items, which included confirming the landing gear had been extended. The aircraft subsequently landed with the landing gear retracted.

**Figure 1: VH-SMO after landing**

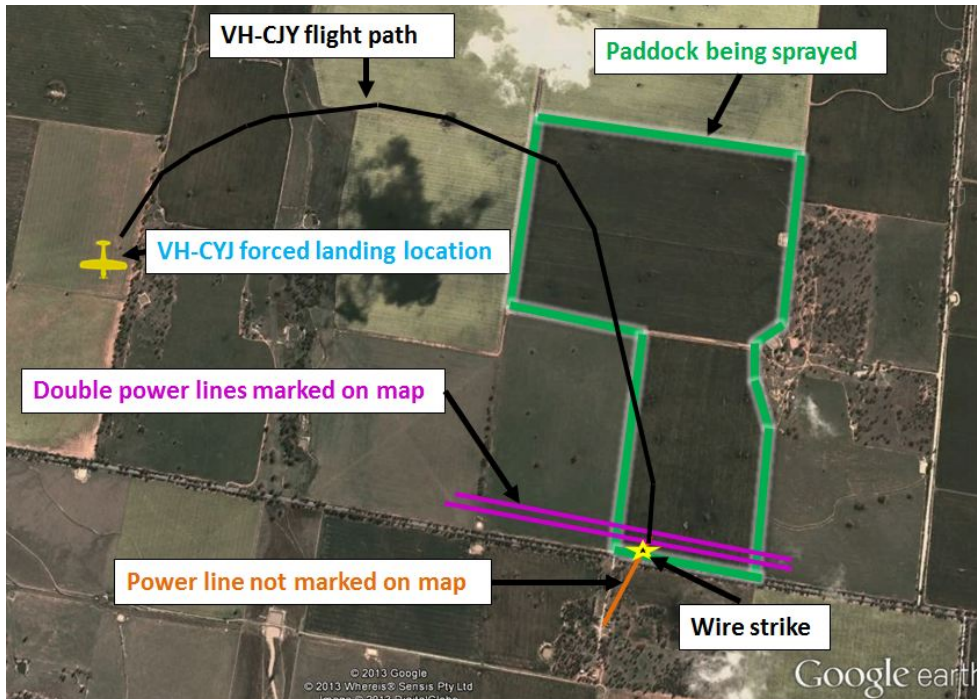
Figure 2: Property, location of wires and flight path of VH-CJY

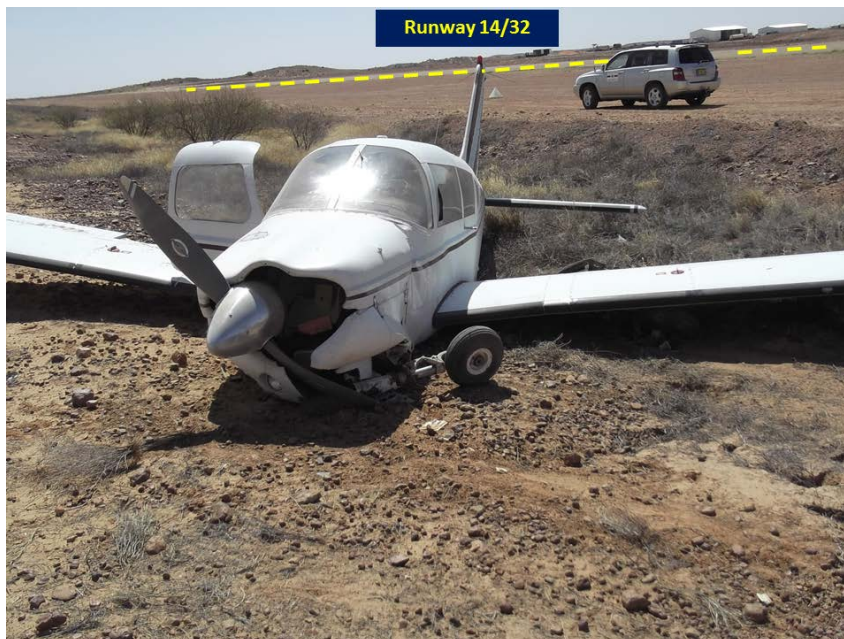
The pilot checked on his passenger before both egressed through the exit door on the passenger side of the aircraft. They remained clear of the aircraft until emergency services arrived. Both the pilot and passenger sustained minor injuries and the aircraft was substantially damaged (Figure 2).

**Figure 2: VH-MMU damage**

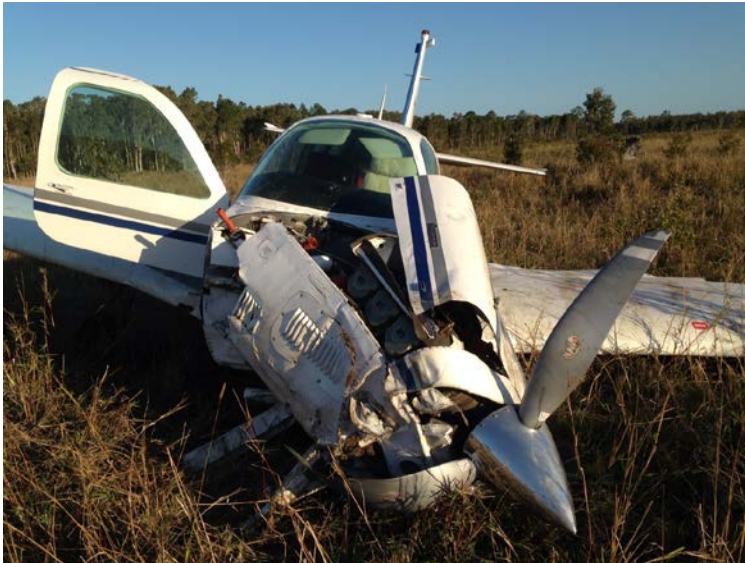
After the accident, the exhaust tailpipe from the turbocharger assembly was found on the runway at Caloundra. An engineering inspection revealed that the tailpipe had separated at a weld joint.

**Figure 1: Damage to VH-FFY**

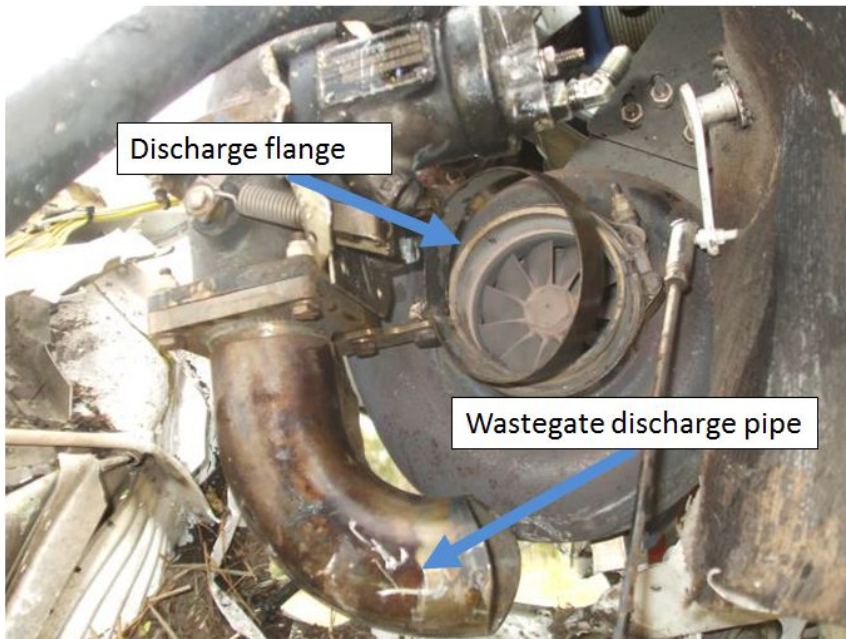
- the hot gas from the turbo-normalizing system was discharged directly onto the wiring, hoses and firewall blanket, which subsequently resulted in the smoke and fumes.

**Figure 2: Turbocharger outlet and wastegate**

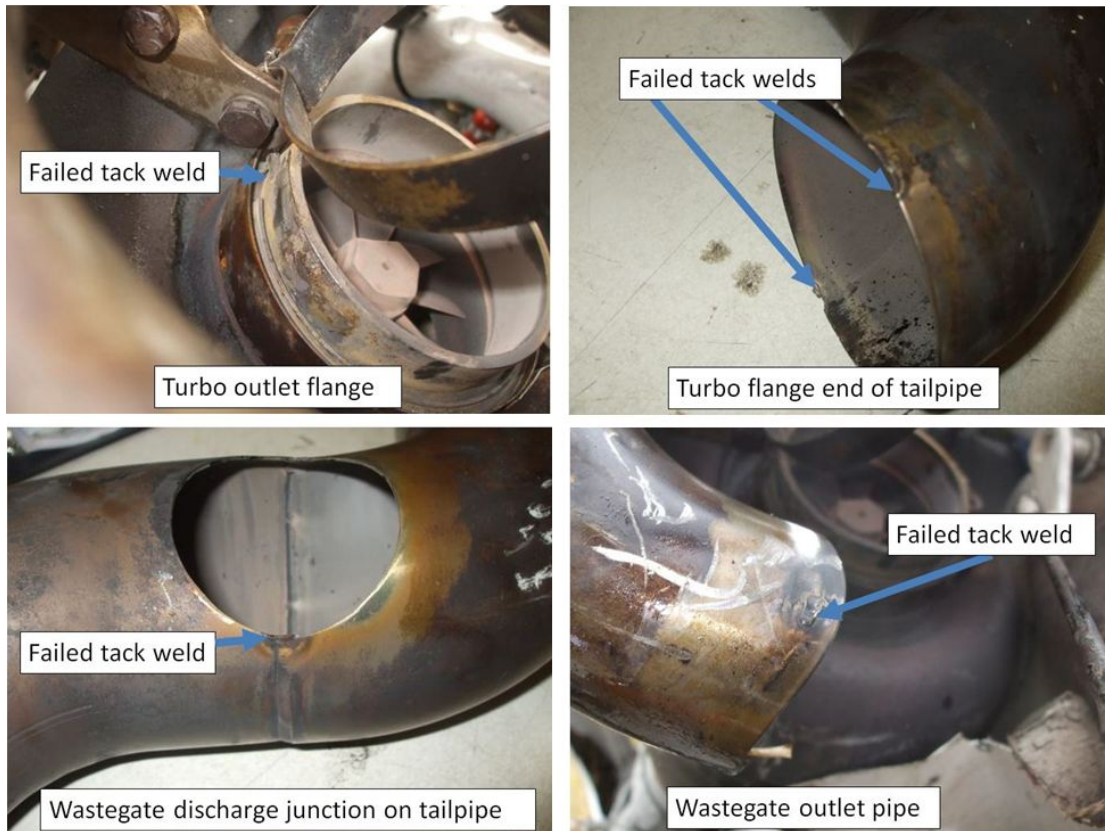
**Figure 3: Failed tack welds**

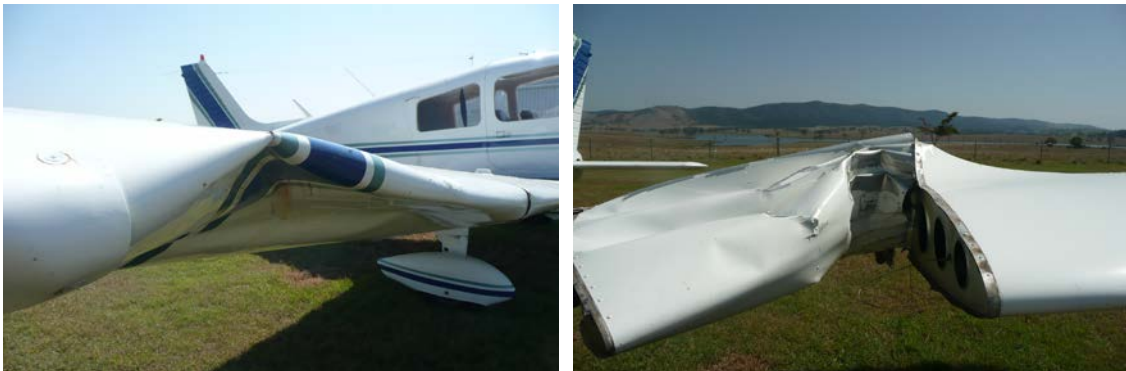
The aircraft sustained substantial damage (Figure 1) but the pilot and passenger did not receive any injuries.

**Figure 1: Damage to VH-RVJ**

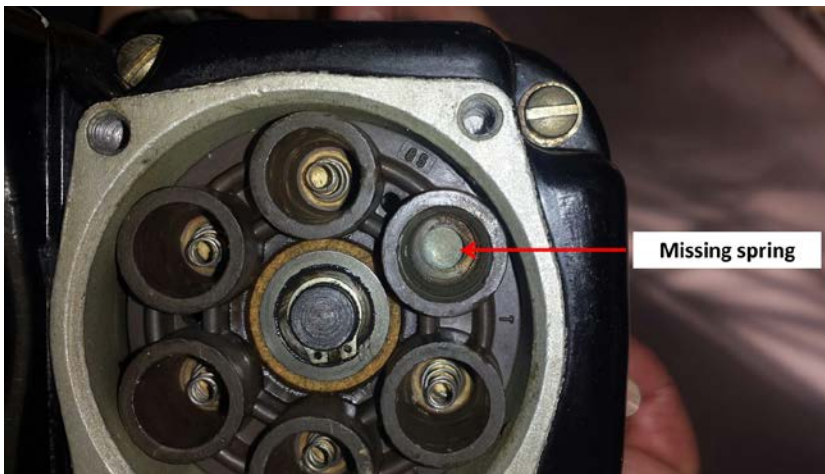
An engineering inspection identified that a spring in the distributor block of the left magneto was missing (Figure 2), which resulted in cross firing in the distributor and an associated loss of power. A new spring was fitted and the left magneto tested, with nil faults found. It could not be determined when or how the spring went missing.

**Figure 2: Left magneto distributor block**

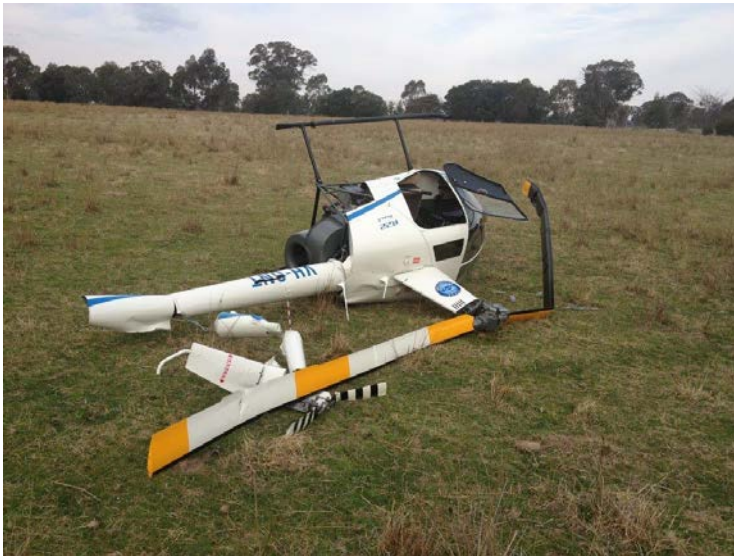
**Figure 1: Damage to VH-ONT**

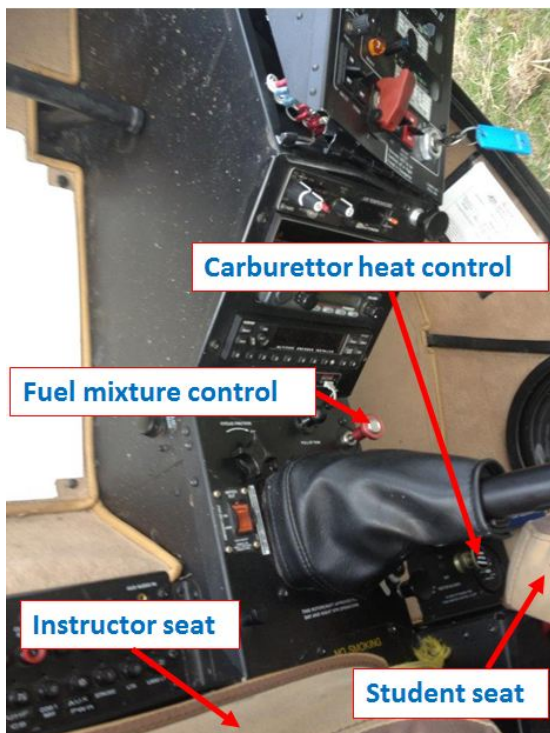
The instructor reported that he could not see the fuel mixture and carburettor heat controls from his normal seated position on the left side of the helicopter as the controls were obscured by the cyclic (Figure 2). He believed that he had observed the student reach down (toward the carburettor heat control) not forward (toward to fuel mixture control), prior to looking outside to check for traffic.

**Figure 2: Location of the controls in VH-ONT**
