Australian Government  
Australian Transport Safety Bureau

# Aviation Short Investigation Bulletin

Issue 27

**ATSB Transport Safety Report**  
Aviation Short Investigations  
AB-2014-024  
Final – 19 March 2014

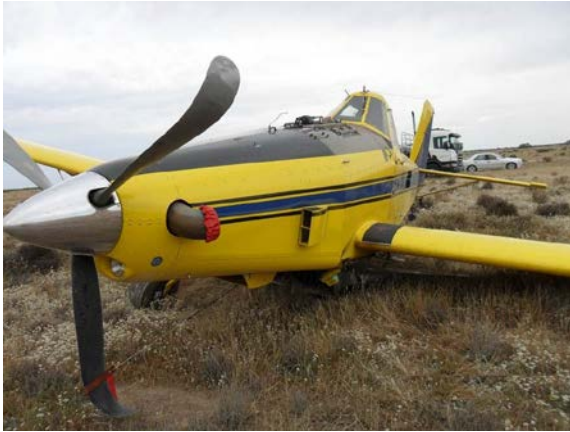
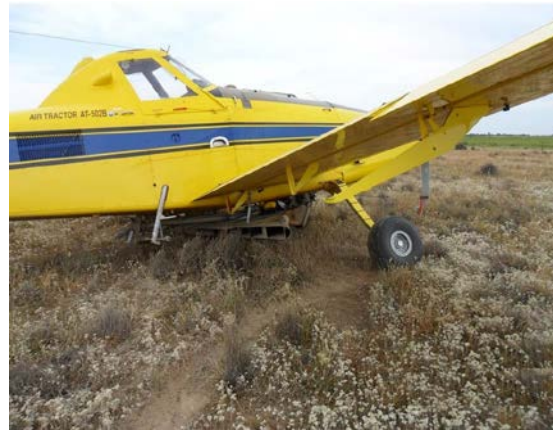
**Figure 2: Damage to VH-FLH**

During the landing, the main wheels touched down first, followed by the tail, which was locked into place. Shortly after, the aircraft suddenly veered right about 45°. The pilot considered a go-around, but was concerned that the aircraft would not clear the boundary fence (Figure 1). Consequently, he elected to continue the landing and selected reverse thrust, applied left brake, left rudder and left aileron in an attempt to re-align the aircraft with the runway. The aircraft did not slow down as the pilot expected. The wheels began to 'grab' and the left undercarriage leg became detached which caused the aircraft to rotate facing about 90° away from the runway. The left wingtip and propeller subsequently contacted the ground. The pilot shut down the aircraft and exited. The pilot was not injured, but the aircraft was substantially damaged (Figure 2).

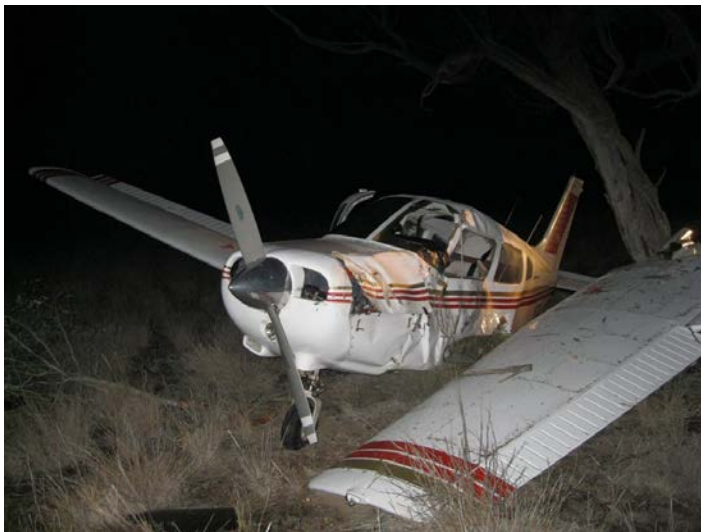
**Figure 1: Damage to VH-CCQ**

The aircraft was substantially damaged (Figure 1), the pilot sustained serious injuries and the passenger sustained minor injuries.

An engineering report provided to the ATSB stated that during an inspection of the engine conducted after the accident, the carburettor float bowl was found to be empty.

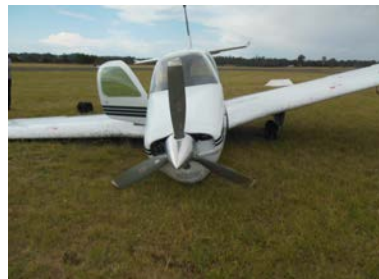
VH-YEN damage

With the left main gear almost extended, the aircraft began to veer to the right. The instructor noted that there were buildings in the path of the aircraft and elected to reject the take-off. When the aircraft had slowed to about 30-40 kt, the nose dug into the grass alongside the runway.

The instructor and student were not injured, but the aircraft sustained substantial damage.

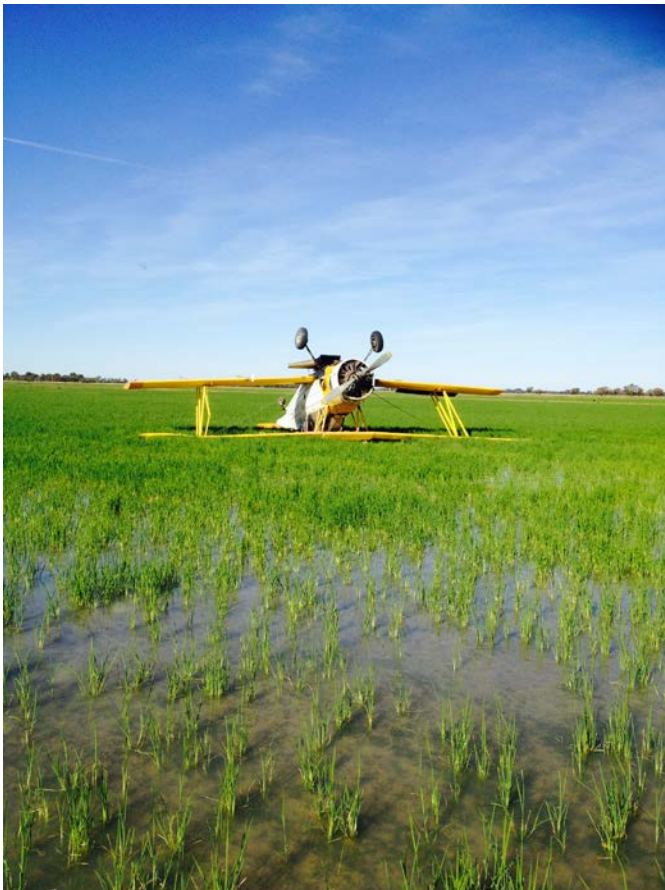
**Figure 1: Damage to VH-CCF**

When at about 20-30 ft AGL, with a nose high attitude, the pilot felt the aircraft's wings shaking, indicating an imminent stall.<sup>1</sup> The pilot increased engine power in an attempt to avert the stall, but the aircraft continued to descend. Shortly after, the wheels touched down in a rice paddy in about 20 cm of water and the aircraft flipped over (Figure 1). The aircraft was substantially damaged. The pilot was uninjured.

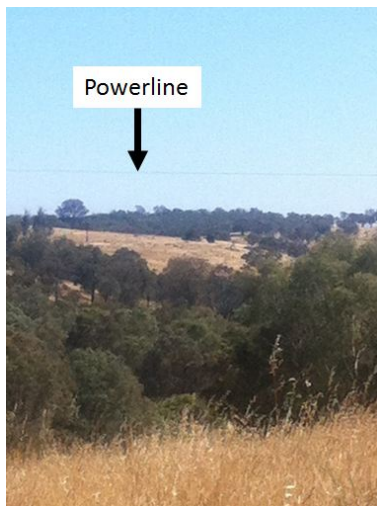
**Figure 1: Unknown powerline**

The pilot then commenced spraying the gully, which required looking out of the helicopter window and door towards the ground. He then sighted power lines (Figure 1) just as the helicopter main rotor disc struck the wires. The pilot immediately conducted a precautionary landing. The helicopter sustained substantial damage to the main rotor blades (Figure 2). The pilot was uninjured. The strike also resulted in insulators being detached from the 22,000 volt power lines.
