Aviation Short Investigations Bulletin

Issue 31

ATSB Transport Safety Report
Aviation Short Investigations
AB-2014-085
Final – 17 June 2014

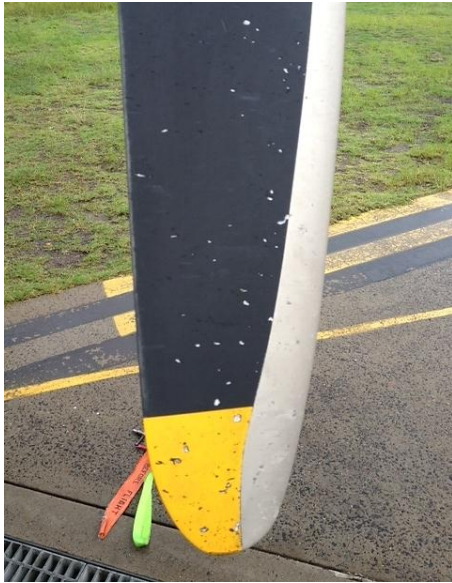
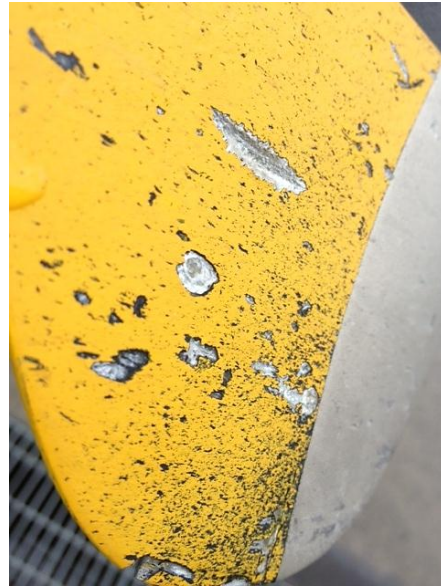
Figure 1: Propeller blade damage

The next day the flight to Grafton was conducted, with the required external inspections of the aircraft conducted by the FO. The aircraft then returned to Sydney, at which time maintenance personnel conducted an inspection of the aircraft and observed damage to the left propeller blades. All four blades had sustained stone damage predominantly on the back (reverse) of the blades (Figure 1). Individual blade damage repairs may have been carried out with the blades remaining in place; however, the four blades were all replaced in order to allow effective repair processes to be completed.

- He had conducted a thorough visual inspection of the left landing gear and top surface of the left propeller blades. When conducting his inspection, he stood facing the propellers and turned the blades in an anti-clockwise direction. This was suitable for sighting the front surface of the blades, but not the reverse side. He had also conducted a tactile inspection of the leading edge of the blades. He had got out of the habit of inspecting the surface of the reverse side of the blades and consequently did not see the damage.

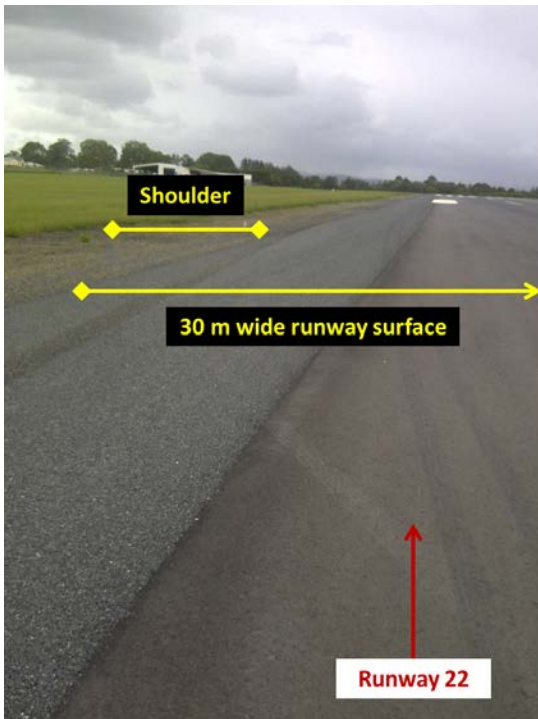
Figure 2: Runway surface

Runway 04/22 at Taree consisted of a 30 m wide runway with a 3-4m wide soil and gravel shoulder either side (Figure 2). A subsequent runway inspection during daylight hours determined that the aircraft had veered onto the runway shoulder (Figure 3).

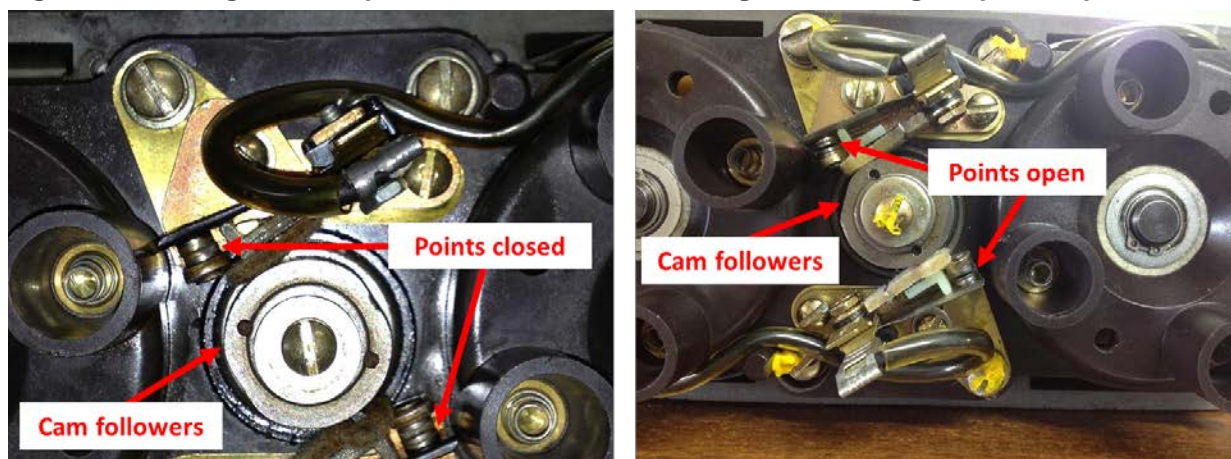
Figure 1: YTT magneto with points failed closed New magneto showing the points open

An examination was conducted of the aircraft engine and the magneto cam followers were found damaged, resulting in the left and right magneto breaker points being failed closed (Figure 1). The operator found that the magneto cap was not grounded and suspected faulty magneto capacitors, resulting in the aircraft engine power loss and subsequent failure. The operator reported that the magneto was installed on the new engine by the manufacturer and at the time of the incident the engine had operated for 283 hours.

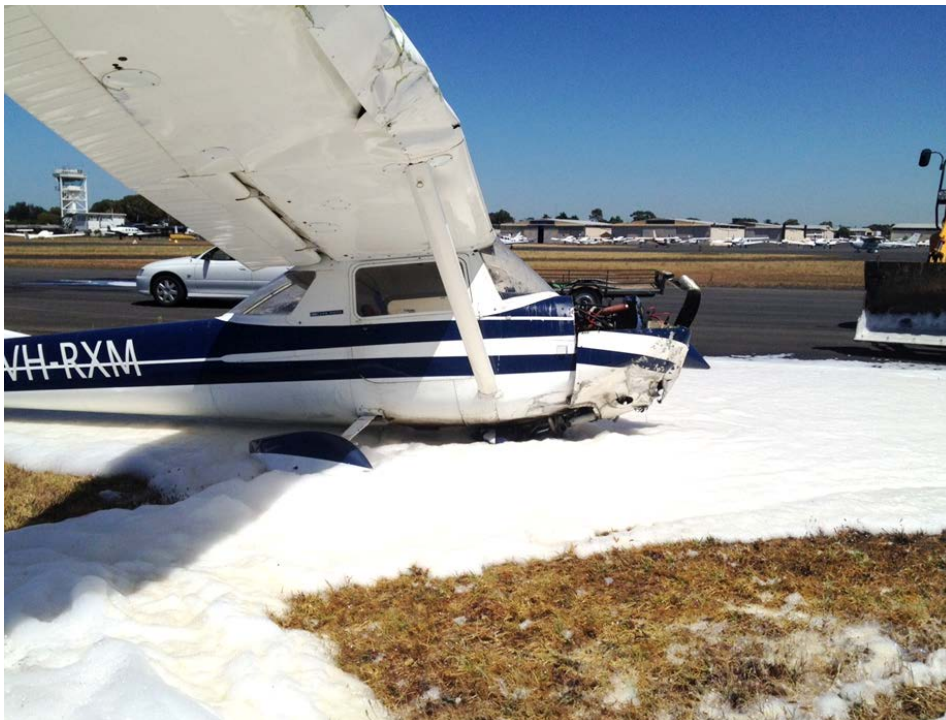
Figure 1: VH-RXM side view of damage

Soon after, emergency services arrived. The pilot and passenger sustained minor injuries, and the aircraft was substantially damaged.

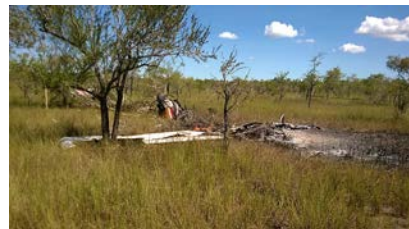
Accident site

The pilot and passenger were rescued about 3 hours later by a helicopter crew. Both sustained serious injuries and the aircraft was destroyed (Figure 1). Due to memory loss incurred as a result of the accident, the pilot had limited recollection of the events.

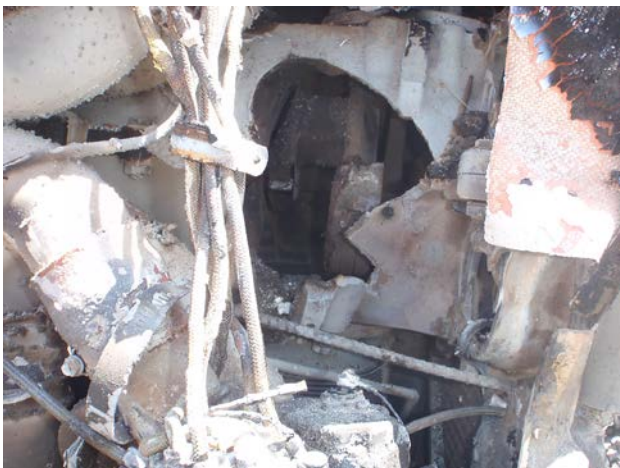
Figure 2: Engine damage to VH-HGZ

From the photographs provided by the operator (Figure 2), the ATSB assessed that a connecting rod appeared to have broken and separated from the crankshaft, resulting in a hole in the crankcase. This precipitated a catastrophic engine failure. The smoke entering the cockpit was likely to have been from burning oil.

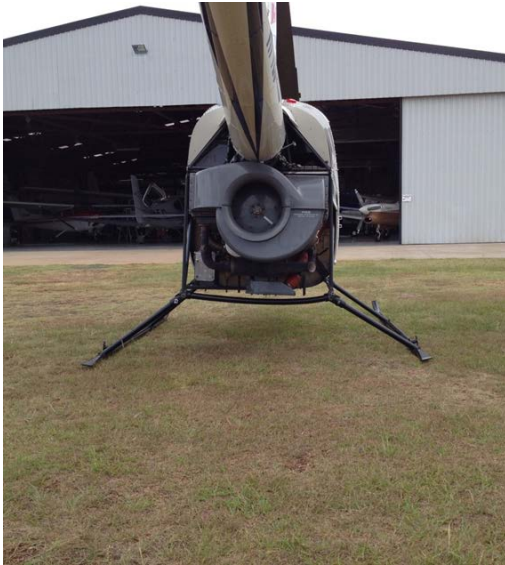
Figure 1: Damage to VH-YZO

The instructor again exited the helicopter and conducted a walk-around inspection with no damage observed. After a further demonstration by the instructor, the student completed the sequence twice more. The instructor and student then conducted further training exercises and subsequently concluded the flight. After landing, the instructor detected that the helicopter was leaning to the right. He exited the helicopter and observed that the landing skid was damaged (Figure 1). The instructor then taxied the helicopter to the hangar for an engineering inspection.
