Australian Government
Australian Transport Safety Bureau

Aviation Short Investigations Bulletin

Issue 32

ATSB Transport Safety Report
Aviation Short Investigations
AB-2014-099
Final – 14 July 2014

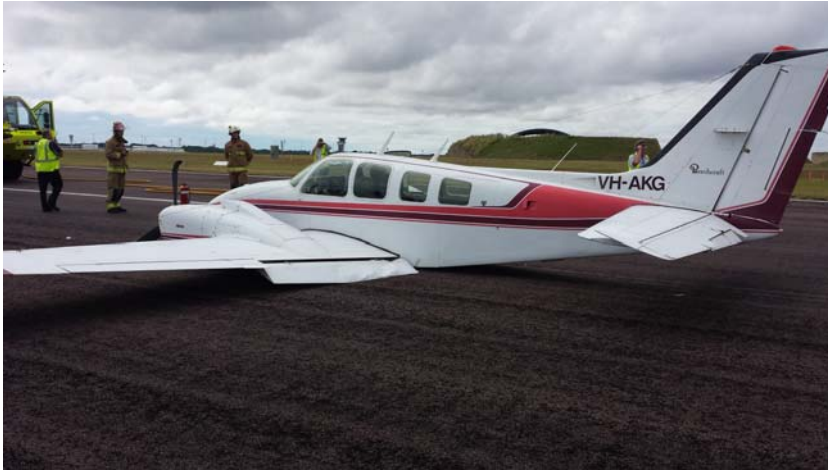
Figure 1: Damage to VH-AKG

The tower controller cleared AKG to land on runway 36, however the pilot requested holding at Lee Point to brief the passengers for a wheels-up landing and subsequent exit from the aircraft. He then fully extended the flaps, which took some time, with repeated resetting of the circuit breaker. At about 1145, the pilot was cleared to land on runway 36. He reported that the workload on the final approach was high, as the aircraft was more responsive without the landing gear extended. He kept some power on during the approach in case a go-around was required. When over the runway threshold, the pilot selected the mixture levers to idle cut-off. The rear step scraped on the runway, the flaps then contacted it, followed by the aircraft fuselage, and the left propeller, which caused the aircraft to yaw to the left. The pilot used right rudder to keep the aircraft straight and then the right propeller contacted the runway and the pilot again corrected the yaw. The aircraft came to rest about half way along the runway and the pilot switched all the electrics and fuel off. The pilot exited the aircraft and assisted the passengers to disembark. No injuries were sustained and the aircraft was substantially damaged (Figure 1).

An engineering inspection found that the up-lock assembly on the right main landing gear was binding and prevented extension of the right main landing gear. The up-lock mechanism pivots on a bolt, which was not listed in the lubrication chart for the aircraft. The binding of the assembly damaged the retract-extend rod and prevented any further movement of the retraction mechanism on the right main landing gear.

The damaged retract-extend rod placed load on the flap actuating cable, causing the flap circuit breaker to trip. This prevented the flaps from extending and retracting normally.

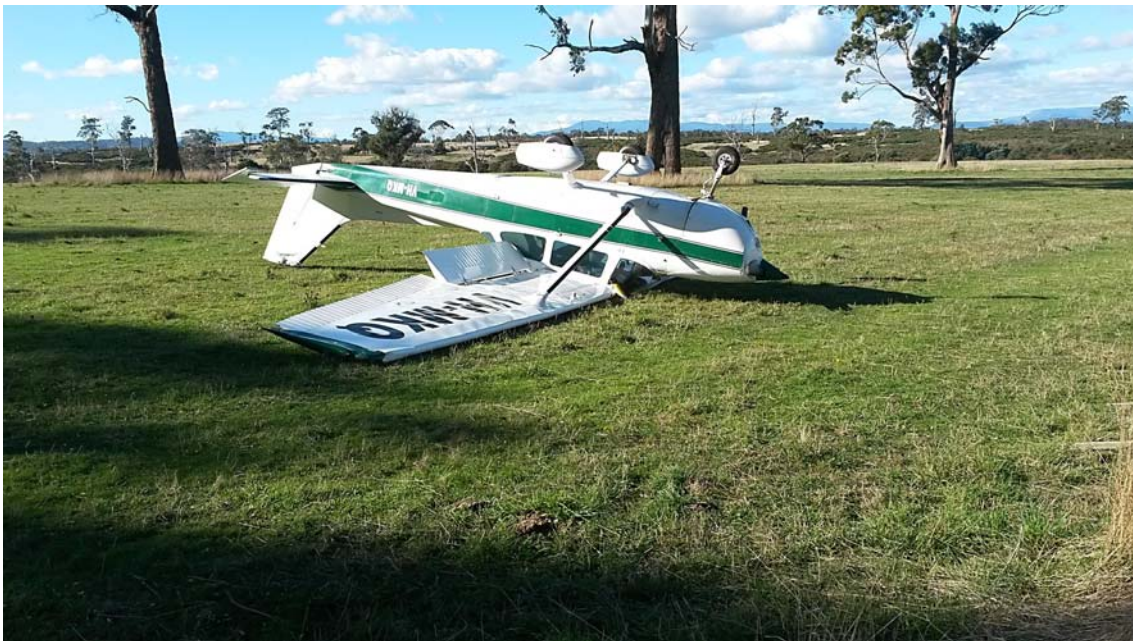
Figure 1: Damage to VH-MKQ

The pilot selected the fuel mixture to idle cut-off and the engine stopped. The aircraft collided with the fence and the nose landing gear entered a ditch. The aircraft nosed over and came to rest inverted. The aircraft was substantially damaged (Figure 1) and the pilot was uninjured.

- He had calculated the landing distance available to be 440 m, and taken into consideration the approach path, including some trees. This was sufficient for the aircraft, however, the surface condition did not provide the deceleration he had expected. It had rained the previous day, however the surface was dry.

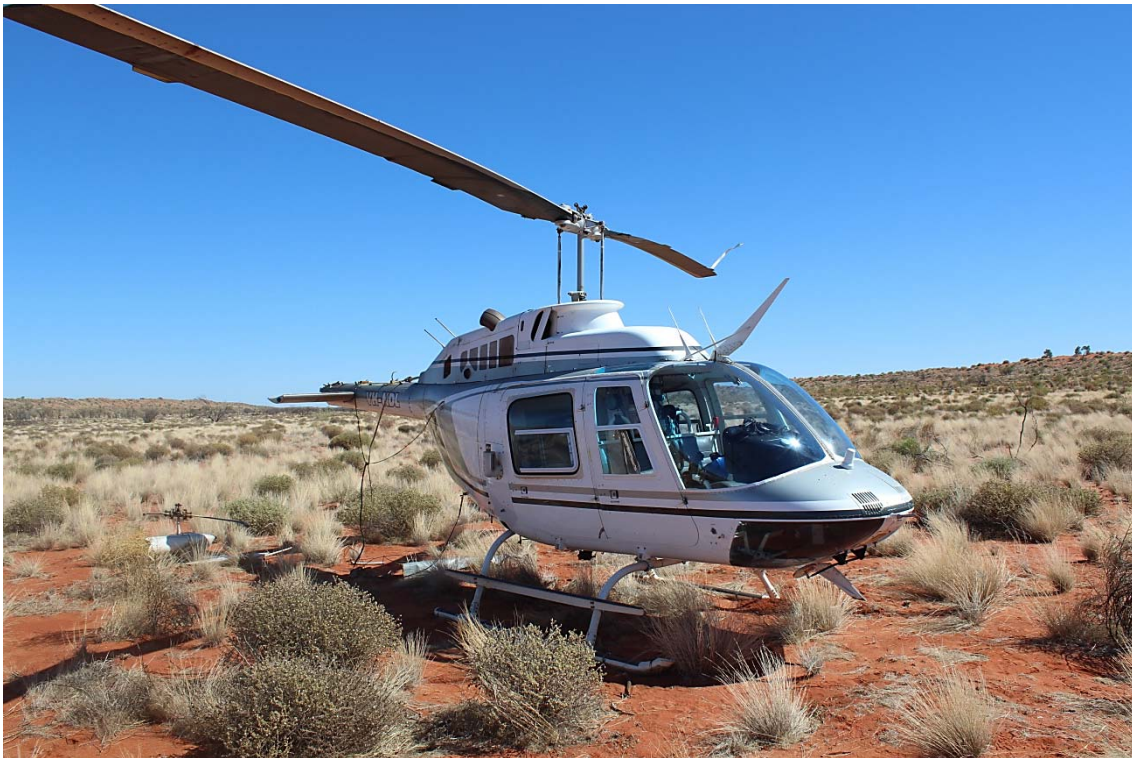
Figure 1: VH-NDL

On 12 November 2013, a Bell 206B helicopter, registered VH-NDL, departed a camp site located 51 NM SE of Alice Springs, Northern Territory, on a charter flight with a pilot and three passengers on board. The flight was conducted in visual meteorological conditions. About an hour into the flight and 2 NM from the landing area, the pilot commenced a slow descent from 2,000 feet above the ground (AGL). When lowering the collective, the pilot heard an intermittent grinding noise above the cockpit. The pilot checked the gauges, with nothing unusual noted. The noise continued to develop and the pilot elected to land. As the helicopter descended through 400 feet, a clunking noise was heard and power was lost to the main rotor. The pilot initiated an auto rotation and briefed the passengers for an emergency landing. During the touch down at about 0705, the main rotor blade severed the tail boom (Figure 1). The pilot secured the helicopter, waited for the main rotor to slow and assisted the passengers to exit. The helicopter sustained substantial damage; the occupants were not injured.

The operator determined that the engine-transmission main drive shaft¹ had failed due to the failure of the forward drive shaft boot. They reported that, during the week prior to the accident, the helicopter had operated short flights to landing areas with extended ground running, in high temperatures and with the helicopter loaded to near its maximum all up weight.

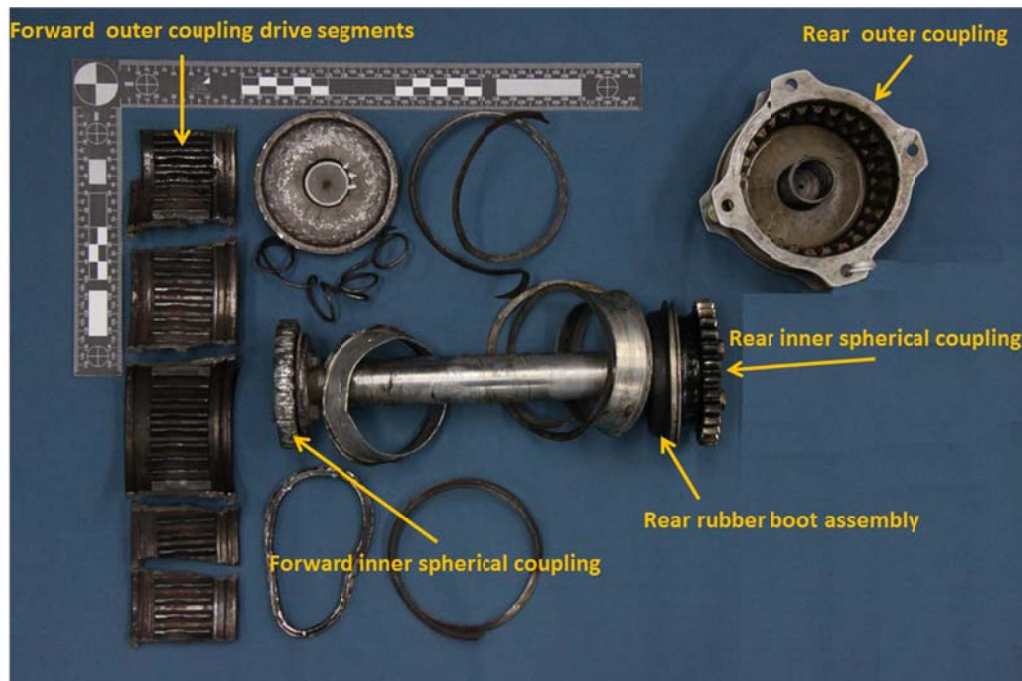
Figure 2: Main drive shaft VH-NDL

The main drive shaft installed on NDL failed about 603.4 hours after it was overhauled. It had been inspected and lubricated and the forward and rear boots were replaced about 132.7 hours prior to the accident.

The forward outer coupling had failed, in overload, into five segments. The surfaces of the segments had evidence of discolouration due to over-temperature and most of the surfaces had turned into red oxide (which forms in air at high temperatures, estimated to be over 500 °C). There was no detected grease that is needed for lubrication to reduce friction (heat) between the rotating parts. Without the grease, the gear teeth on the forward inner spherical coupling softened, deformed, fractured and became jammed, resulting in the forward outer coupling shattering into the five segments. The four Temp-Plate indicators (which indicate when there has been excess temperature) were not present on the forward outer coupling exterior. There were no detected remnants of the forward rubber boot that is part of the seal assembly for containment of the grease.

The rear outer coupling and rear inner spherical coupling were well lubricated and exhibited normal condition. All four Temp–Plate indicators were attached to the rear outer coupling exterior, with no apparent indication of an over-temperature. The rear rubber boot, which is part of the seal assembly for containment of the grease, was flexible and undamaged.

- Replace the main drive shaft assembly with a KAflex drive shaft system to all operator effected helicopters.

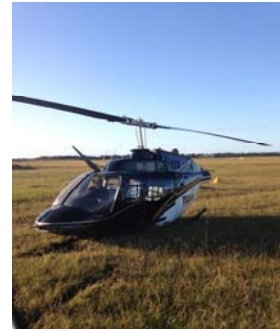
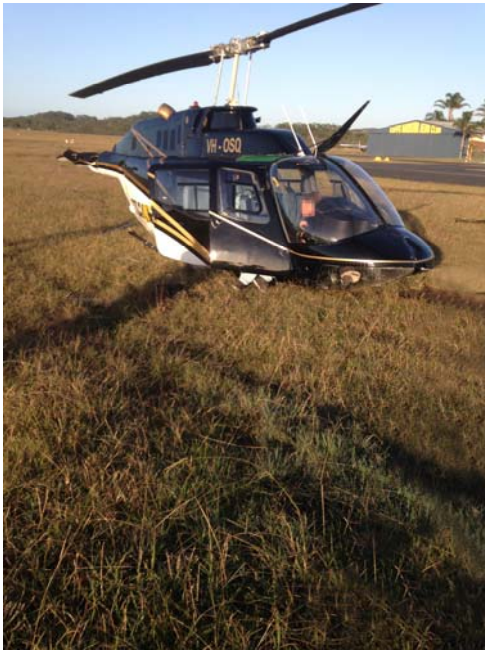
Figure 1: Damage to VH-OSQ

The pilot selected the master switch on, confirmed all indications were normal and started the engine. However, he had omitted to complete the pre-start checklist, in particular to select the fuel valve to 'ON'. The pilot lifted the helicopter off into the hover and obtained a clearance from air traffic control. The pilot commenced the transition to forward flight and, at about 35 ft above ground level, heard the turbine engine wind down, the red ENGINE OUT warning light illuminated and the helicopter descended in an autorotation.
