Terrain awareness warning system alert involving Eurocopter BK 117C-2, VH-SYB

near Crookwell, New South Wales | 21 October 2016

ATSB Transport Safety Report
Aviation Occurrence Investigation
AO-2016-160
Final – 6 November 2018

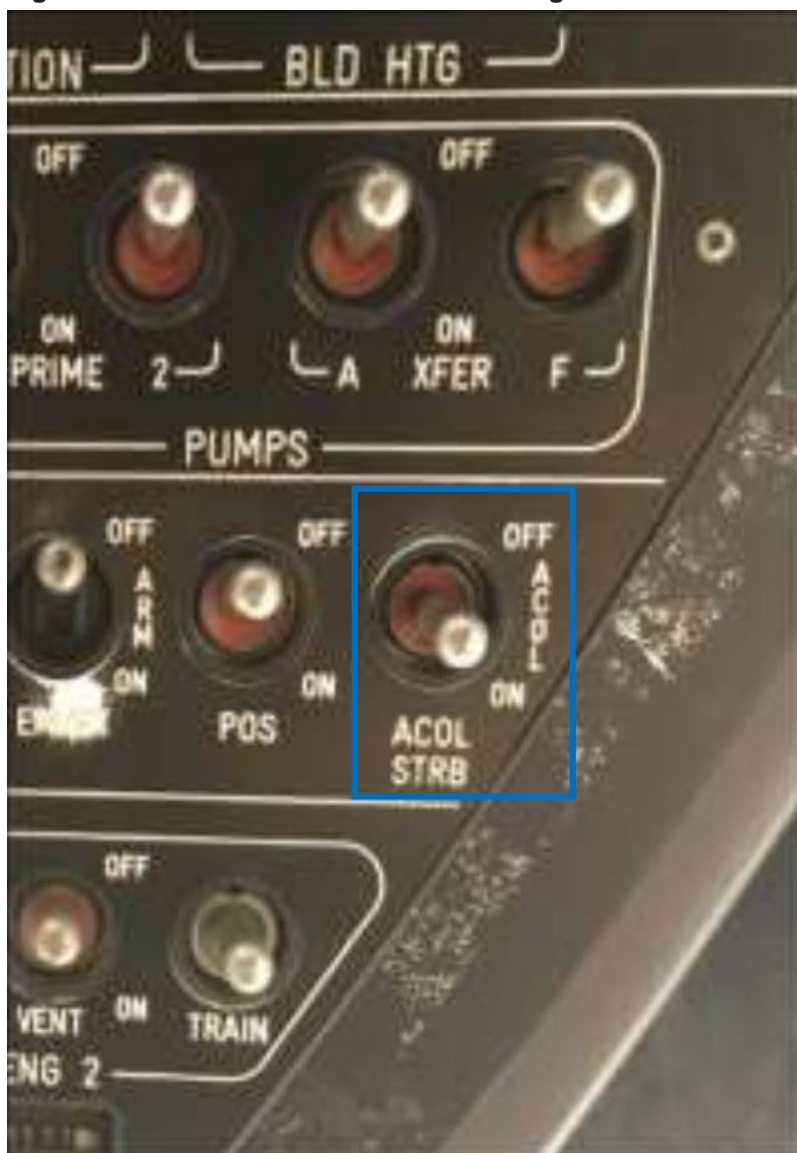
Figure 2: VH-SYB’s anti-collision / strobe light switch

In an attempt to reduce the distracting effect of the anti-collision light, the pilot asked the ACM to turn the light off. The ACM removed her NVG, took a few seconds to locate the switch and, not realising the switch had three positions, inadvertently moved the anti-collision/strobe light switch from the ACOL (anti-collision light) position to the ON (anti-collision and strobe light) position. This changed the reflected light from red to bright white, which the pilot subsequently reported had a blinding effect on her vision while wearing NVG. The pilot again asked the ACM to turn the light off, which the ACM then actioned.

- OFF
- ACOL, which operated the helicopter's red anti-collision light only
- ON, which operated the red anti-collision light and white strobe light.

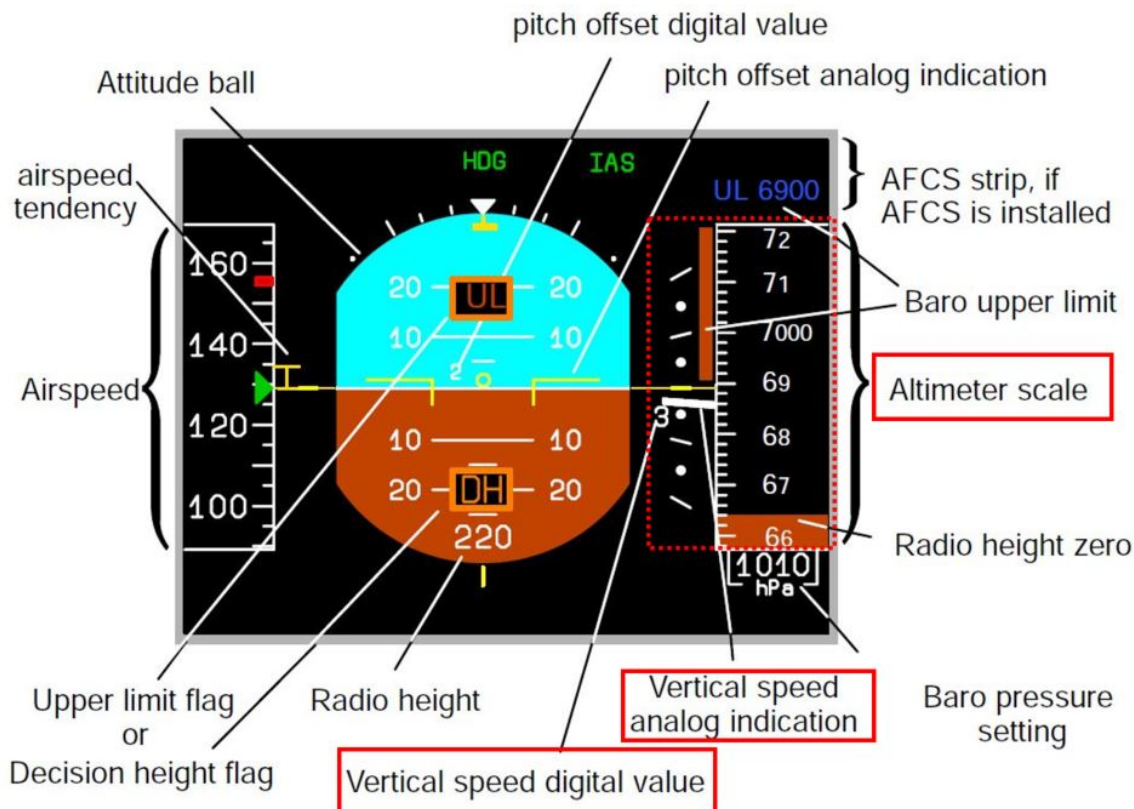
Figure 3: VH-SYB's primary flight display

The BK 117 C-2 flight manual noted a limitation of the accuracy of the VSI, which stated:

Vertical speed indication may be unreliable in gusty conditions and at airspeeds around 30 kt during fast transition from hover flight into steep descent and from level flight to hover during rapid pull up's.

As noted in *Departure from Crookwell*, the ACM recalled seeing the VSI indicate a rate of descent of 3,000 ft/minute at the time of the EGPWS alert. She also recalled seeing a rate of climb of 2,900 ft/minute during the initial unusual attitude recovery. The ACM stated she read these figures from the digital VSI display.
