# Engine failure involving SAAB 340, VH-RXS

near Dubbo Airport, New South Wales, 23 March 2017

Aviation Occurrence Investigation

AO-2017-034

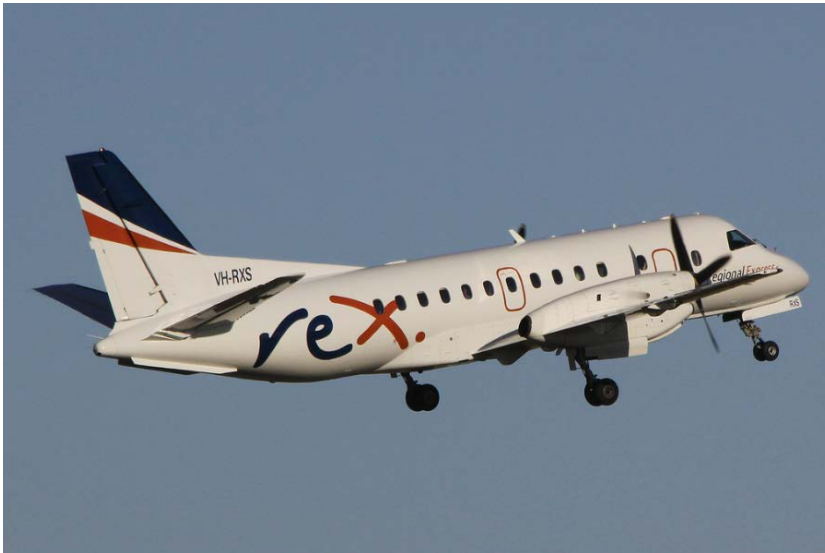
**Figure 1: VH-RXS**

On 23 March 2017, at about 0942 Eastern Daylight-saving Time (EDT), a Regional Express SAAB 340B, registered VH-RXS (Figure 1), departed Dubbo Airport, New South Wales (NSW) to operate scheduled passenger flight ZL821 to Sydney, NSW. There were three crew and 23 passengers on board.
