Smoke in the cockpit involving Bombardier DHC-8-315, VH-TQH

Adelaide Airport, South Australia, 23 June 2017

ATSB Transport Safety Report
Aviation Occurrence Investigation
AO-2017-065
Final – 5 September 2017

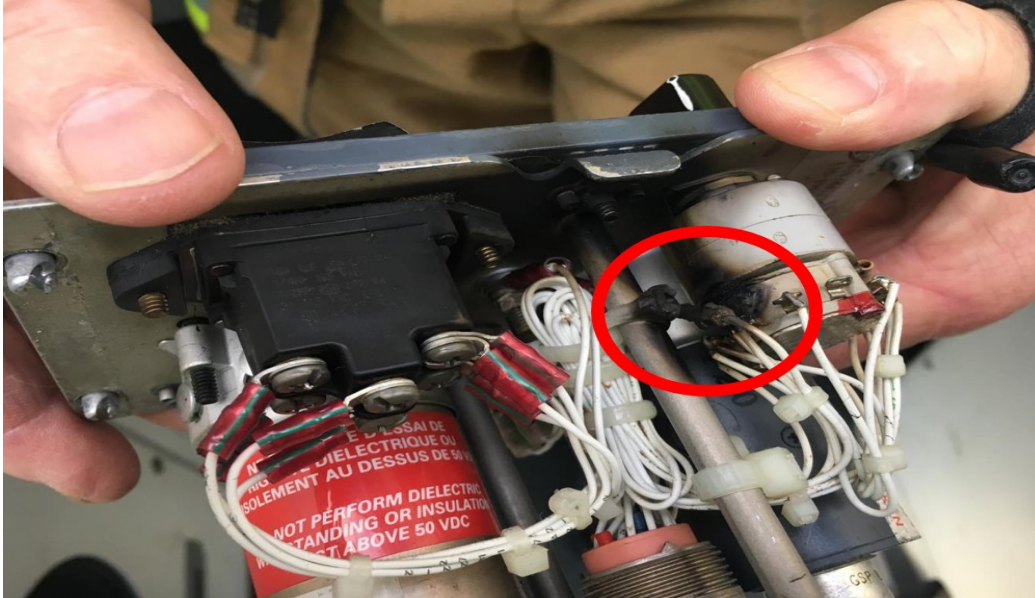
Following the incident, engineers removed the aileron/rudder trim control panel for inspection. That inspection identified visible damage underneath the rudder trim switch. Specifically, the rudder trim potentiometer⁴ was blackened and burnt (Figure 1). The trim control panel was subsequently replaced.

Figure 1: Burnt potentiometer in the aileron/rudder trim control panel (circled in red)

- The rudder trim potentiometer burnt in-flight, resulting in fumes and smoke in the cockpit during a critical phase of flight.
- Shortly after landing, the crew conducted a precautionary disembarkation on the taxiway, which reduced the risk of fumes exposure to the aircraft's occupants.
