FINAL REPORT
A - 051/CENIPA/2016

OCCURRENCE:	ACCIDENT
AIRCRAFT:	PP-MBN
MODEL:	AS-350B
DATE:	21MAR2016

This is the Final Report of the 21MAR2016 accident with the AS-350B aircraft, registration PP-MBN. The accident was classified as “Fuel Exhaustion”.

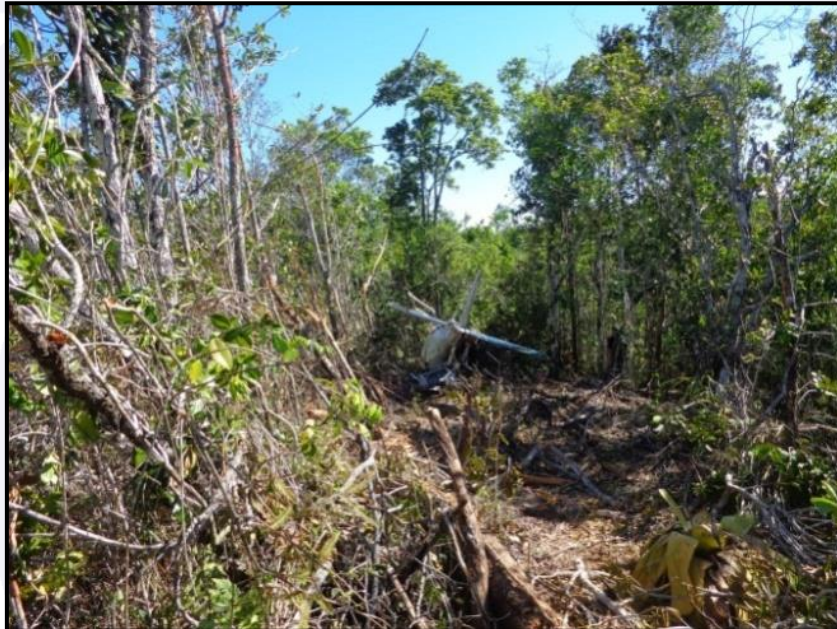
At the site of the accident, evidence showed that the helicopter dragged itself about 15 meters above the vegetation (Figure 1) until full stop, landing with the right side facing the ground and nose pointing south.

Figure 1 - View of aircraft trajectory.

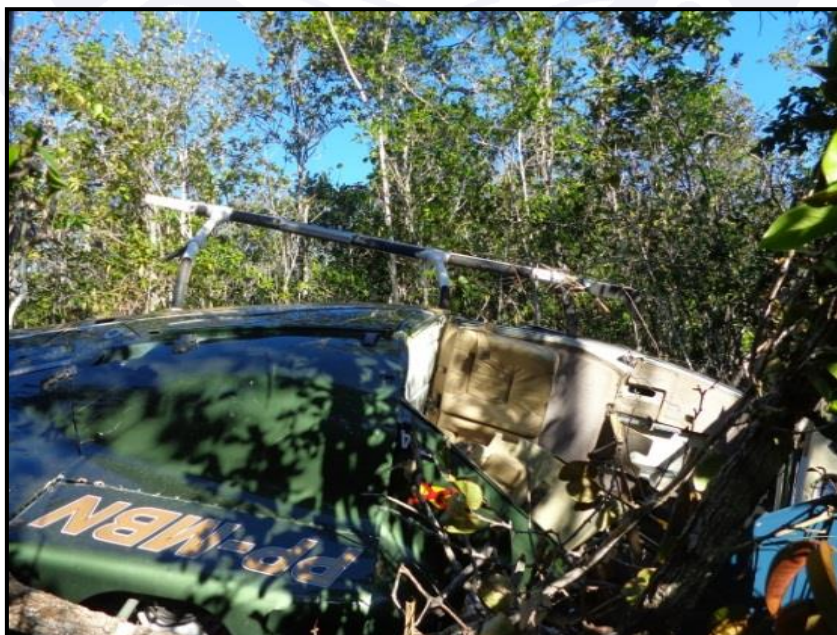
The impact was concentrated on the right side of the aircraft (Figure 2).

Figure 2 - Positioning of the aircraft after full stop.

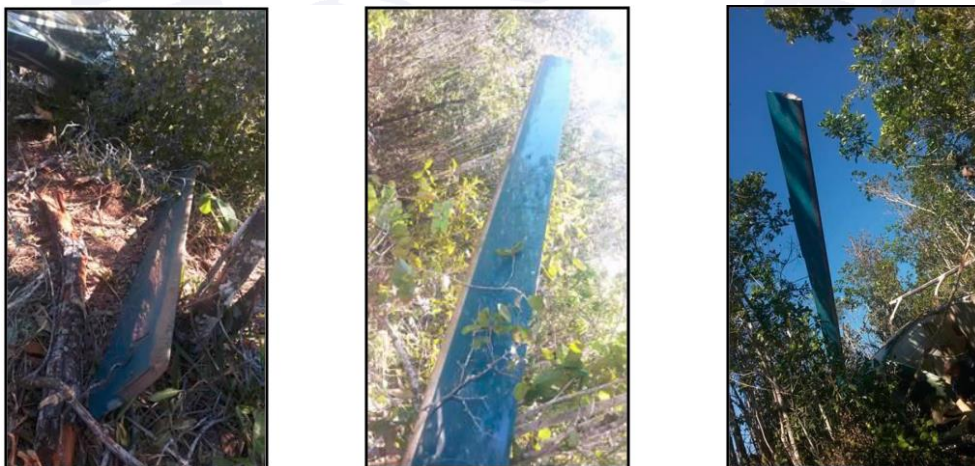
The main rotor blades (Figure 3) showed no significant impact on the leading edge. The observed damages were not characteristic of impact with power (torque and NR).

Figure 3 - Main rotor blades without impact on the leading edge.

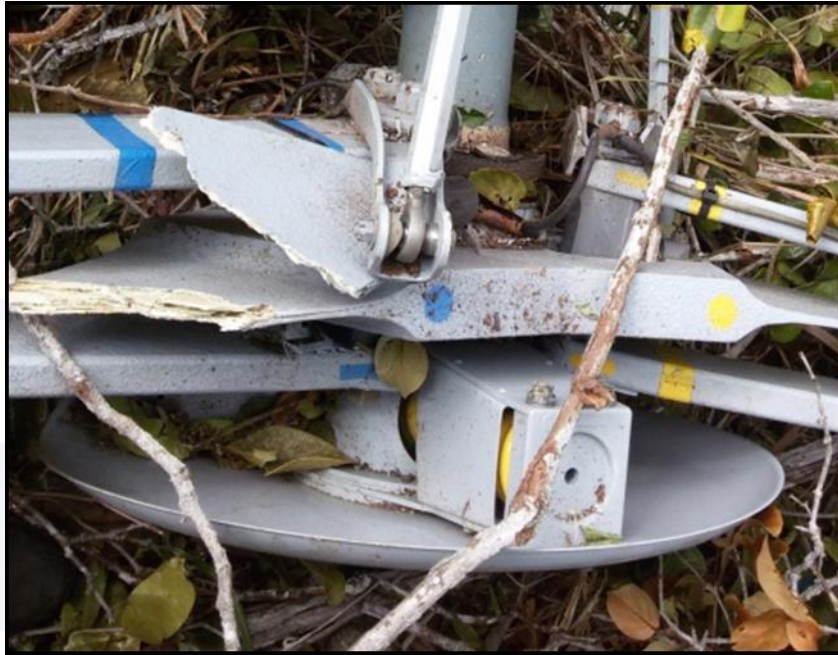
The components of the main rotor head (Figure 4) showed little damage. The general state of the main rotor head indicated that the impact of the blades occurred with low rotational energy.

Figure 4 - main rotor head.

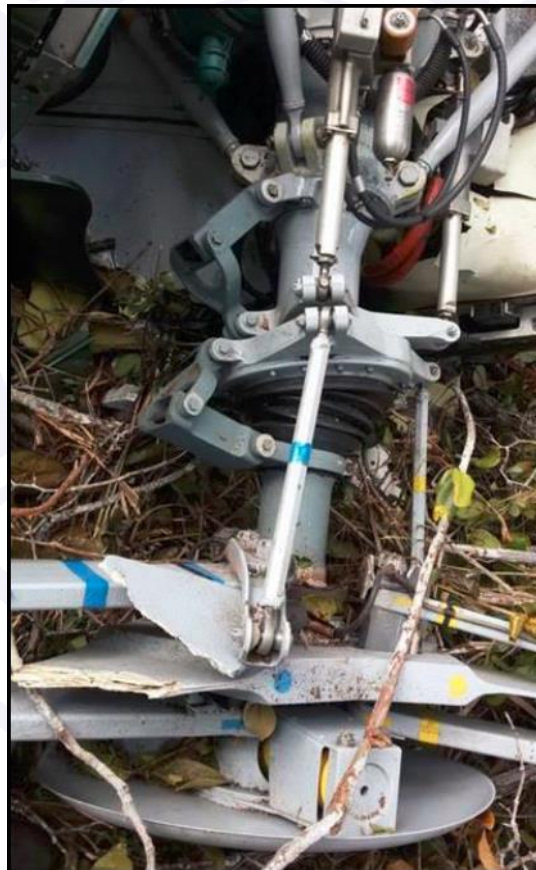
The main rotor pitch control rods (Figure 5) were connected and there was no damage due to wire or ground impact.

Figure 5 - Main rotor blade pitch control rod.

The good general condition of the main rotor's pitch control rods reinforces the idea that the collision with the power grid wire did not cause damage that could compromise the operation of the aircraft to the point of contributing to the accident.

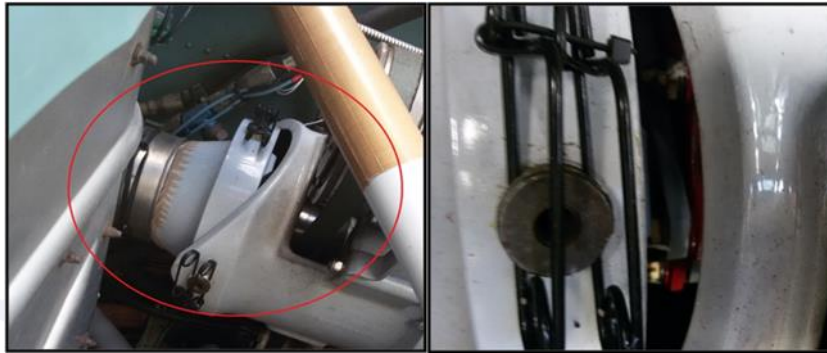
The connection between the engine and the CTP was not damaged (Figure 6). The state of the components of this coupling suggested that, at the time of the accident, the impact of the main rotor blades on the ground occurred when the engine of the aircraft was with low power.

Figure 6 - Connection between the engine and the CTP.

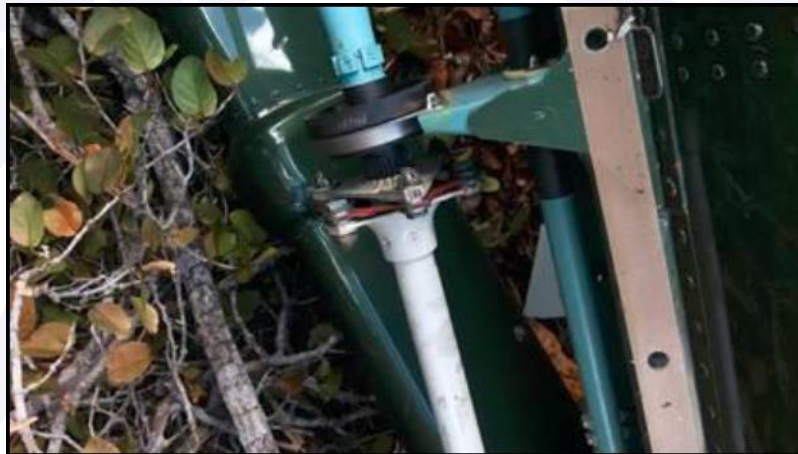
The coupling of the connecting shaft between the engine and the drive shaft of the tail rotor was normal (Figure 7). The absence of damage in the component indicated that the contact of the tail rotor blades with some obstacle occurred when the engine was with low power.

Figure 7 - Coupling of the connecting shaft with the drive shaft of the tail rotor.

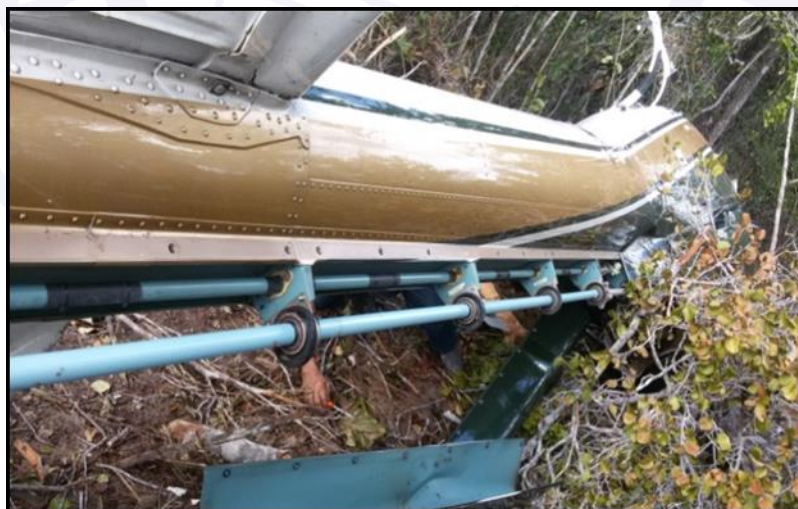
The tail rotor drive shaft (Figure 8) showed normal conditions with no signs of damage or reaction stress due to the impact of the tail rotor blades with the ground.

Figure 8 - Tail rotor drive shaft.

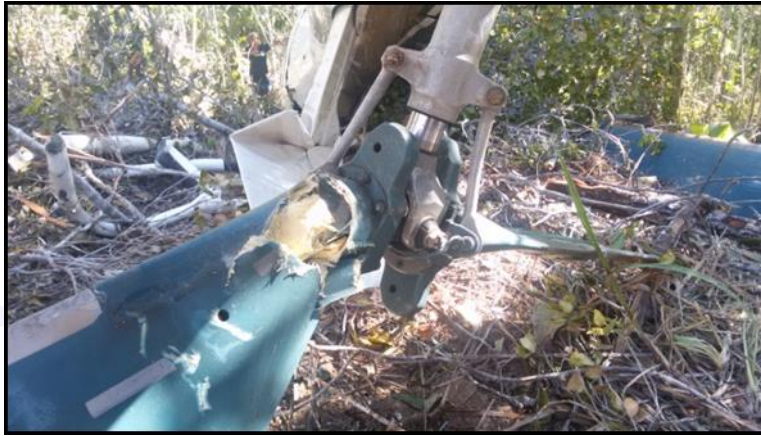
The tail rotor blades did not show signs of significant impact (Figure 9). The observed damages were not characteristic of impact with the engine developing power.

Figure 9 - Tail rotor blades.

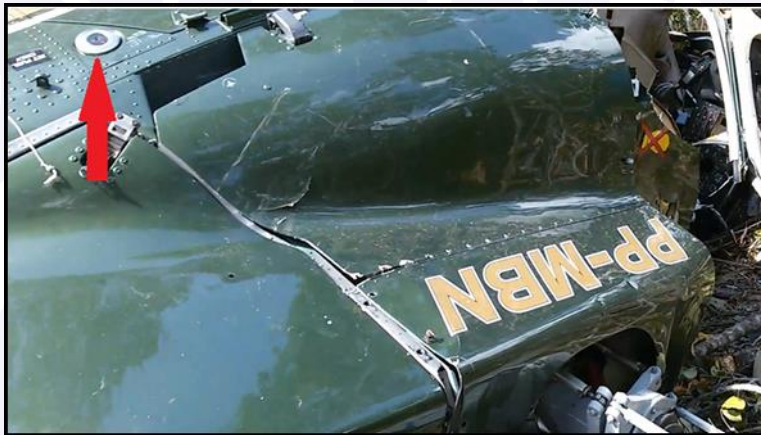
At the crash site, there was no characteristic smell and no signs of fuel leakage. The aircraft had the left side up and the reservoir nozzle was preserved (Figure 10).

Figure 10 - Preserved Reservoir nozzle.

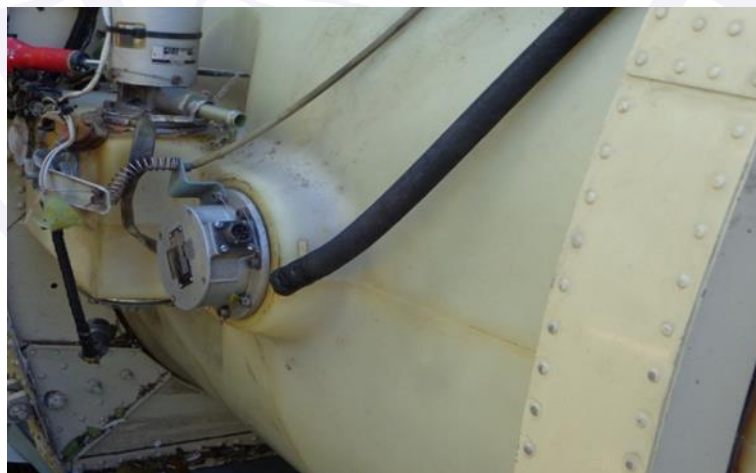
The fuel pump outlet hose has been removed (Figure 11). There was no fuel in the hose.

Figure 11 - Fuel hose.

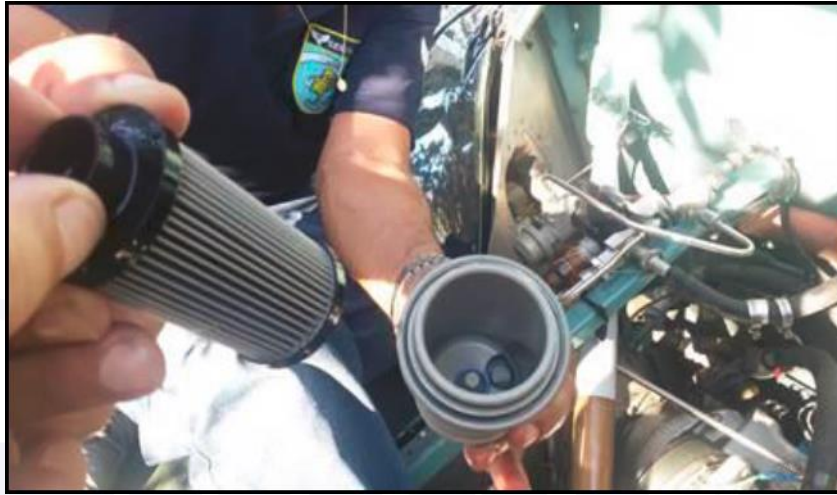
It was also observed that there was no fuel in the fuel filter housing (Figure 12).

Figure 12 - View of the housing of the fuel filter element.

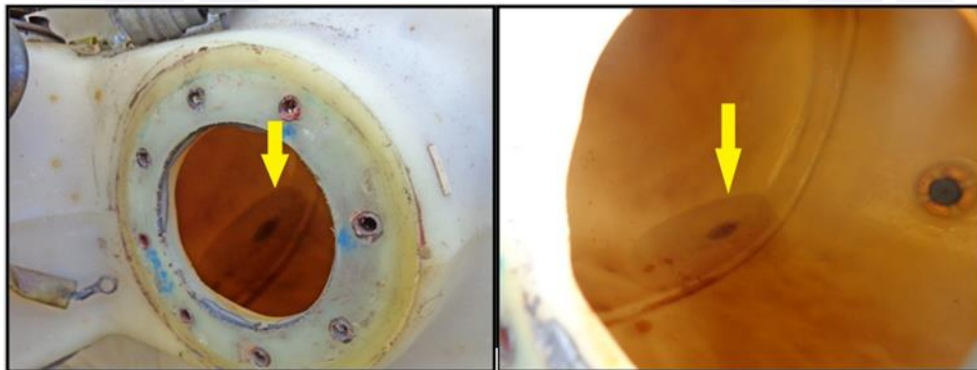
In the tank of the aircraft, there were approximately 1.75 liters of fuel (Figure 13).

Figure 13 - Views of the remaining fuel in the tank.

The amount of fuel found in the tank was not enough for the fuel system to keep the engine running.

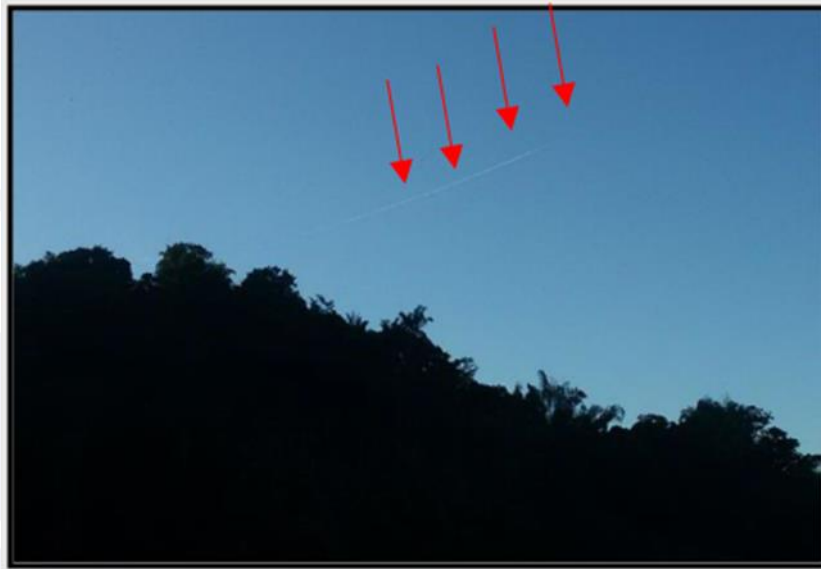
Figure 16 - Wire reached by the aircraft (already repaired).

Before proceeding to the destination, the aircraft carried out a local flight over the city of Nazaré, and collided with a power grid wire that crossed the area used for the open market of that city.

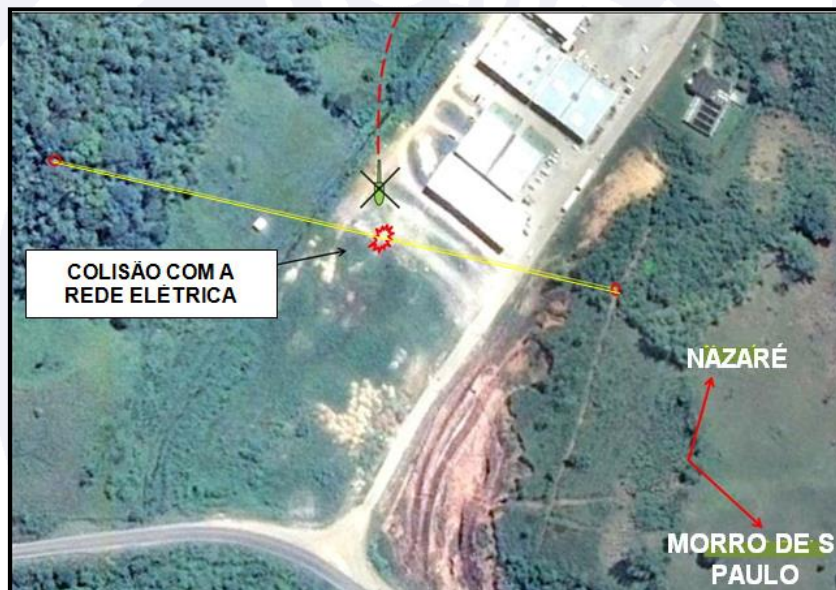
Figure 17 - Sketch of takeoff / collision site with the wire.

Between the area where the collision with the wire happened and the location of the accident, the aircraft covered a distance of 5,15 NM.
