FINAL REPORT
IG-013/CENIPA/2016

OCCURRENCE:	SERIOUS INCIDENT
AIRCRAFT:	PR-CVL
MODEL:	AT- 402B
DATE:	18JAN2016

This is the Final Report of the 18JAN2016 serious incident with the AT 402B aircraft, registration PR-CVL. It was classified as (SCF-PP) "System/Component Failure or Malfunction (Powerplant)".

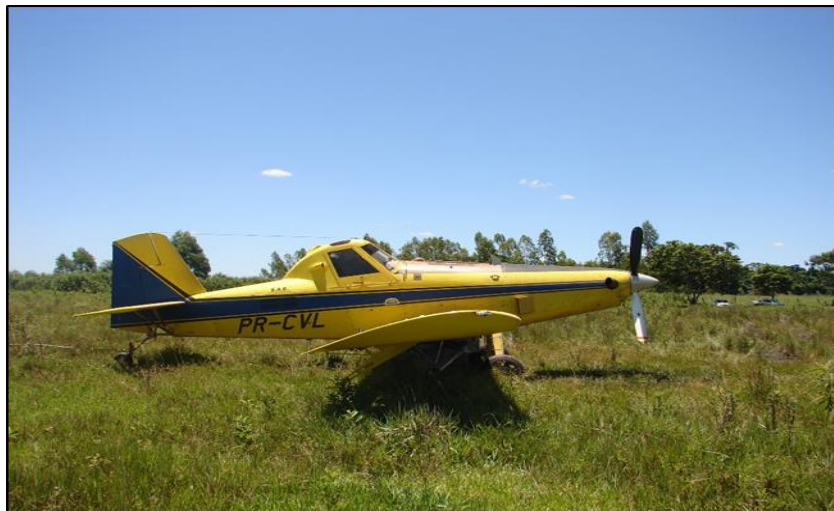
Figure 1 - Overview of the aircraft.

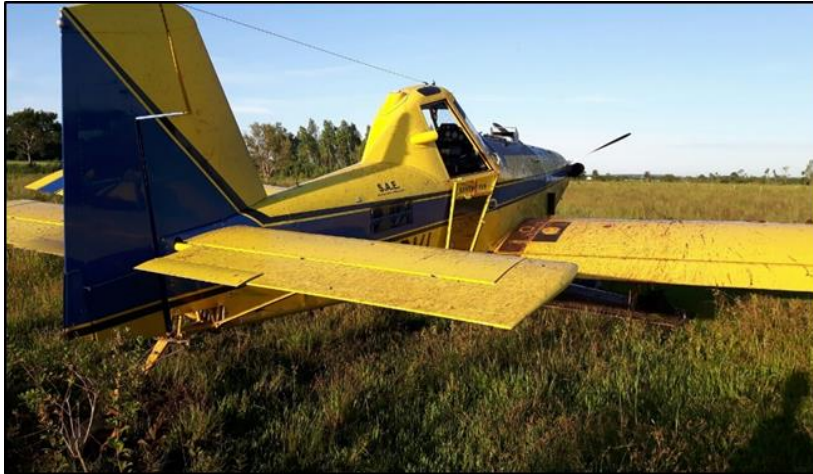
Figure 2 - Overview of the aircraft.

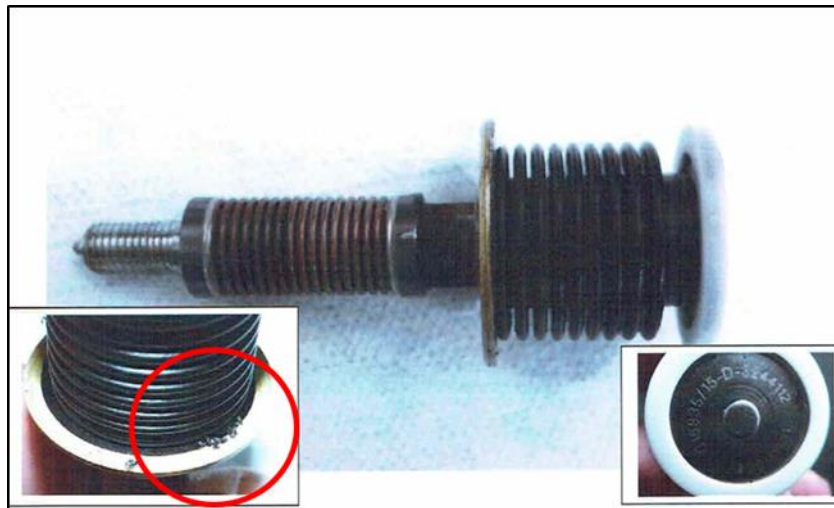
Therefore, in the performed examinations, the inoperativeness of the aneroid capsule (bellows) of the engine's FCU that equipped the aircraft AT-402B PR-CVL was concluded. This caused a blockage in the fuel flow, stagnating its flow in idle condition, which forced the pilot to make the forced landing.

The Pratt & Whitney Canada (P & WC) shop in Brazil also conducted an investigation into the FCU of the aircraft and found that there were micro-cracks in the aneroid capsule and confirmed leakage in that component (FCU acceleration area), as reported by the company's support representative.

Figure 3 - View of the FCU aneroid capsule. On the right, it is shown its identification and on the left side, it is shown the contamination.

The Pratt & Whitney report found that the aneroid capsule was in contact with the inner wall of its housing (vacuum chamber) and suggested that the micro-cracks were associated with the vibration of this component, but the report was not conclusive as to the source of that vibration.

Follow the survey carried out by Pratt & Whitney Canada (P & WC), in order to verify the need to issue corrective actions, aiming to ensure adequate compliance with applicable airworthiness requirements.
