COMANDO DA AERONÁUTICA
CENTRO DE INVESTIGAÇÃO E PREVENÇÃO DE
ACIDENTES AERONÁUTICOS

FINAL REPORT
A-103/CENIPA/2013

OCCURRENCE:	ACCIDENT
AIRCRAFT:	PR-DJC
MODEL:	EC 130 B4
DATE:	30MAY2013

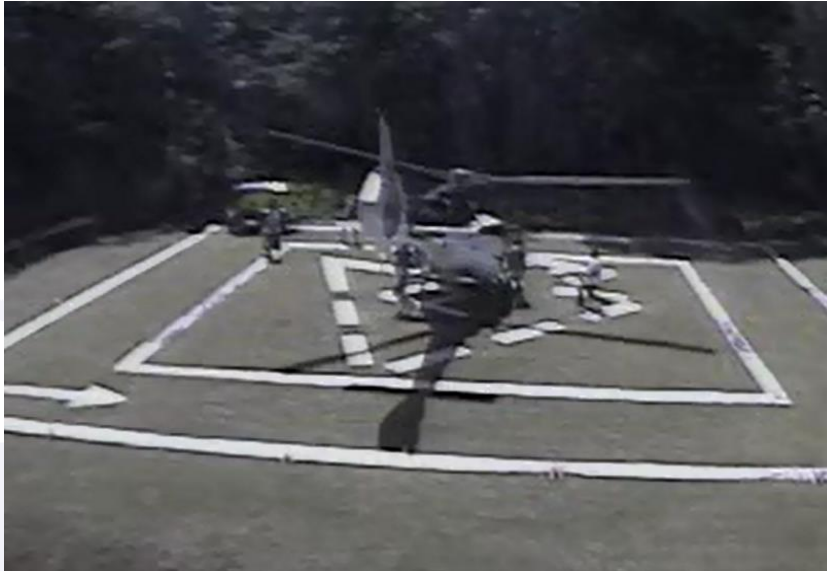
While the passengers left the helicopter with rotors running, the aircraft tailboom raised, and the helicopter initiated a forward movement supported by the front part of the skids. After about three meters, the helicopter yawed to the right and tipped over on its left side (Figures 1 and 2).

Figure 1 - Beginning of the movement.

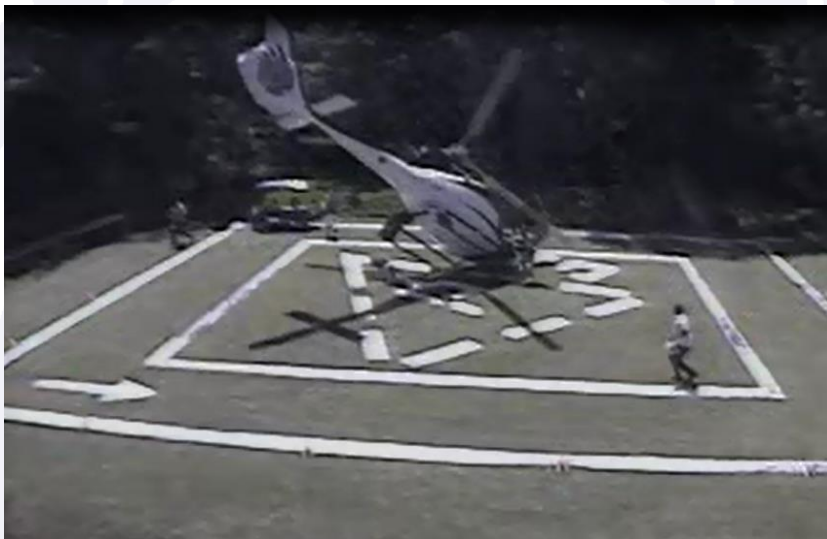
Figure 2 - Tailboom lift, and helicopter tipping over.

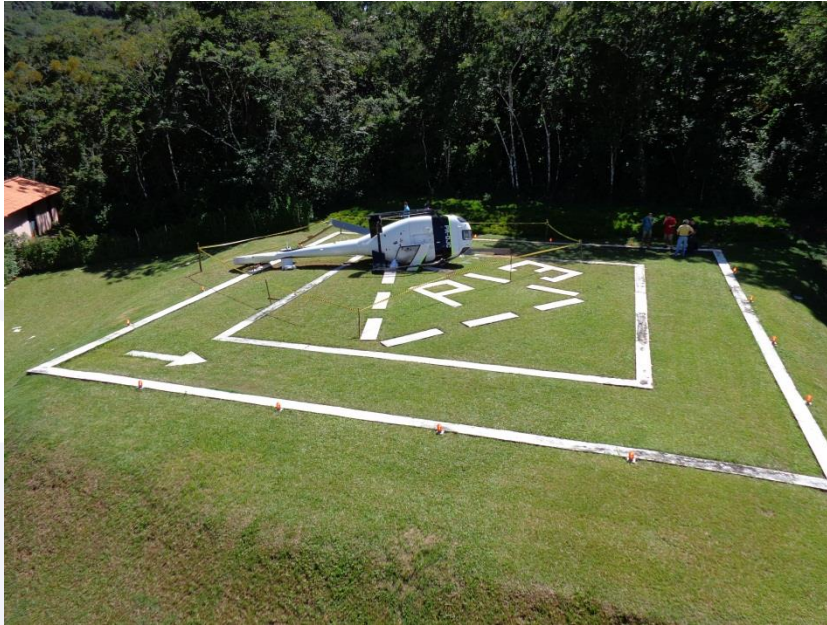
The aircraft came to rest with the longitudinal axis 60° of the position it had landed (Figure 3).

Figure 3 - Post accident tipped aircraft.

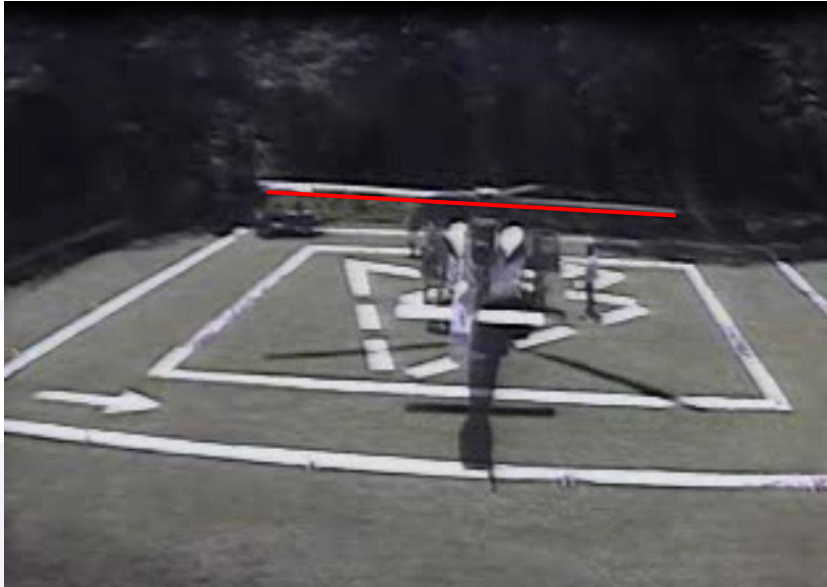
Figure 8 - Increase of the rotor blades coning.

A small increase of the coning in the instants that preceded the inadvertent takeoff can be observed by the increase of the angle between the blades and the solid red line (used as reference) in figures 8 and 9. IPEV stated that it was a consequence of an increase of the aircraft collective pitch.

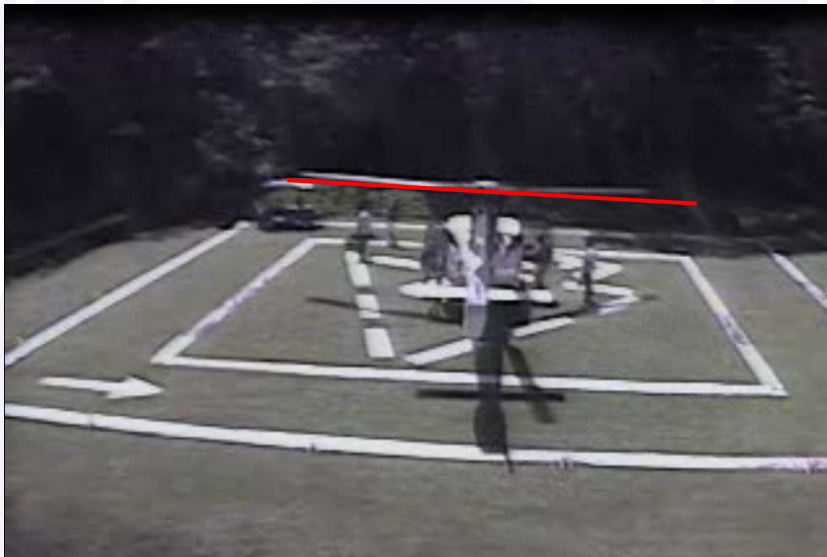
Figure 9 - Increase of the rotor blades coning.

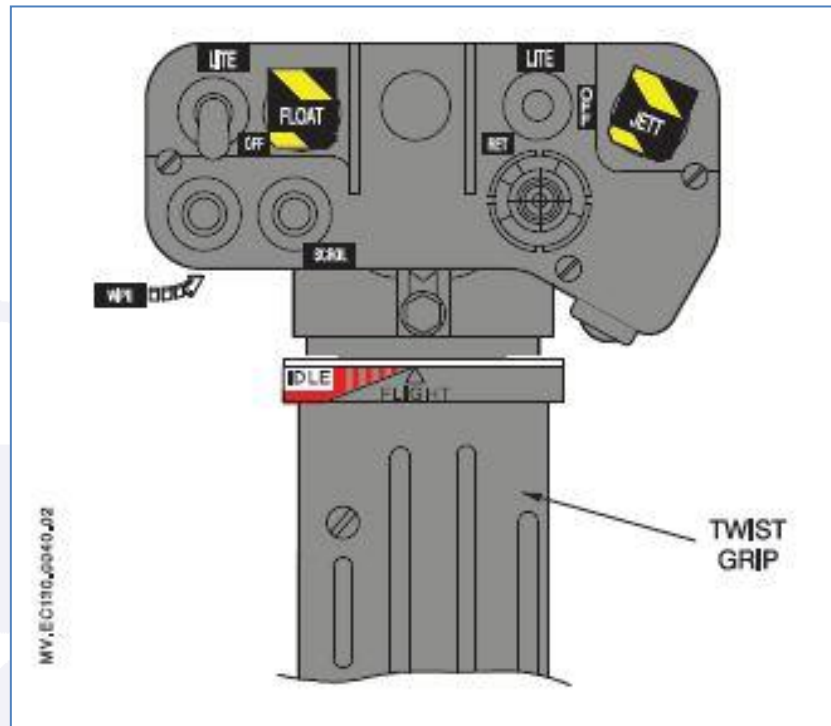
Figure 10 - Twist Grip.

The aircraft has a fuel outflow control located at the collective lever. The Twist Grip (Figure 10) exerts such control.

By turning the Twist Grip in a counter clockwise direction, the engine functions at ground-idle, and NG at approximately 68%. (Credit: EC-130 *Flight Manual Supplement* page 6-2)

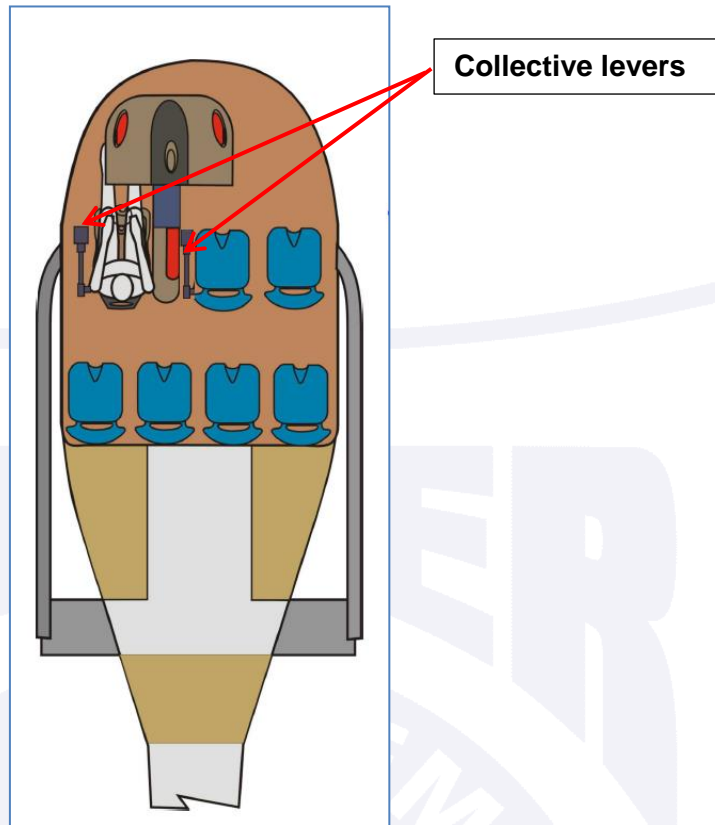
Figure 12 - Helicopter interior configuration.

One of the accident helicopter characteristics was that captain's seat was the left front seat (Figure 12).

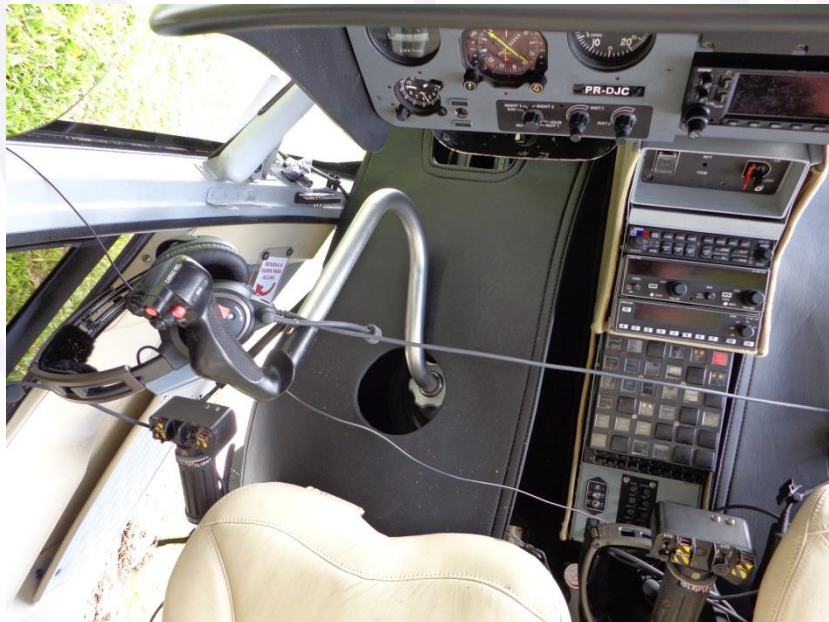
Figure 13 - Aircraft collective levers.

The aircraft was equipped with two collective levers (one at captain's seat left side, and the other between the captain's seat and the central seat) (Figure 13).

The passenger who left the aircraft by the left front door used one of the collective levers as support during the exit, and inadvertently changed the Twist Grip position from “ground idle” to “flight idle”.

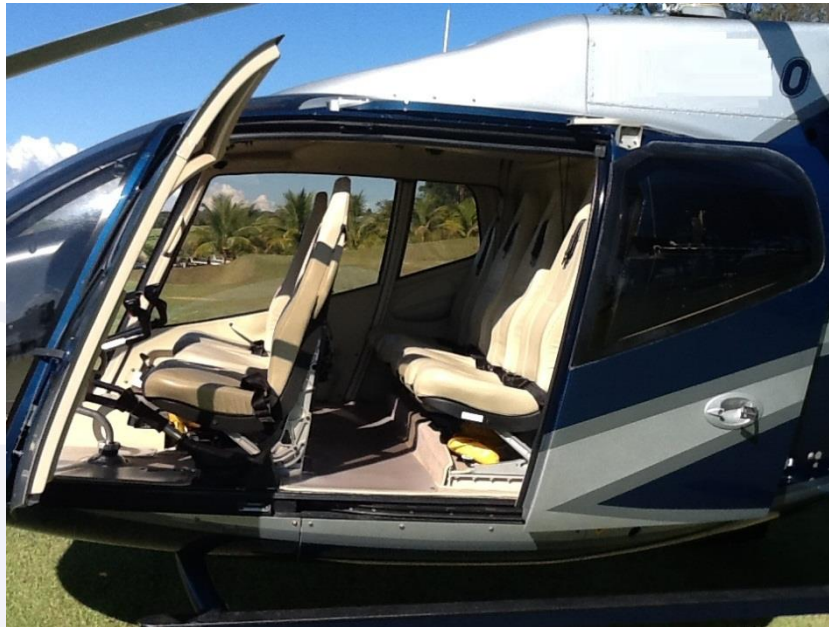
Figure 14 - Aircraft doors (left side).

At that moment, one of the rear passengers disembarked by the left front door, as the left rear door was closed.

The aircraft was equipped with two front doors and two rear doors. The rear ones were sliding doors (Figure 14).
