**FINAL REPORT**  
**IG - 135/CENIPA/2014**

<b>OCCURRENCE:</b>	<b>SERIOUS INCIDENT</b>
<b>AIRCRAFT:</b>	<b>PR-HRV</b>
<b>MODEL:</b>	<b>S-61N</b>
<b>DATE:</b>	<b>16AUG2014</b>

This is the Final Report of the 16AUG2014 serious incident with the S-61N aircraft, registration PR-HRV. The serious incident was classified as “Foreign Object Damage (FOD)”.

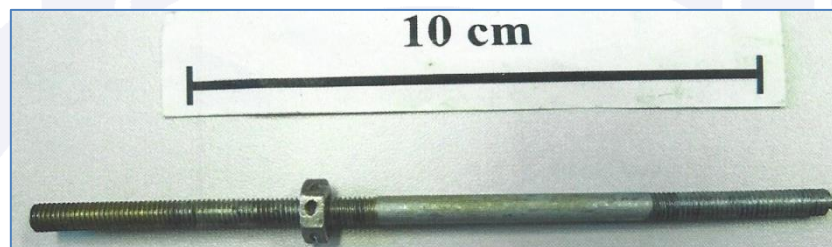
In the same way, the remaining part of the engine air intake screen-fixing screw (ROD CLAMP PN 61088-20222-130) was collected for laboratory testing at the DCTA.

Figure 1 - Screen fixing screw.

Two types of examinations were performed by the DCTA: preliminarily, a stereoscopic analysis; and as an additional examination, an analysis by scanning electron microscopy was also performed. Both pointed out as a result that the screw fracture occurred due to fatigue by alternating bending stress.

Stereoscopic analysis and analysis by scanning electron microscopy indicated that the screw fracture occurred due to fatigue by alternating bending stress.

- The Company's maintenance and engineering department has determined that a Maintenance Inspector check the torque on all air intake screens of the fleet's helicopter engines in order to ensure a safe continuity of the operation.

- The Company's maintenance and engineering department has issued an Engineering Order changing the braking method of the screw for securing the air inlet screens of the fleet's helicopter engines to ensure a safe continuity of the operation.

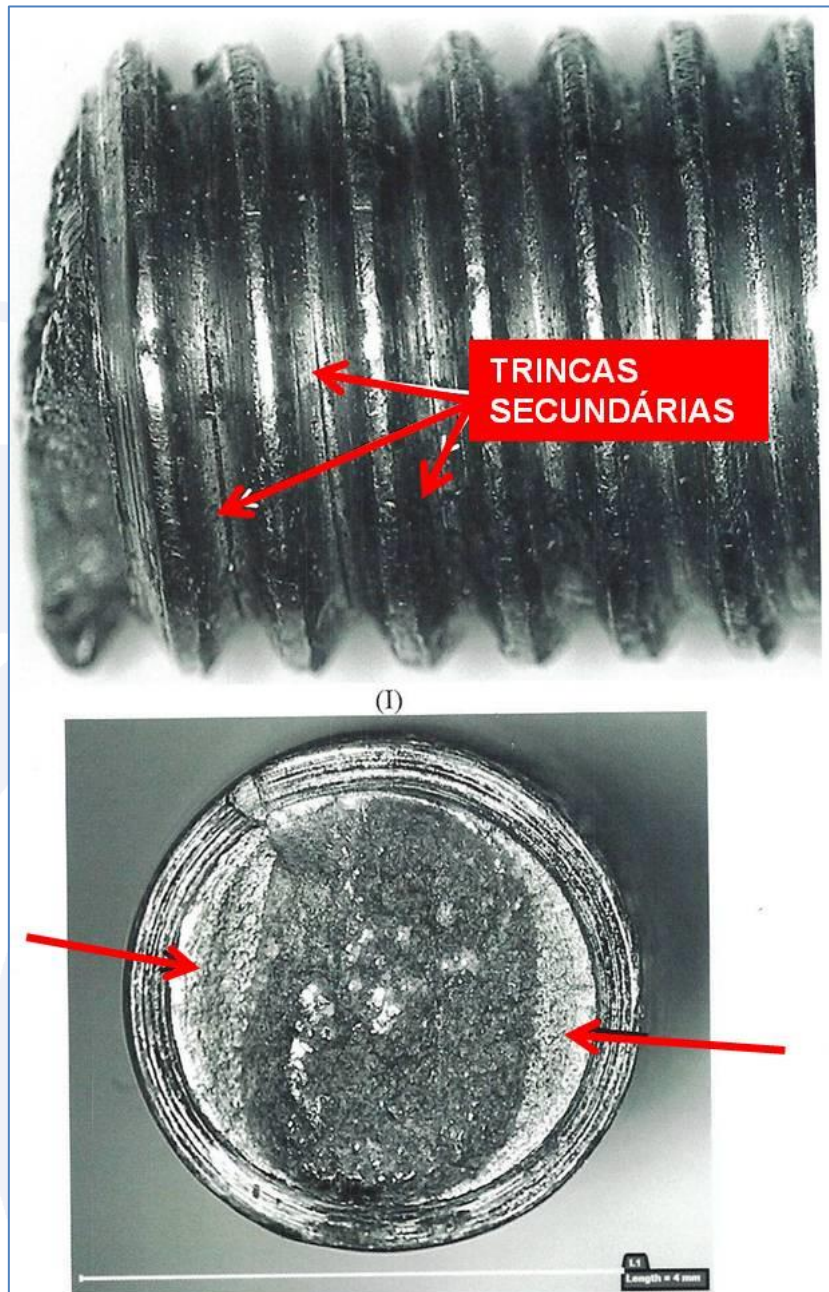
Improper mounting of the engine air intake screen (Rod Clamp Rigging), which caused cracks (Figure 2) on the screw thread and its consequent rupture possibly caused the alternating bending.

Figure 2 - Cracks in the screw thread.

It was not possible to verify exactly the cause of the cracks that originated the alternating bending failure in the screw. In this way, the following possibilities for the failure occurred: out of specification torque, incorrect braking or inadequate inspection of the screws.

It is possible that during the last inspection of the engine air intake screen, there may have been some failure related to braking, torque, or inspection of the screen-fixing screws.
