FINAL REPORT
A-023/CENIPA/2015

OCCURRENCE:	ACCIDENT
AIRCRAFT:	PT-KBV
MODEL:	182P
DATE:	19FEB2015

This is the Final Report of the 19FEB2015 aeronautical accident with the 182P aircraft, registration PT-KBV. The accident was classified as "Spacial Disorientation".

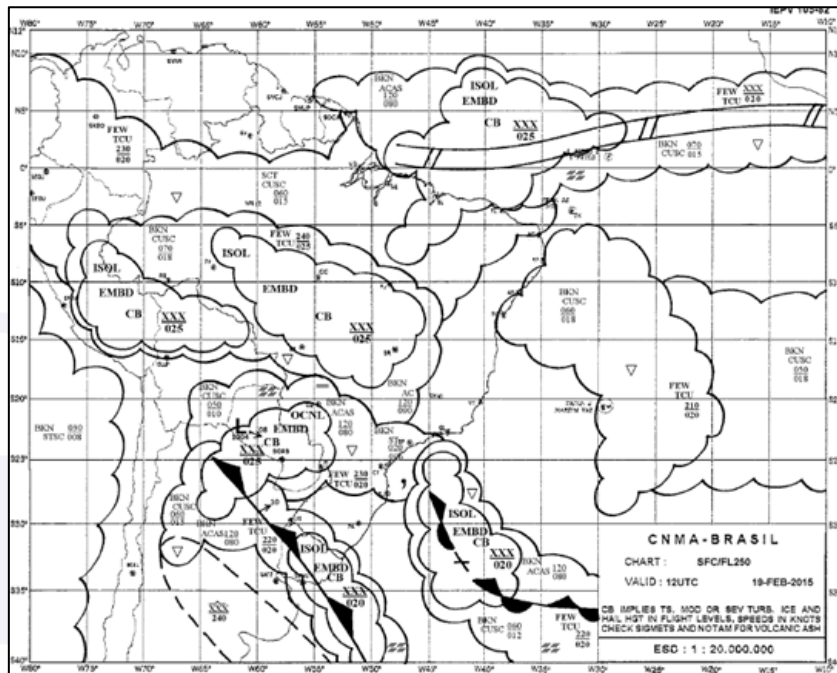
At Parati's departure, weather conditions were favorable for the visual flight, but conditions at the chosen flight level were getting worse, as noted in the Wind and Cloud Forecast Chart (SIGWX) on the day of the occurrence.

The meteorology of the route indicated that there would be significant formation of clouds at the flight level chosen by the pilot, including the possibility of formation of clouds of great vertical development and thermal convection, from 2,000ft altitude. This information could also be observed in the SIGWX of the day and time of the occurrence (Figure 1).

Figure 1 - SIGWX chart of the region on the day of the occurrence.
(The red arrow indicates the desired route).

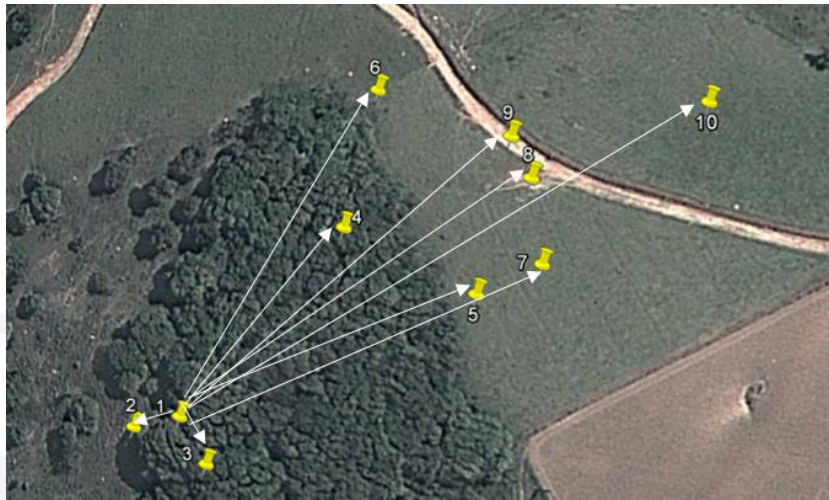
The aircraft crashed directly into the ground, with no previous impacts. There was separation of some of its parts in flight, which were scattered in an area of approximately 190x70 meters. (Figure 2).

Figure 2 - Placement of the aircraft wreckage.

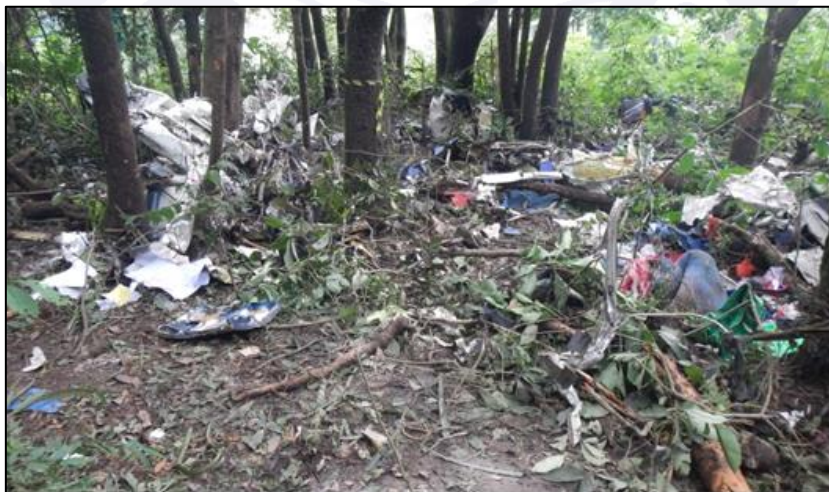
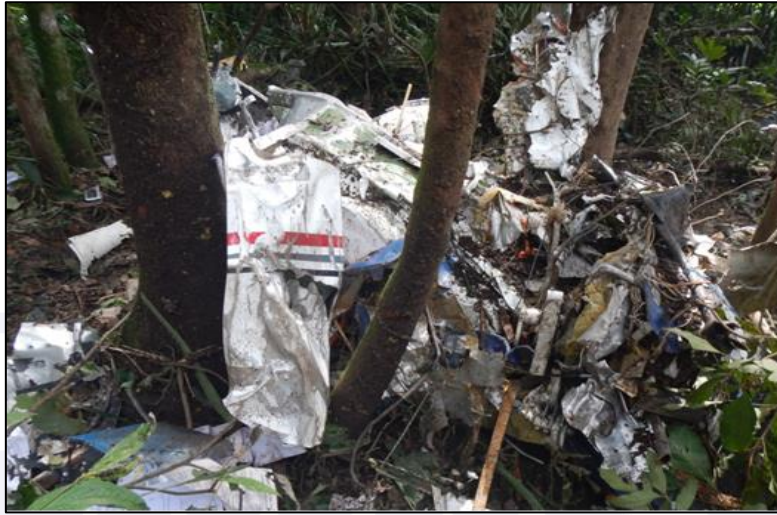
At the core of the wreckage, there were the following items: flight and passenger cabin; left wing; wheels; seats; part of the fuselage; engine and propeller. The great energy of the impact of the aircraft against the ground caused enormous damages, deforming and fragmenting its components in several parts (Figures 3 and 4).

Figure 3 - Core of the wreckage.

Figure 4 - Core of the wreckage.

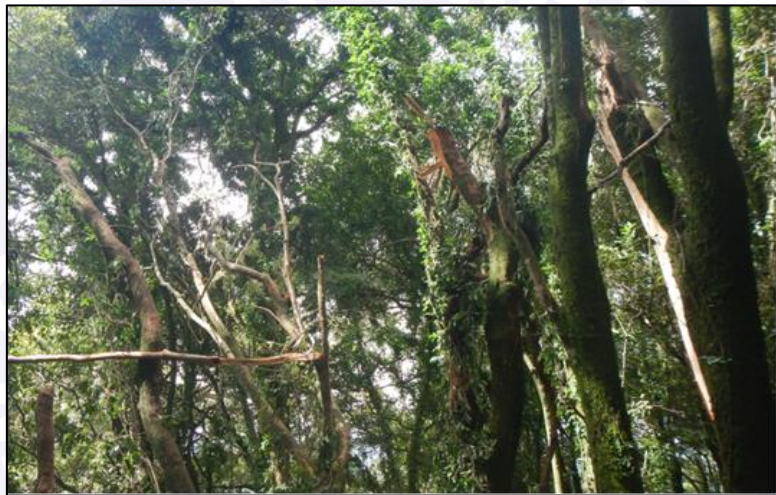
The marks left on the ground and the damage caused to the vegetation indicated that the aircraft and its components collided against the ground with reduced horizontal displacement, and it can be seen that the angle of impact was approximately 80° (Figure 5).

Figure 5 - Marks of the impact of the aircraft on vegetation.

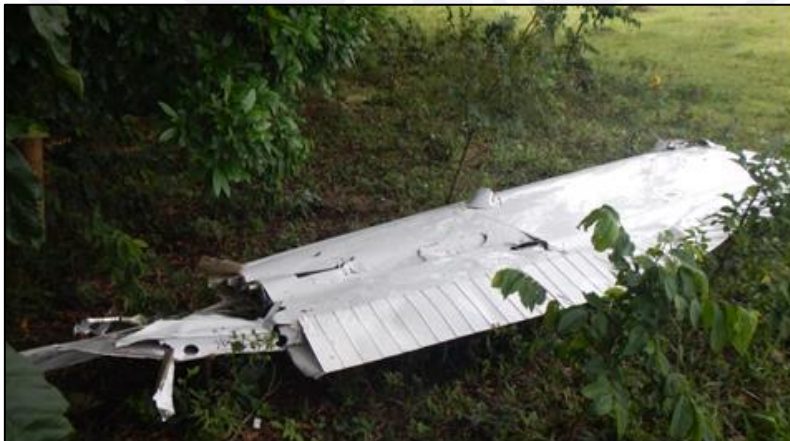
The right wing was sectioned near the fuselage and divided into three main parts. Signs of collision could be observed at the end of the wing, which was 92 meters from the core of the wreckage (Figure 6).

Figure 6 – Bigger part of the right wing.

provoking the right wing breakage near the fuselage (primary fault) and possibly, the collision of the wing against the tail (secondary fault) of the aircraft, triggering the entire observed fragmentation sequence.

What strengthens the hypothesis raised is the fact that the aircraft has been sighted by observers in descending and spiraling trajectory, losing parts in flight. It also corroborates the fact that the right wing was found divided in three parts, with signs of collision at its end, in a prominent position of the core of the wreckage, which suggests that it was the first part to be detached.

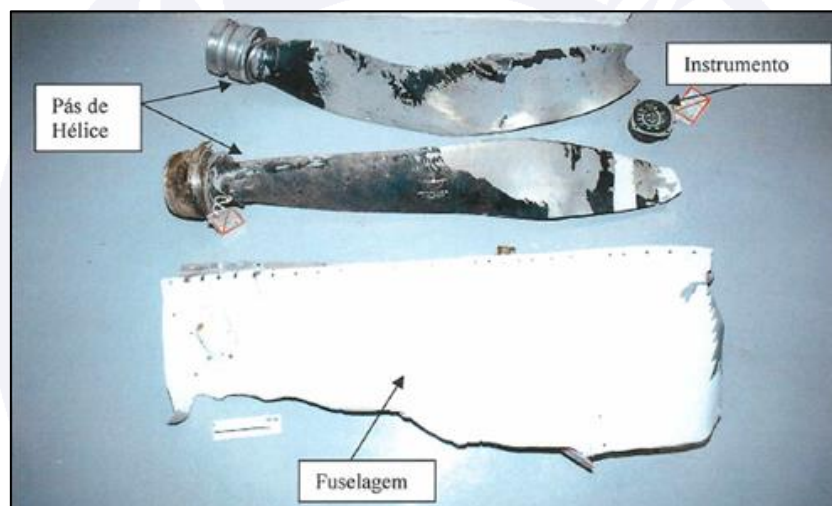
The Aeronautics and Space Institute (IAE), of the Aeronautics' Science and Technology Department (DCTA), conducted tests and research concerning the analysis of fault occurred with the following components of the aircraft: two propeller blades, the speedometer and parts of the fuselage (Figure 7).

Figure 7 - Components submitted to DCTA failure analysis.

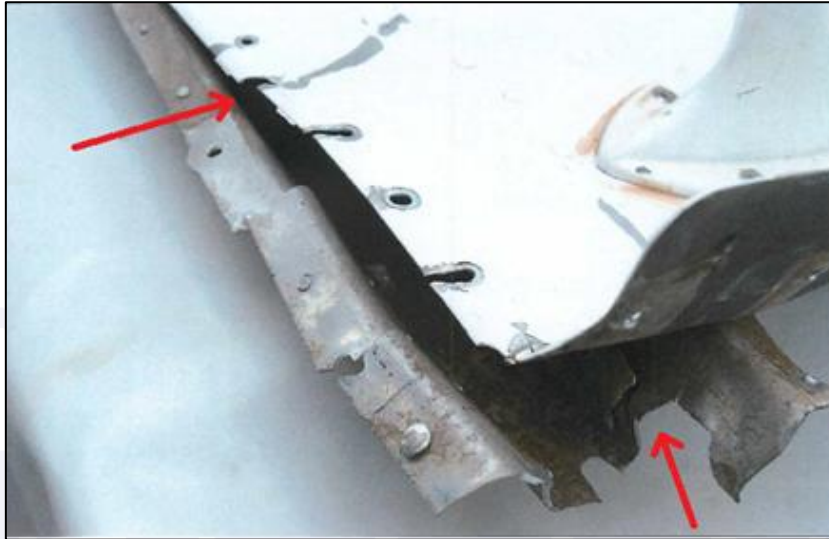
The fractures examined in the fuselage section indicated rupture by overload, presented tearing aspects of the aluminum plate and fracture with angles of approximately 45° in the reinforcement profile (Figures 8 and 9).

Figure 8 - Tearing aspects of the aluminum plate of the fuselage.

The fractures observed in the examined pieces corroborated the hypothesis of aerodynamic overload and the other damages were produced by the impact against the ground. In the exams and signs collected, it was not possible to indicate another type of failure.

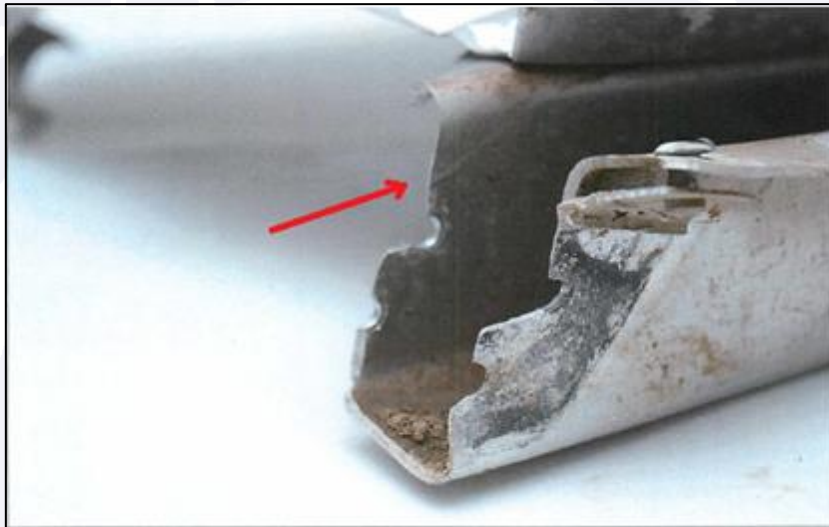
Figure 9 - Fracture in the fuselage reinforcement profile.

- v) damage to propellers occurred due to the impact on the ground;
- w) the fractures in the fuselage section presented indications of breakage by overload.

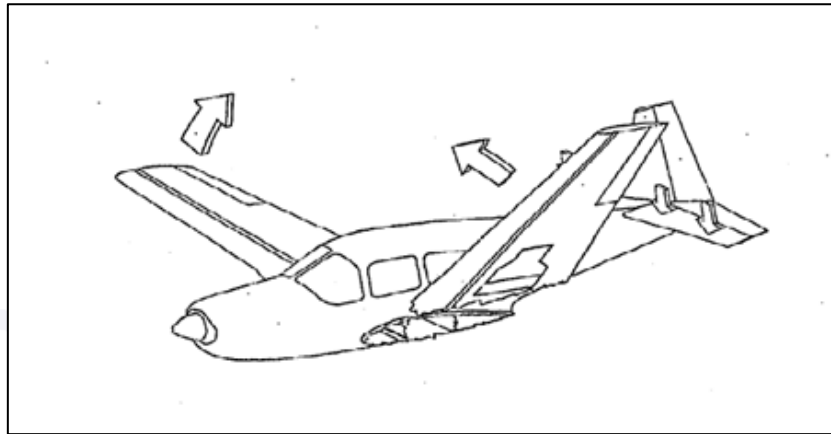
In small aircraft, the places where the break usually occurs are in the wings and in the horizontal stabilizers. The wing, when subjected to a high "G" positive load, deflects upward, generating tension stress on the lower surface and compression on the upper one. The wing, when detached due to an excessive positive load "G", causes a rolling movement of the aircraft towards its side, while it will do the same over the fuselage (Figure 10).

Figure 10 - Illustration of wing break caused by positive "g" excess load.

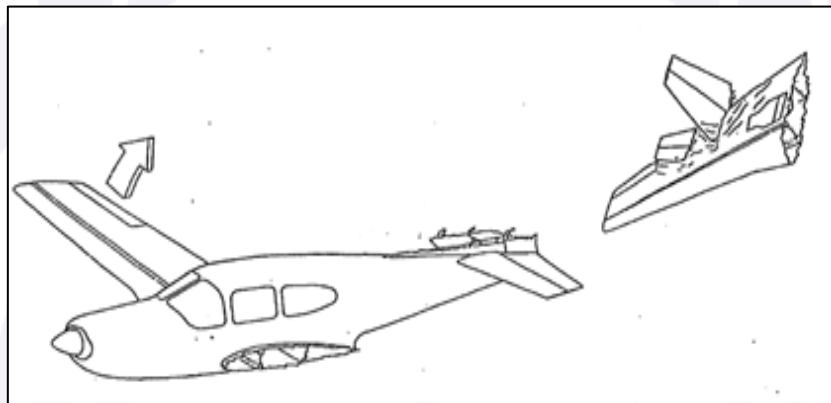
This situation may result in the collision of the wing against the tail of the aircraft, horizontal or vertical stabilizer, characterizing the occurrence of a primary and a secondary fault, as shown in Figure 11.

Figure 11 - Secondary stabilizer break illustration.
