**FINAL REPORT**  
**A - 070/CENIPA/2014**

<b>OCCURRENCE:</b>	<b>ACCIDENT</b>
<b>AIRCRAFT:</b>	<b>PT-ROS</b>
<b>MODEL:</b>	<b>EMB720D</b>
<b>DATE:</b>	<b>06APR2014</b>

This is the Final Report of the 06APR2014 accident with the EMB-720D aircraft, registration PT-ROS. The accident was classified as "Collision with Obstacle in-Flight".

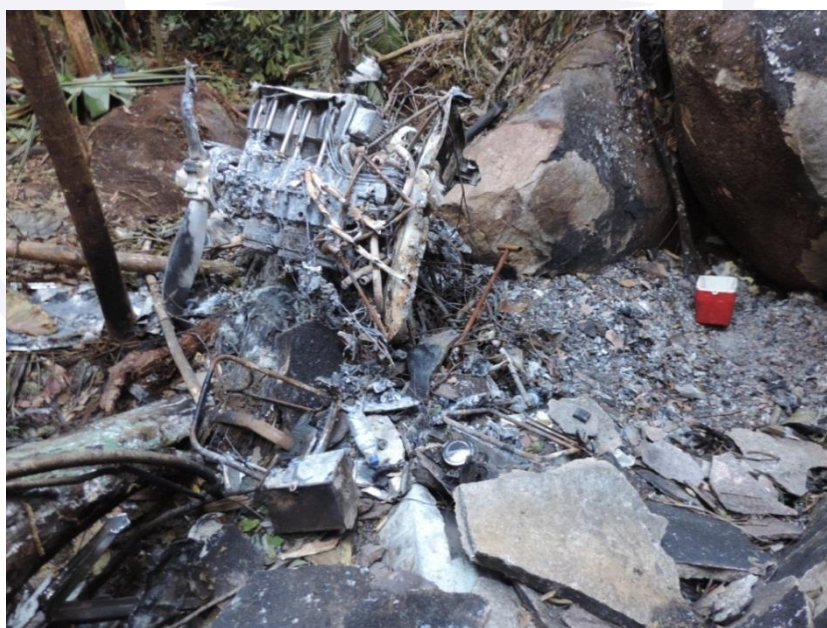
The aircraft was completely destroyed.

Figure 1 - View of the fuselage, empennage and engine's resting location.

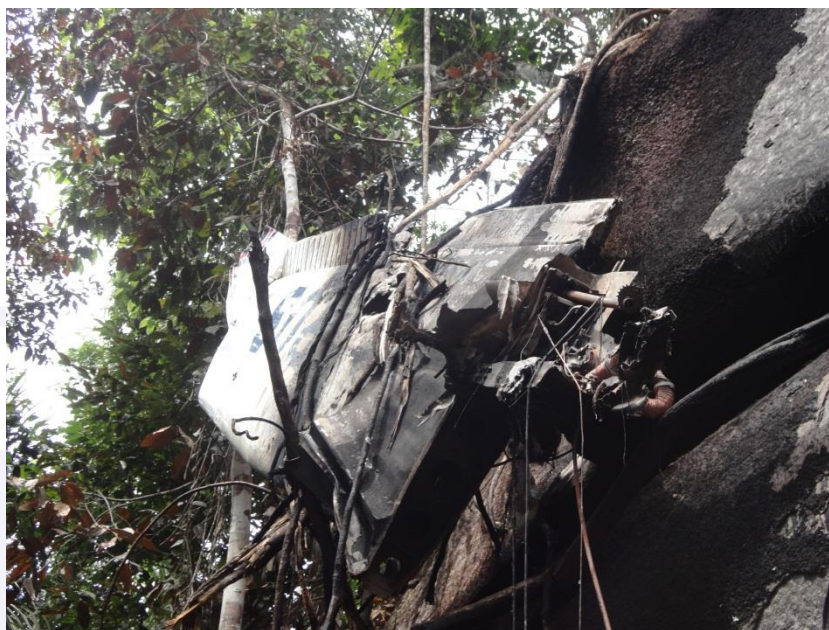
Figure 2 - View of the right wing.

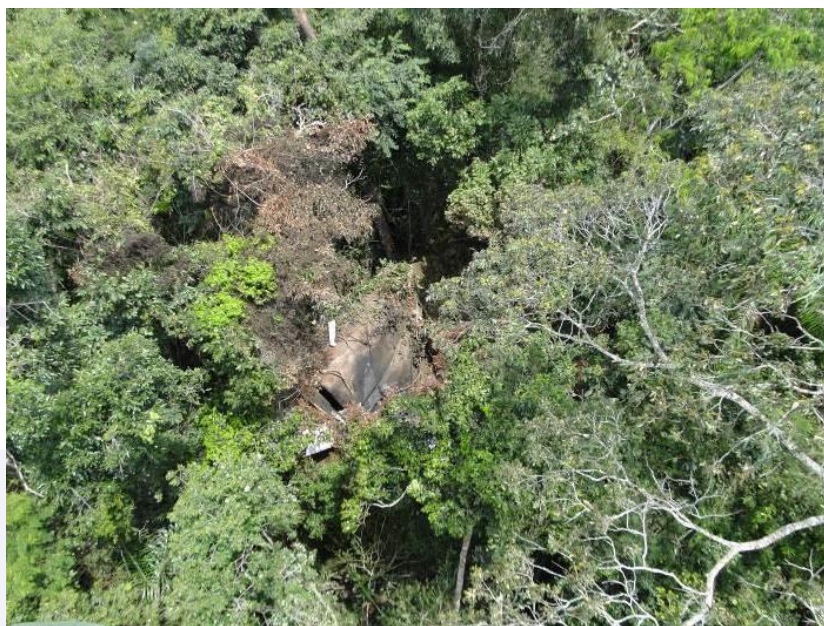
The accident happened in an area of high and dense forest, on an elevation of 299 meters of altitude at Triângulo Farm, municipality of Aripuanã, MT.

Figure 3 - View of the impact location of the aircraft.

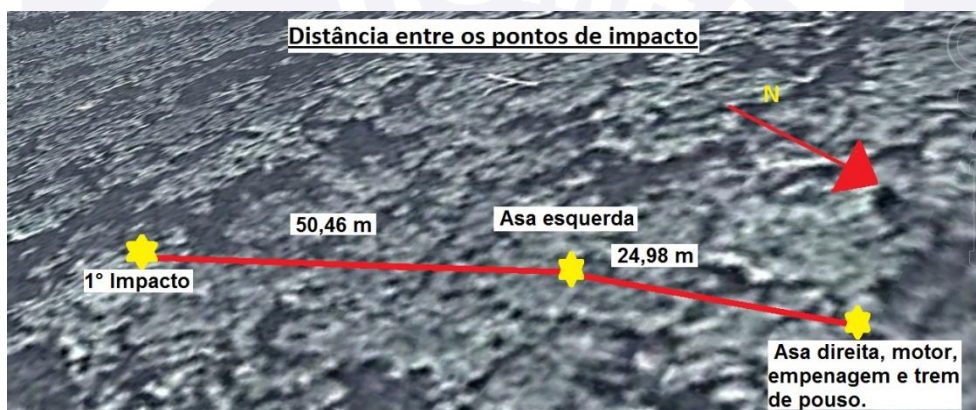
Figure 4 - Distances between the first impact, the left wing resting place and the last impact location.

The aircraft was 50.46m away from the first impact point and 29m above, it collided against the treetops and the left wing was sectioned, causing bearing movement.

The last crash of the aircraft against the trees broke the right wing and caused the plane's fuselage to fall, impacting "from top to bottom" on the back, away 24.98m from the left wing resting place and 9m above.

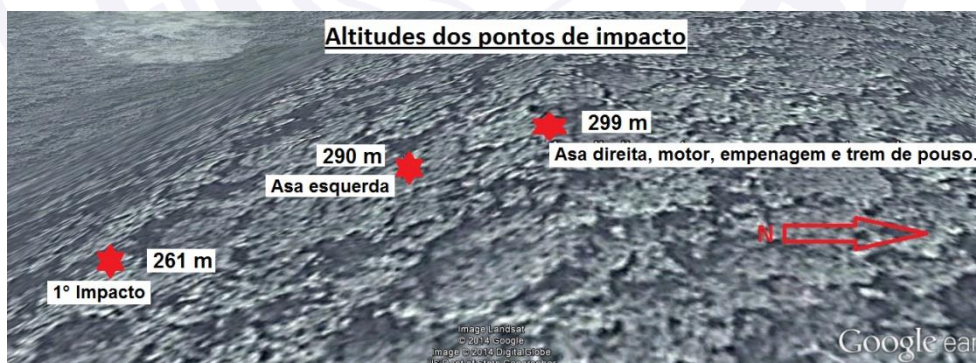
Figure 5 - Altitudes of the points of impact.

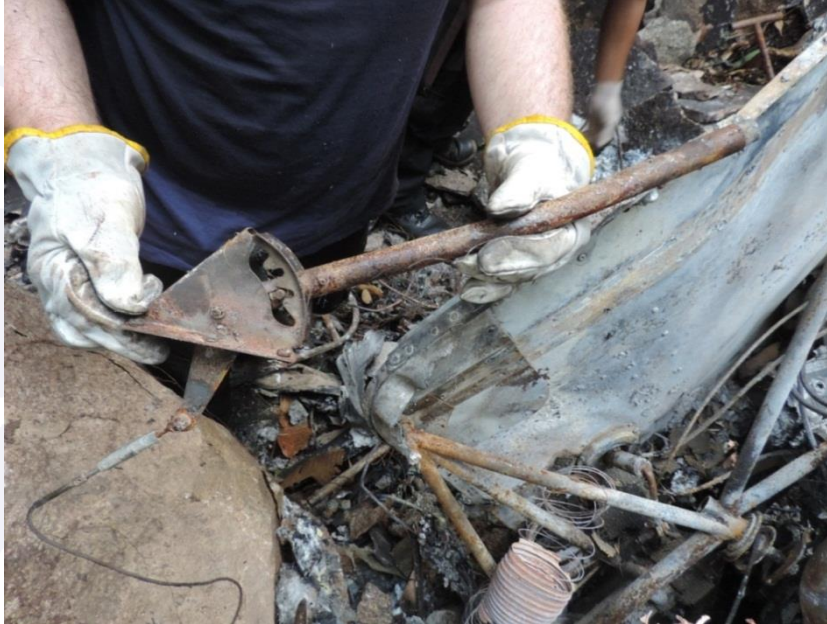
The mechanical control lever of the flaps was found in the 10 ° extension position. It was not possible to observe the positioning of the surfaces due to the state of the wrecks.

Figure 6 - View of the flaps control lever.

It was not possible to determine if the deflection of 10° in the flap control occurred intentionally, in an attempt to increase the lift to clear the obstacles or if it occurred due to forgetfulness after takeoff. Also, if it was the result of a large number of people who accessed the place of the accident before the arrival of the investigation group. The lack of training to operate under IMC conditions also contributed to the commander's inadequate piloting judgment, as he believed it was possible to keep the flight, even in unfavorable conditions to the VMC flight.

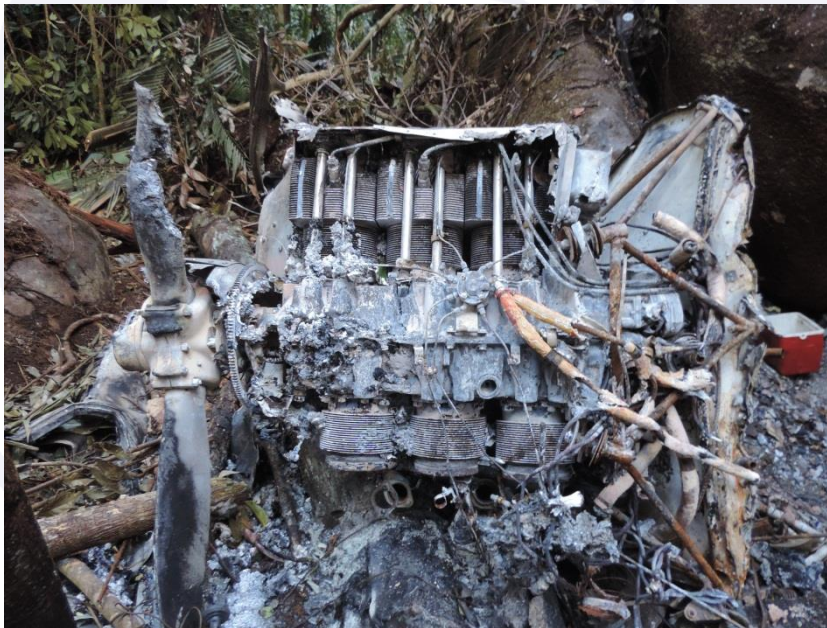
Figure 7 - View of the engine and propeller damaged by fire.

Fire was extinguished without interference from firefighting service, after consuming all inflammable material present. The temperature reached by the flames in the wreck was enough to melt the engine carter and the governor of the propeller.

It was not possible to test propellers and power plant system due to fire. Therefore, it is not possible to rule out completely a possible failure in these components.

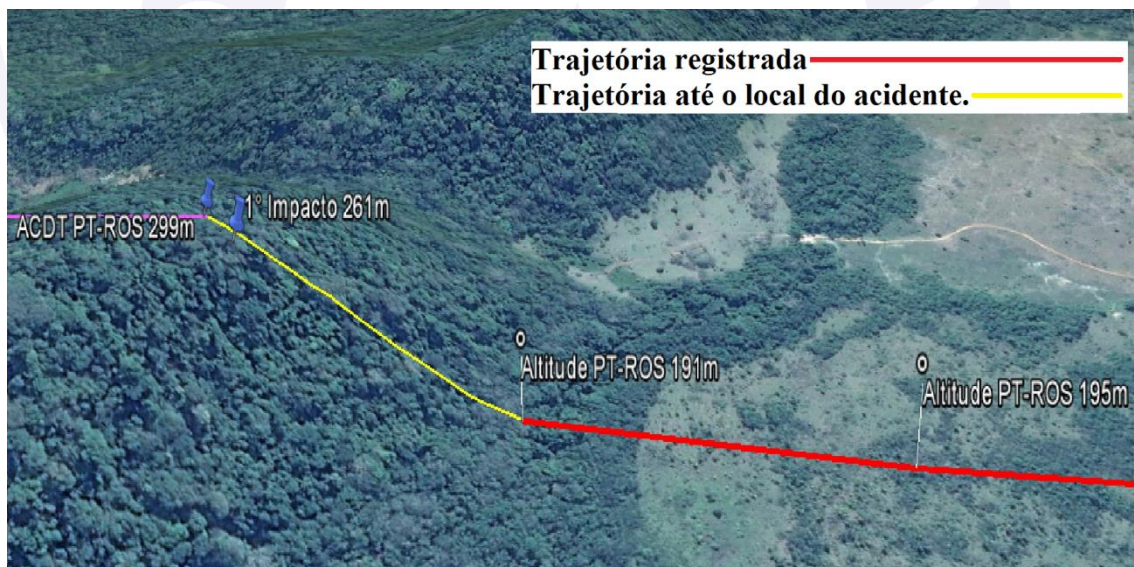
The distance and duration recorded on the equipment were not equivalent to the totality of the performed flight, since the last position indicated on the device corresponded to a point distant 0.2 NM from the position where the wreckage was found.

Figure 9 - Trajectory recorded by the GPS and trajectory till the point of impact.

This gap can be explained by the recording method of flight data in the GPS. For memory savings, the data is recorded in certain time intervals.

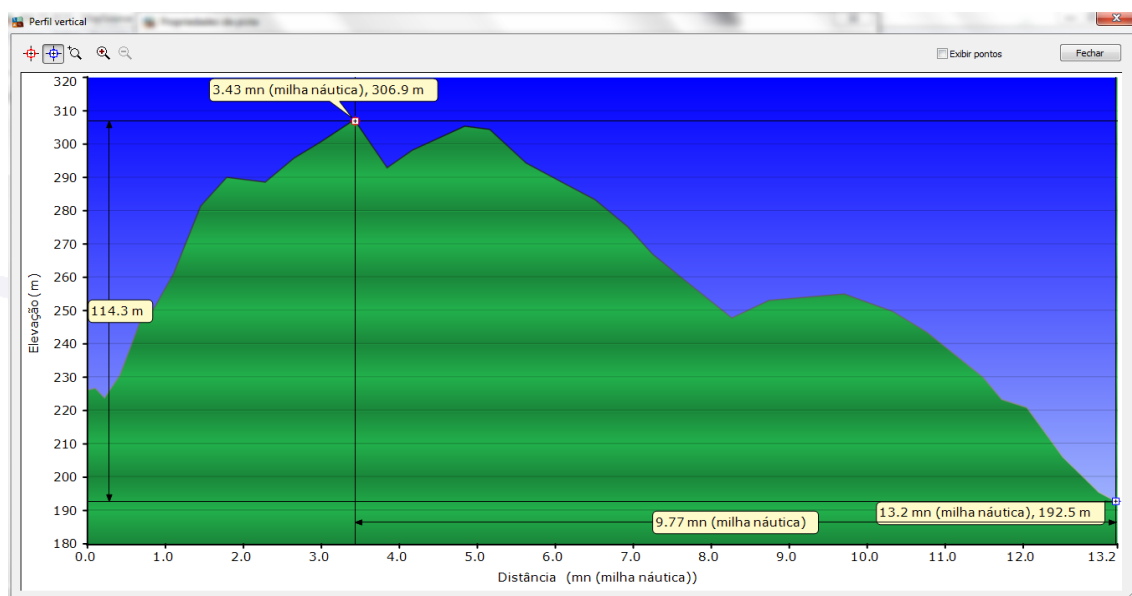
Figure 10 - Vertical profile recorded by the GPS of the PT-ROS (Garmin 296).

During the climb, it is likely that the ceiling conditions, along with the need to keep the flight with references on the ground, have led the Commander to level at an altitude of less than 1,000ft. When approaching to *Triângulo Farm*, it is assumed that the conditions have worsened, leading to the performance of a flight closer to the ground obstacles, that is, 192 meters.
