**AVIATION INVESTIGATION REPORT  
A13H0002**

**COLLISION WITH WATER**

**GOVERNMENT OF CANADA, DEPARTMENT OF TRANSPORT  
MBB BO 105 S CDN-BS-4 (HELICOPTER) C-GCFU  
M'CLURE STRAIT, NORTHWEST TERRITORIES  
09 SEPTEMBER 2013**

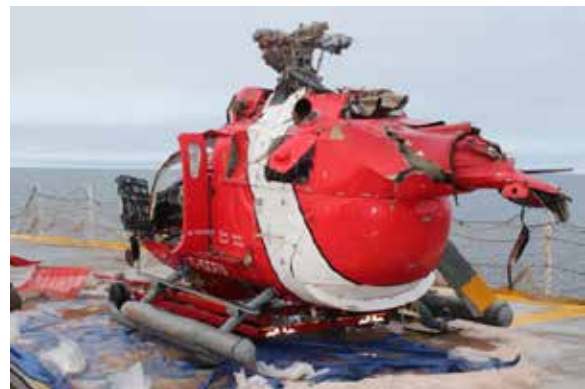
Photo 1. Wreckage of helicopter C-GCFU on deck

The helicopter was substantially damaged on impact with the surface of the water. There was severe upper frontal damage of the windshield and instrument panel. The tail boom was separated near the front of the tail boom and 3 main rotor blades had been torn off at their roots (Photo 1).

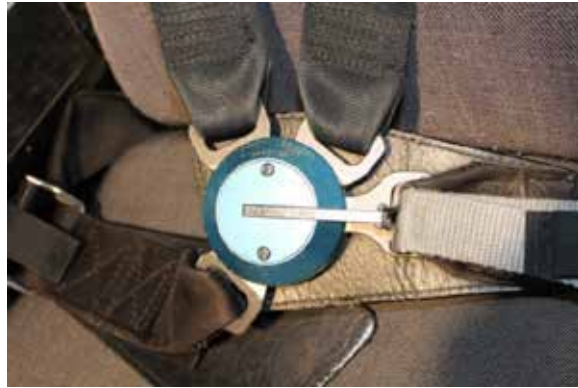
Photo 2. Front seat 4-point safety harness

When the helicopter was recovered, it was noted that all of the occupants' seat harnesses were released. There was no indication that any of the lap belt or shoulder harness tongues had been forced from the buckle assembly. Examination of occupants' safety harnesses did not identify any discrepancies that would have prevented normal operation.

The pilot's seat had been pushed back to the end of the right (outboard) rail and slightly short of the left rail end. The seat frame was deformed and buckled in a way that was consistent with the back having been forced backward. These observations suggest that a backward force had been applied to the upper body of the occupant and transmitted to the back of the seat. The left front seat was found secured with no sign that it had been displaced during the occurrence. No deformation of the seat frame was observed. The absence of significant damage to the left front seat suggests it had not been exposed to the same rapid ingress of water that the pilot's seat had. The rear bench seat's left supporting strut had fractured and was deformed forward. It is considered likely, therefore, that the left-front vertical strut fractured due to the dynamic loading caused by the vertical deceleration of the occupant at the time of impact.

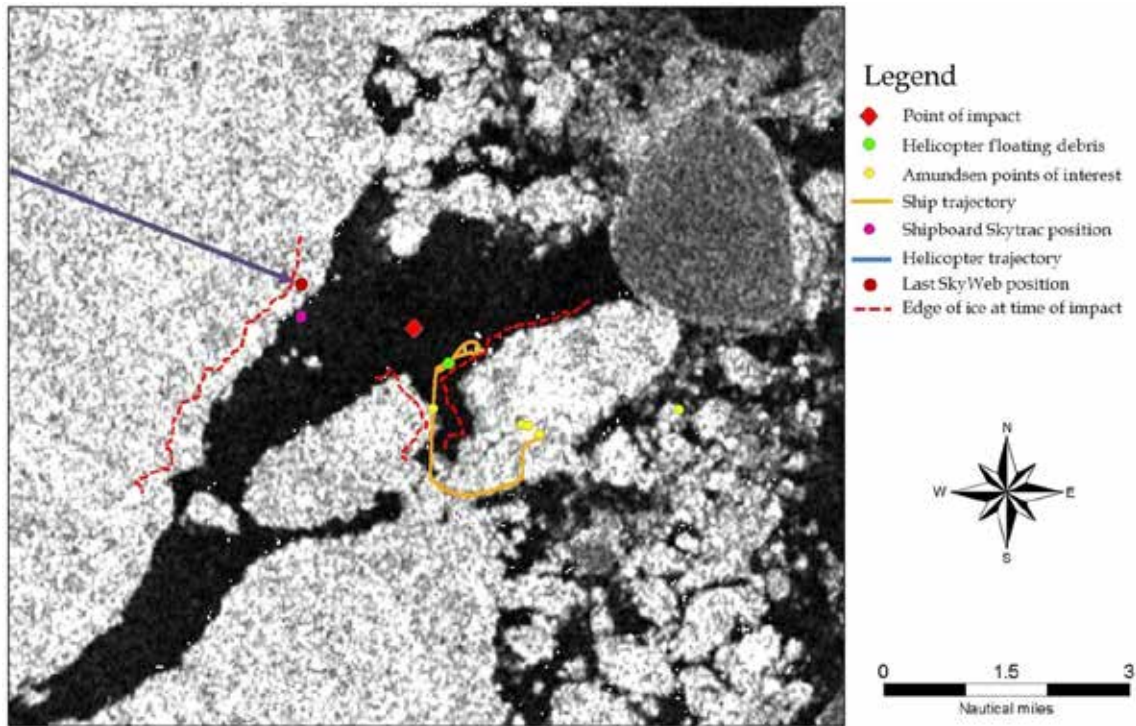
Figure 5. RADARSAT-2 imagery taken on the day of the occurrence, indicating the helicopter and ship trajectories (Source: Canadian Ice Service, with TSB annotations)

Ice movement (flow) was measured from the image taken at 1403:36 on 09 September 2013, 3 hours and 40 minutes before the accident. The use of images taken before and after the occurrence allowed investigators to determine an approximate position of the edge of ice at the time of impact, which is represented by the red dashed lines in Figure 5.

The imagery indicates that the open water area the helicopter was overflying was about 2.3 nm wide. Based on the actual wreckage position indicated on the RADARSAT-2 imagery, the helicopter crashed about 0.7 nm before reaching the next ice edge.

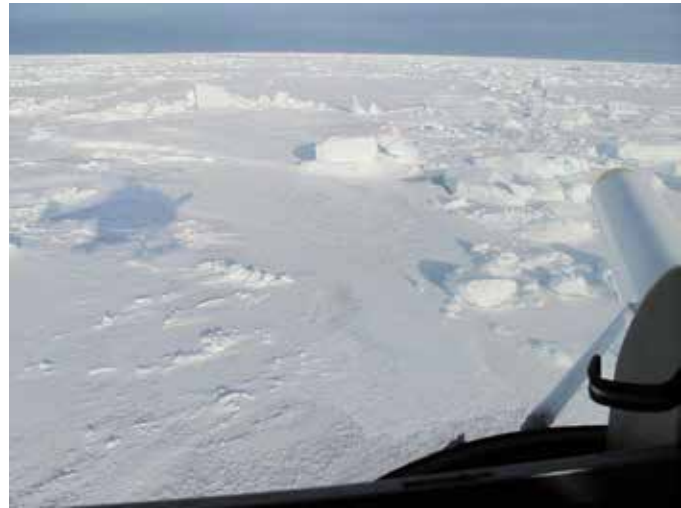
**Photo 5. Still image taken approximately 10 minutes before the occurrence**

No images or videos showed evidence of an imminent accident. However, the last image from the photos taken at 1732:57 – approximately 10 minutes prior to the accident – was used for the photogrammetric analysis (Photo 5).

The images also show that the scientist had a laptop computer on his lap with the screen cover opened. The laptop computer is part of the scientist's equipment used for ice measurement operations.

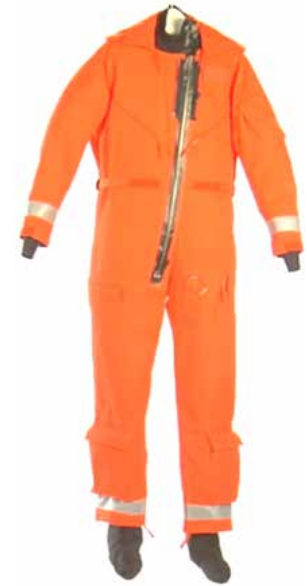
Figure 8. Viking PS4089

During recovery, it was noted that pilot's suit was full of water and that the zipper was done up to about the mid-sternum position. Examination of the suit noted that the hood and gloves were in the storage pockets and that the pockets were closed. Additionally, a small tear was noted on the back of the right upper sleeve. To completely close the zipper requires the use of both hands: one to pull the zipper, the other to ensure the zipper does not get caught on the suit material. As the zipper is being pulled past the neck, the wearer must bend their head back and to the right, which allows the zipper to be pulled straight.
