## AVIATION INVESTIGATION REPORT A15C0130

### **Collision with terrain**

Apex Helicopters Inc.  
Robinson R44, C-GZFX  
Foleyet, Ontario, 17 nm S  
08 September 2015

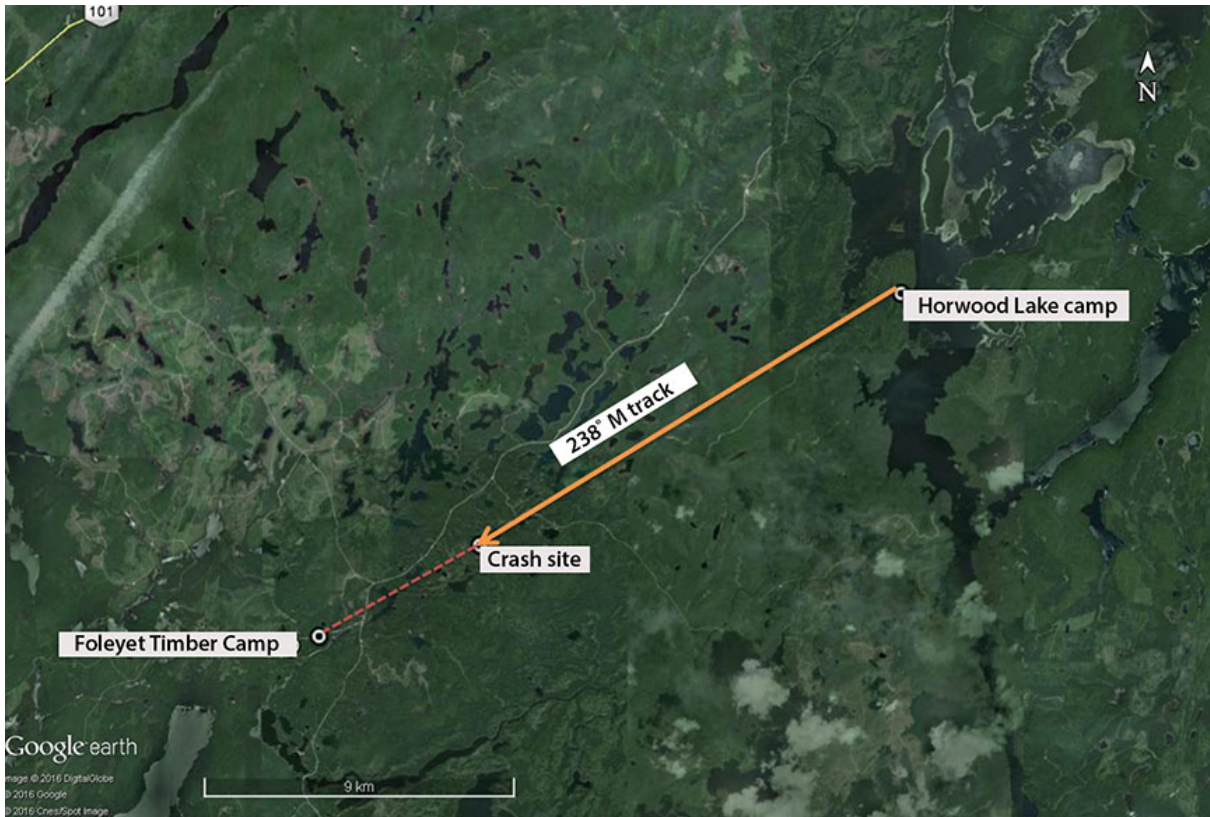
Figure 2. Map of the accident site along the direct route to the Foleyet Timber Camp. (Source Google Earth, with TSB annotations)

At approximately 2000, the supervisor drove the pilot of C-GZFX and the mix rig operator back to the helicopter and watched them lift off at approximately 2015. Sometime later, C-GZFX struck trees and the terrain at the top of a small hill approximately 8 nautical miles (nm) southwest of the Horwood Lake camp and along the direct route back to the FTC (Figure 2).

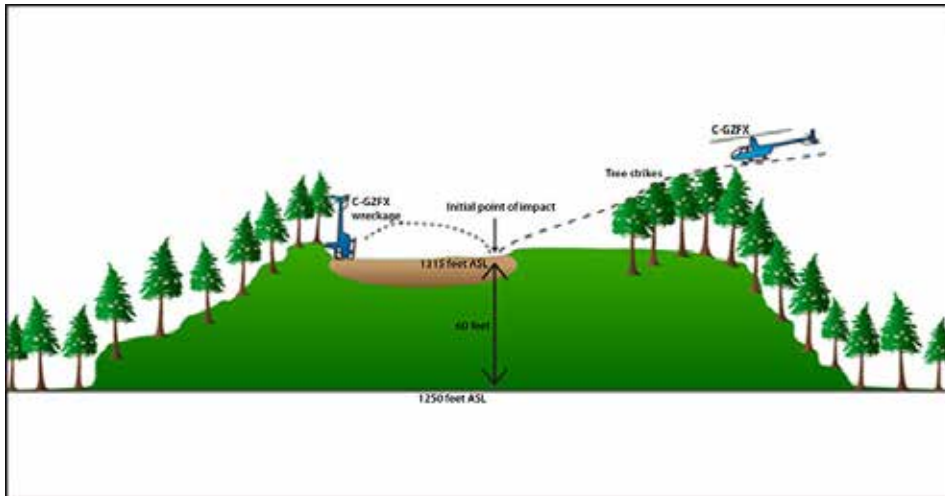
Figure 3. Diagram of wreckage site

The wreckage site (Figure 3) was located at the top of a small hill that was approximately 65 feet higher than the surrounding terrain. The initial direction of the tree strike trail was 200° magnetic (M). The helicopter struck the ground in a sparsely treed area. The subsequent wreckage trail was approximately 30 feet long and lay in a direction of approximately 305°M. Ground scars and damage to the main rotor blades were indicative of high rotor torque at

the time of impact. An inspection of the wreckage, including the main rotor system, tail rotor system, engine, and flight controls, did not reveal any pre-impact anomalies. The level of damage to the cockpit indicated that the impact with the ground was not survivable. The carburetor heat control was set to the “ON” position; therefore it is likely that carburetor icing did not affect the engine’s performance.
