# Air Transportation Safety Investigation Brief A16W0094

## COLLISION WITH TERRAIN

North American Aviation Inc. T-28B, C-GKKD  
Canadian Forces Base Cold Lake, Alberta  
17 July 2016

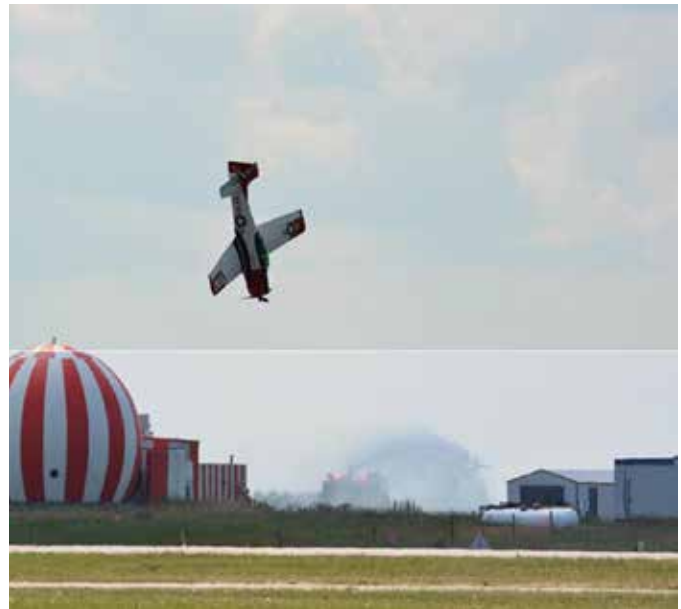
The pilot flew from show right to left at about 500 feet above ground level (AGL) within the defined airspace for the routine, then entered a roll just before show centre. As the aircraft reached the inverted position, the roll stopped and the nose began to pitch toward the ground. The aircraft elevator was seen to move to full up deflection as the aircraft continued toward the ground in an arc until its collision with terrain, in a near-vertical position with a slight right roll (Figure 1).

Figure 1. Composite image of 2 photographs taken 3 minutes apart. The upper portion of the image was photographed just prior to impact, and the lower portion during the emergency response.

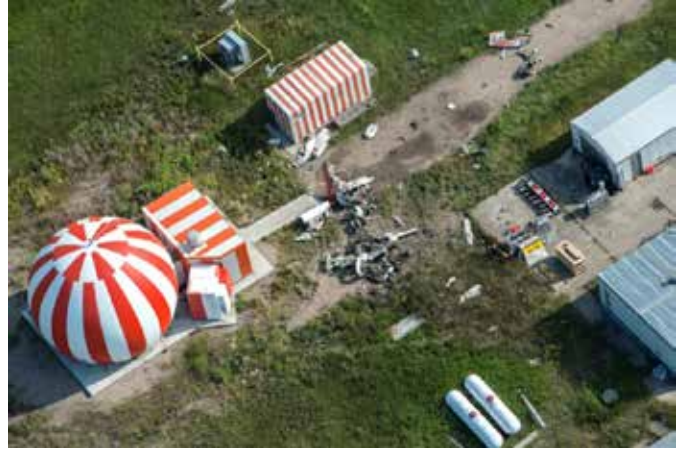
The aircraft struck the ground at a high velocity, in a near-vertical attitude. It was destroyed by impact forces. The impact site was located among several structures used for provision of airfield services. These included the buildings that housed the precision approach radar equipment and its backup power generator, and twin 1000-gallon propane tanks (Figure 2).

Debris from the aircraft penetrated the walls of the backup power generator building; however, there was no significant damage to any of the infrastructure and it remained operational.

Figure 2. Aerial photograph of the accident site, located near the precision approach radar facility (Source: Department of National Defence)

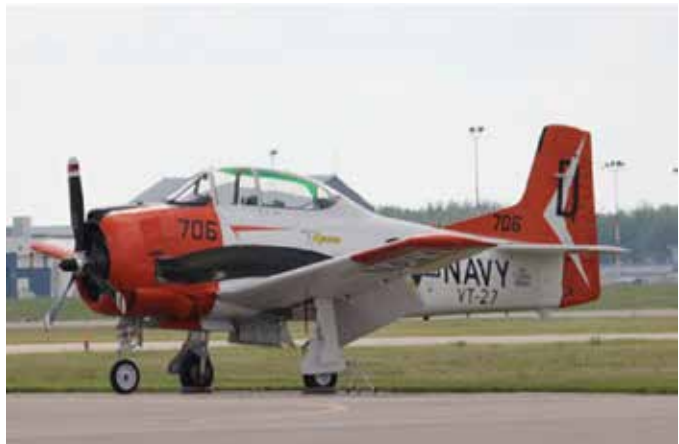
Figure 3. C-GKKD, pictured at Canadian Forces Base Cold Lake on the day of the accident (Source: Department of National Defence)
