## AVIATION INVESTIGATION REPORT A16W0126

### **Loss of power and collision with trees**

Bell 206B (Helicopter), C-GHHU

Fox Creek Airport, Alberta, 12 nm SW

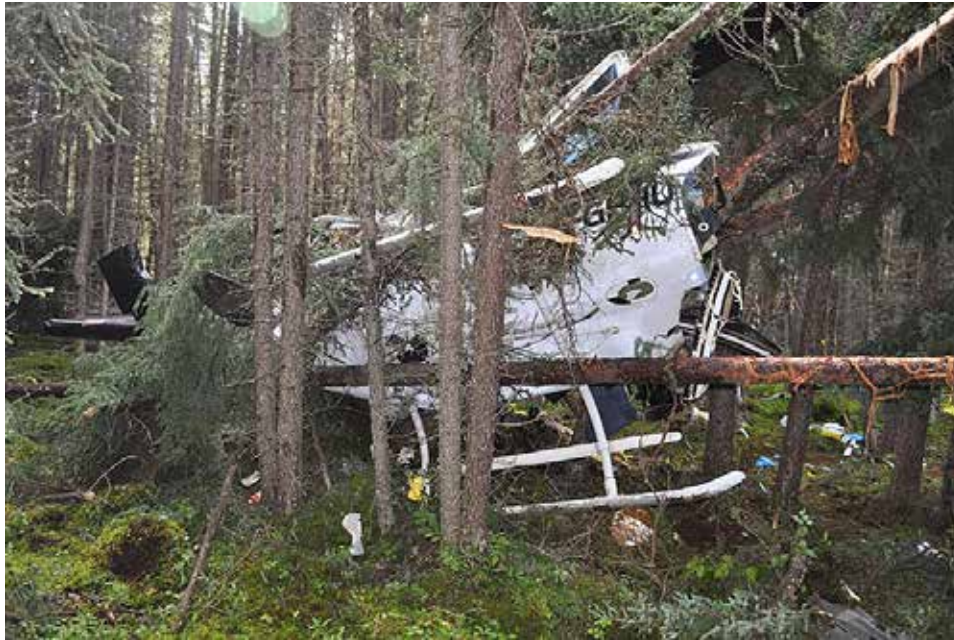
All of the helicopter's components were located and identified within a 50-foot radius of the aircraft (Figures 3 and 4). The helicopter's forward section and cockpit were destroyed. The cabin sustained substantial impact damage, particularly on the left side of the fuselage. The fuel cell was punctured during the impact sequence and was leaking. The main-rotor head was intact, with its 2 rotor blades still attached. Both main-rotor blades sustained minor damage consistent with low  $N_R$ , indicating that no power was being produced at the time of impact.

Figure 4. View of C-GHHU from front right (underside of helicopter visible)
