## FINAL REPORT

<b>HCLJ510-000439</b>	<b>Air Traffic Incident (Airprox)</b>	
Date / Time (UTC):	25.9.2007 at 1522 hrs	
Location of occurrence:	Copenhagen Airport, Kastrup (EKCH)	
Airspace class:	Kastrup CTR, airspace class D	
Aircraft:	A	B
Aircraft registration:	N444NL	F-GFKD
Aircraft type:	PA-31T Cheyenne	A320
Flight phase:	Taxi	Landing
Flight rules:	IFR	IFR
Operation type:	General Aviation	Commercial Air Transport
	Business	Scheduled revenue ops
		International Passenger
Weather conditions:	VMC	VMC
Light conditions:	Daylight	Daylight
Air Traffic Services:	Kastrup Tower (118,100 MHz) and Tower/marshaller (FM Channel 15)	
Classification::	A) Risk of collision

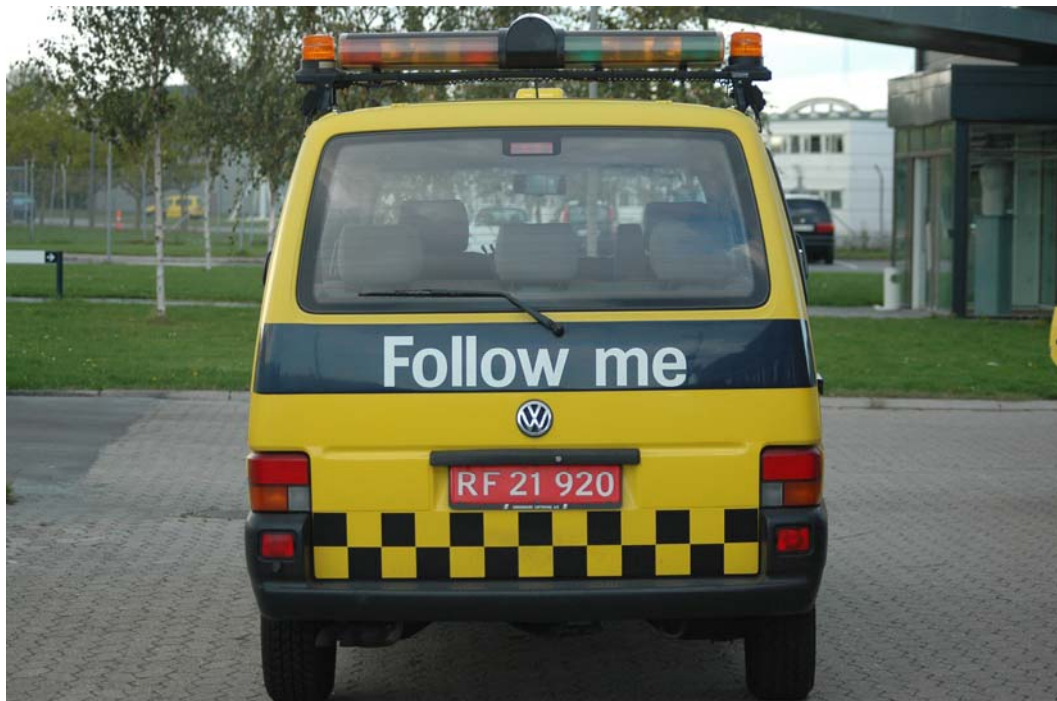
"FOLLOW ME" vehicle.

At 1522:23 hrs, the “FOLLOW ME” vehicle on runway 30 initiated a 180° turn. The pilots in aircraft A got visual contact with the “FOLLOW ME” vehicle and it was their opinion at that time that the green lights of the luminous bridge, on the top of the “FOLLOW ME” vehicle, had been turned on. See enclosure 2. The taxi speed of aircraft A was increased.

- The positioning of the “FOLLOW ME” vehicle on runway 30 (the other side of an active runway). (As regards this matter, the Danish AIB has not been able to determine whether or not the green lights of the luminous bridge on top of the “FOLLOW ME” vehicle had been turned on. But an increasing taxi speed succeeded the 180° turn of the vehicle, which means that the “FOLLOW ME” vehicle was in position for picking up aircraft A before an ATC crossing clearance had been issued).
- Glaring sun combined with a wet runway

- A marshaller shall never be brought into a position on the opposite side of an active runway for aircraft picking up.
- Marshaller guidance is compulsory to/from the below stands while aircraft are taxiing by own power:
  - Apron West (incl. R and W1 stands)
  - G15-G19 on Apron East
  - S1 and S2 (in area East)
  - E60
  - A50
- TWR decides how far the marshaller should guide the aircraft to/from the abovementioned stands with the following restrictions:
- An aircraft to/from the abovementioned stands shall never cross an active runway without marshaller guidance.

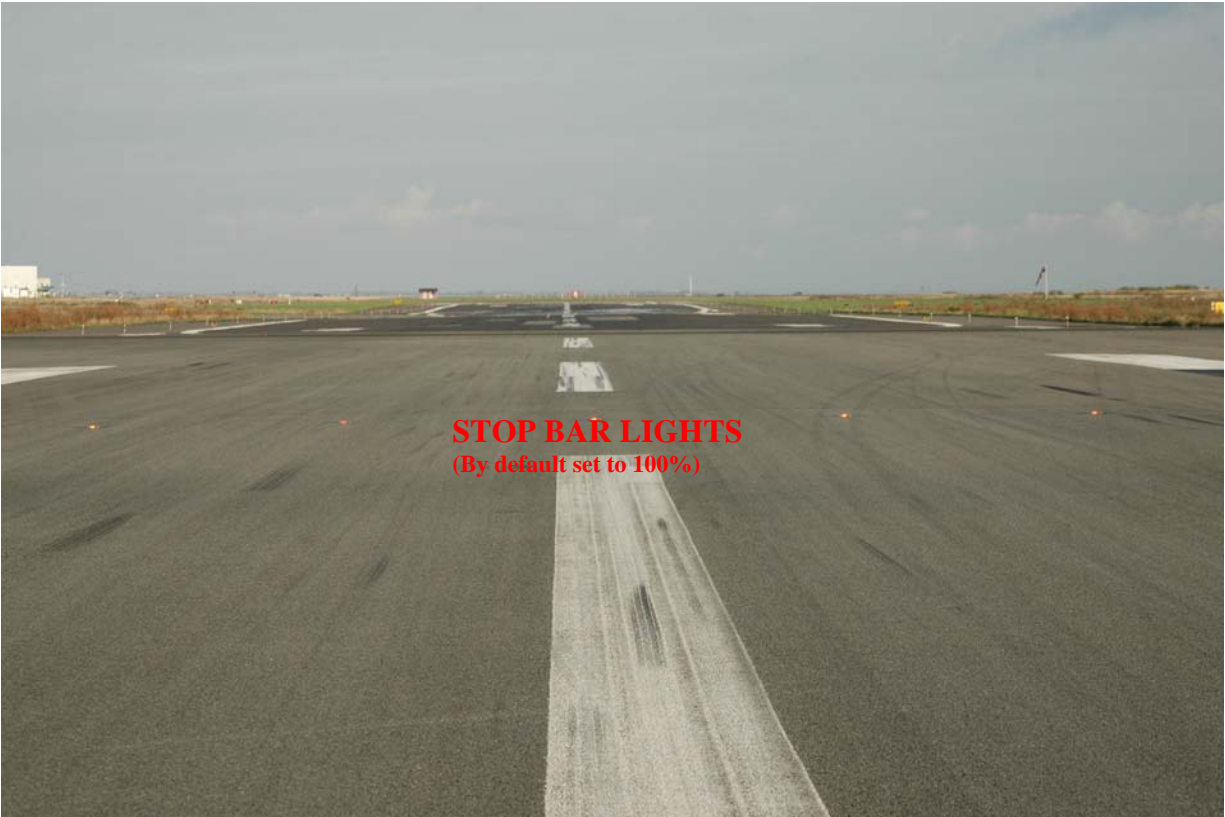
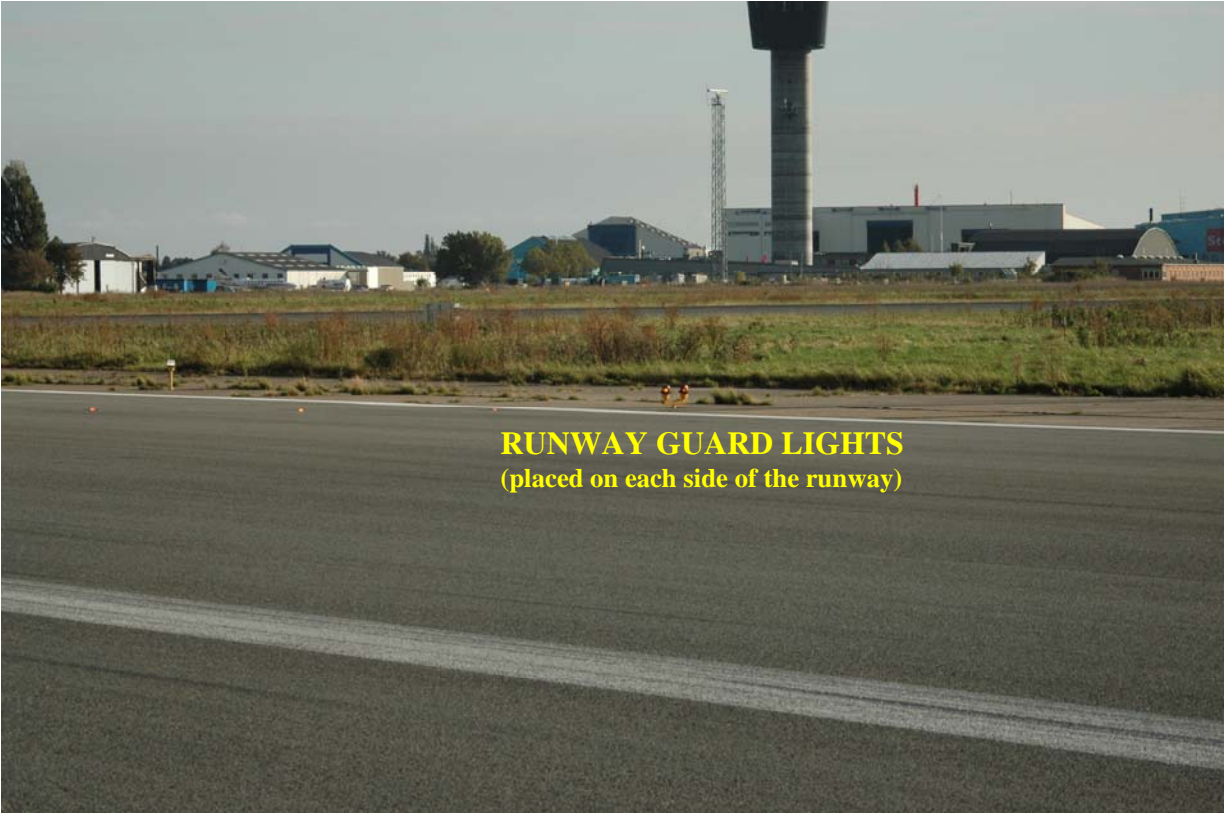
Stop bar and runway guard lights on runway 12

The pilots in aircraft A did not observe the red stop bar lights and the yellow flashing runway guard lights (runway 12) and continued taxiing towards the waiting “FOLLOW ME” vehicle on the other side of runway 22L. At that point, it was the opinion of the pilots that a combination of a glaring sun and a wet runway made the lights invisible.

The combination of loss of situational awareness and pilot confusion probably increased the workload in the cockpit to such degree that the pilots did not follow the actually received ATC instruction but the one they expected to receive. The pilots were most likely exposed to pilot “target fascination/tunnel vision” by positioning the “FOLLOW ME” vehicle on the other side of runway 22L. For that reason, neither red stop bar lights nor yellow runway guard lights nor ATC instructions were perceived.

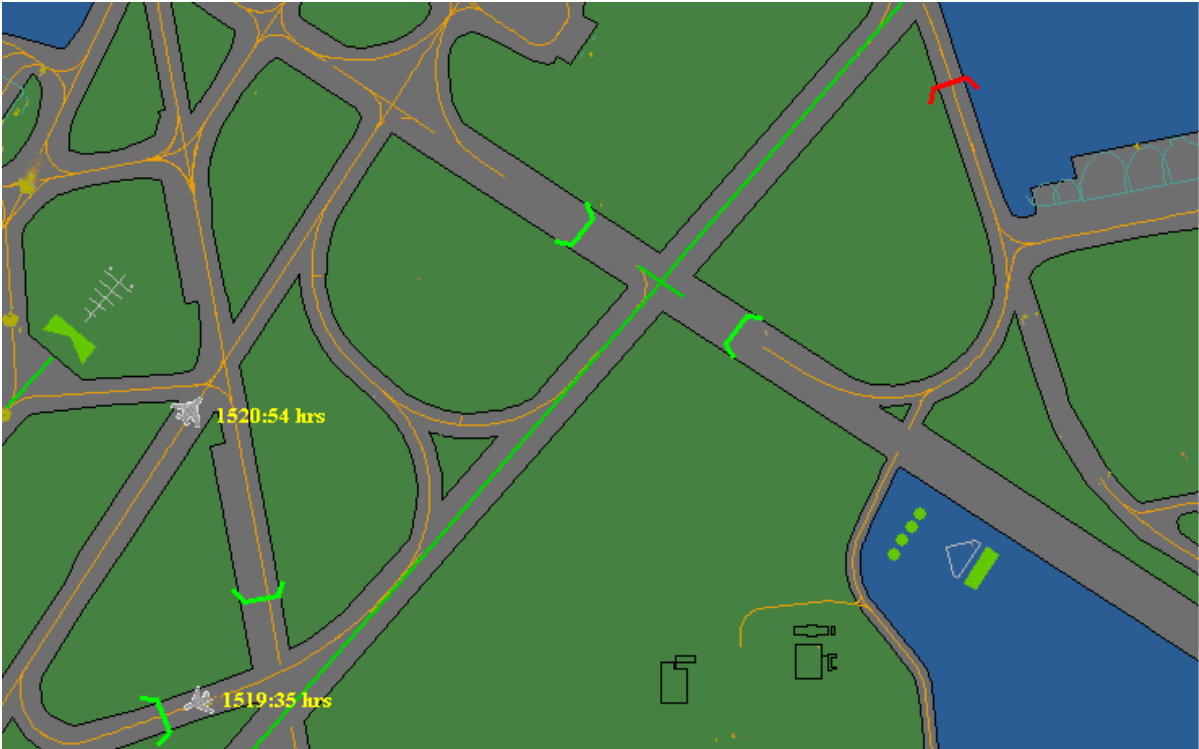
**Enclosure 1**

After landing on runway 22L, the pilots in aircraft A were instructed to taxi via taxiway B and runway 12 to hold short of runway 22L. See enclosure 1, 4 and 6.

The Tower Air Traffic Controller (ATCO) noticed an overall pilot hesitation (aircraft A) (the radio communication and the taxi movement). For that reason, the ATCO from 1520:54 hrs used progressive taxi instructions and furthermore, the ATCO decided to turn on the red stop bar lights on runway 12 (active at 1521:12 hrs). See enclosure 1, 2 and 4.

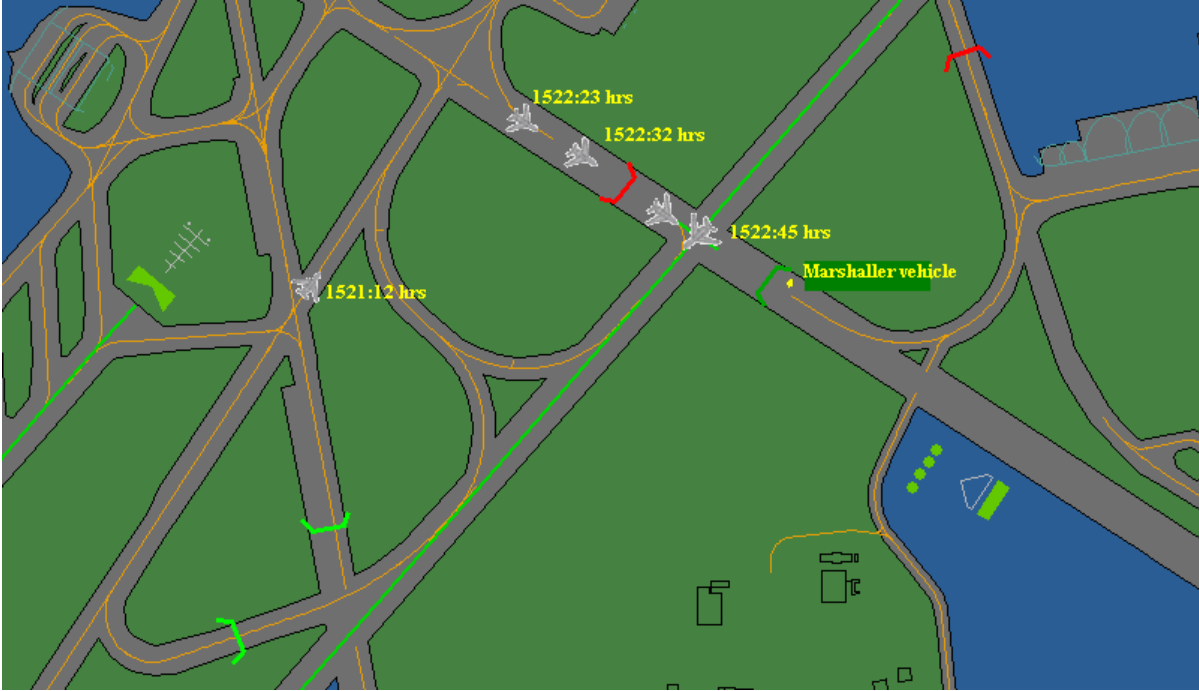
**Enclosure 2**

At 1518:07 hrs and in order to pick up aircraft A, a "FOLLOW ME" vehicle (front facing runway 22L) was in position on runway 30. See enclosure 2 and 5.

While aircraft A was approaching the stop bar on runway 12, the ATCO observed the increasing taxi speed and at 1522:32 hrs, the ATCO instructed the pilots to confirm the previous instructions of holding short of runway 22L and finally instructed the pilots to hold short. See enclosure 2 and 4. The pilots in aircraft A did not read back.

At 1522:45 hrs, the minimum separation (approximately 25 metres) between aircraft A and aircraft B was recorded. See enclosure 2 and 3.
