Endelig rapport HCLJ510-000387

Rapport over hændelsen med Diamond DA 40D OY-RBB ved Roskilde den 7. juni 2007.

FINAL REPORT

HCLJ510-000387	Incident		
Aircraft type:	Diamond DA 40D	A/C Registration:	OY-RBB
Engine:	Thielert TAE 125-01	Type of flight:	Test flight, VFR
Crew:	1- no injuries	Passengers:	1 - no injuries
Place:	1 nm west of Copenhagen Airport, Roskilde (EKRK)	Date and time:	07.06.2007 1330 UTC

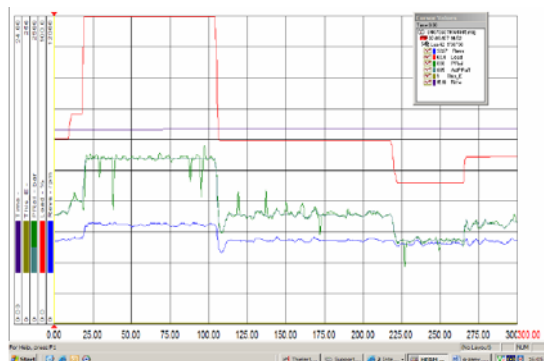
The ECU data logger graph 1 and 2 (below) shows that, the rail pressure was fluctuating during the incident flight on 7 June 2007. The event log remarks were “Low Prail” and High negative Prail delta”.

Graph 1: engine run 10 minutes before the power loss, nothing unusual noted by pilot, data shows fluctuations in the rail pressure

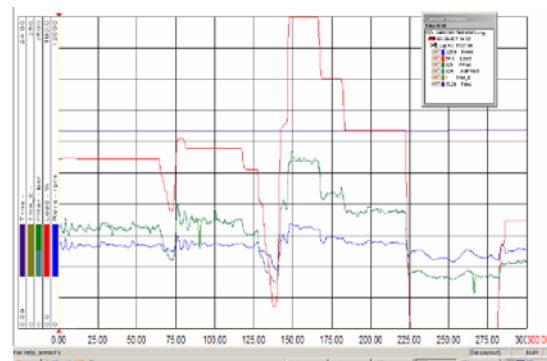
Graph 2: engine run 5 minutes before the power loss, nothing unusual noted by pilot, data shows fluctuations in the rail pressure

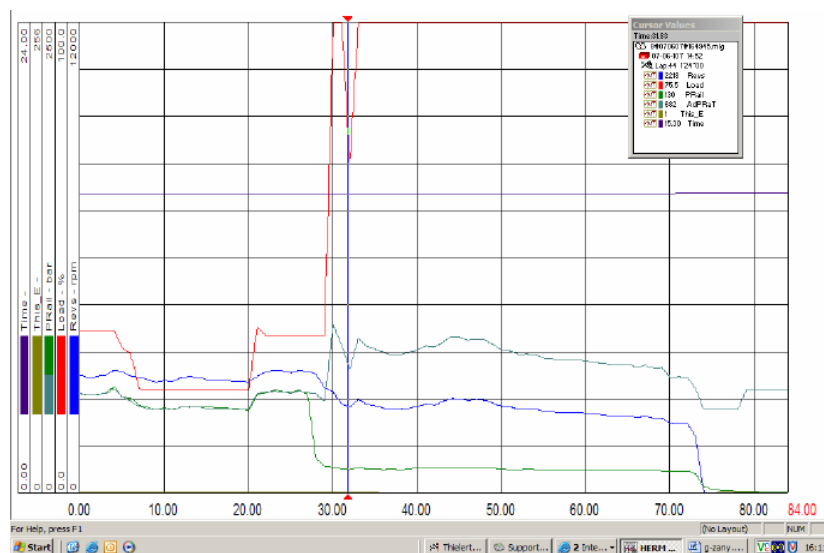
The ECU data logger graph 3 (below) shows that, the rail pressure dropped to a minimum of 130 BAR within one second, the engine stayed at low RPM and there was no engine reaction to power control lever movement.

Graph 3: Rail pressure drops to a minimum of 130 bars, causes the engine to quit

The ECU data shows that the engine lost power when the fuel rail pressure dropped to a minimum of 130 BAR within one second. Prior to the drop in fuel pressure the fuel rail pressure was fluctuating. Similar fluctuations were found on the data downloaded from the former flight on 31 May 2007.

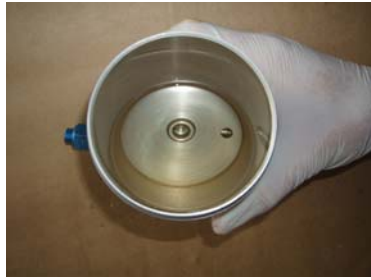
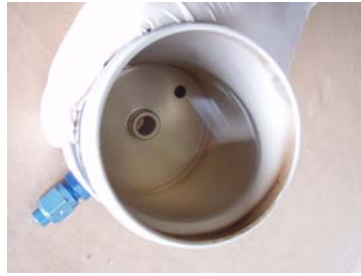
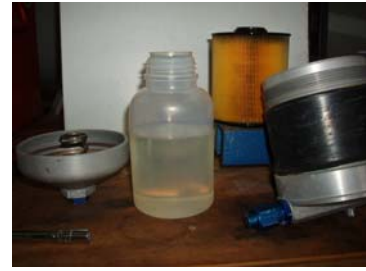
Fuel filter was disassembled by a licensed mechanic. According to the mechanic the fuel filter bowl contained the same amount of fuel as when he replaced the filter at 100 hrs inspection. The exact amount of fuel in the filter bowl was not measured.

The pictures below show the quantity of fuel found in the filter bowl that was removed from another Diamond DA 40D aircraft. According to the licensed mechanic it was the same amount of fuel that was found in the filter bowl removed from OY-RBB.

The fuel filter bowl would normally contain 250 to 300 milliliters of fuel.

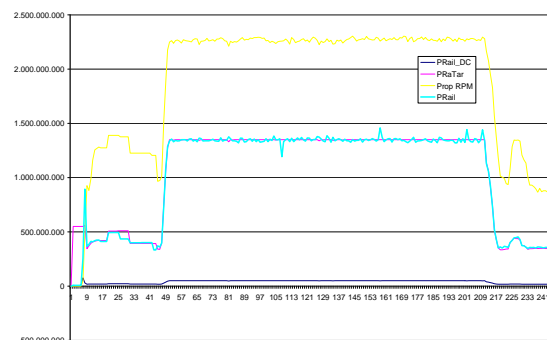
The full power test with new pumps installed showed one drop in fuel rail pressure, see graph below right.

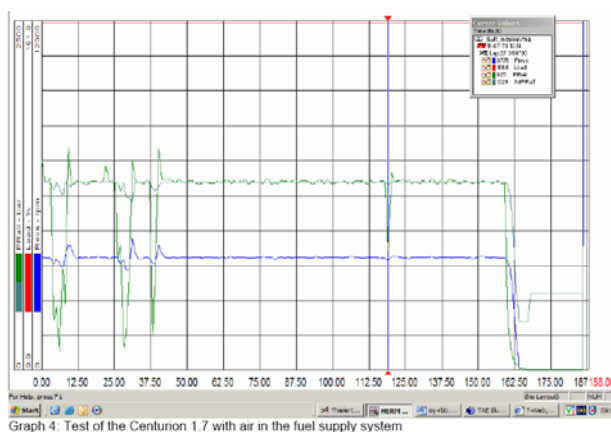
Earlier tests of the Centurion 1,7 engines (TAE 125-01), done with air in the fuel supply, show the similar rail pressure fluctuation than in this occurrence of the OY-RBB. This is visualized in graph 4 (below).

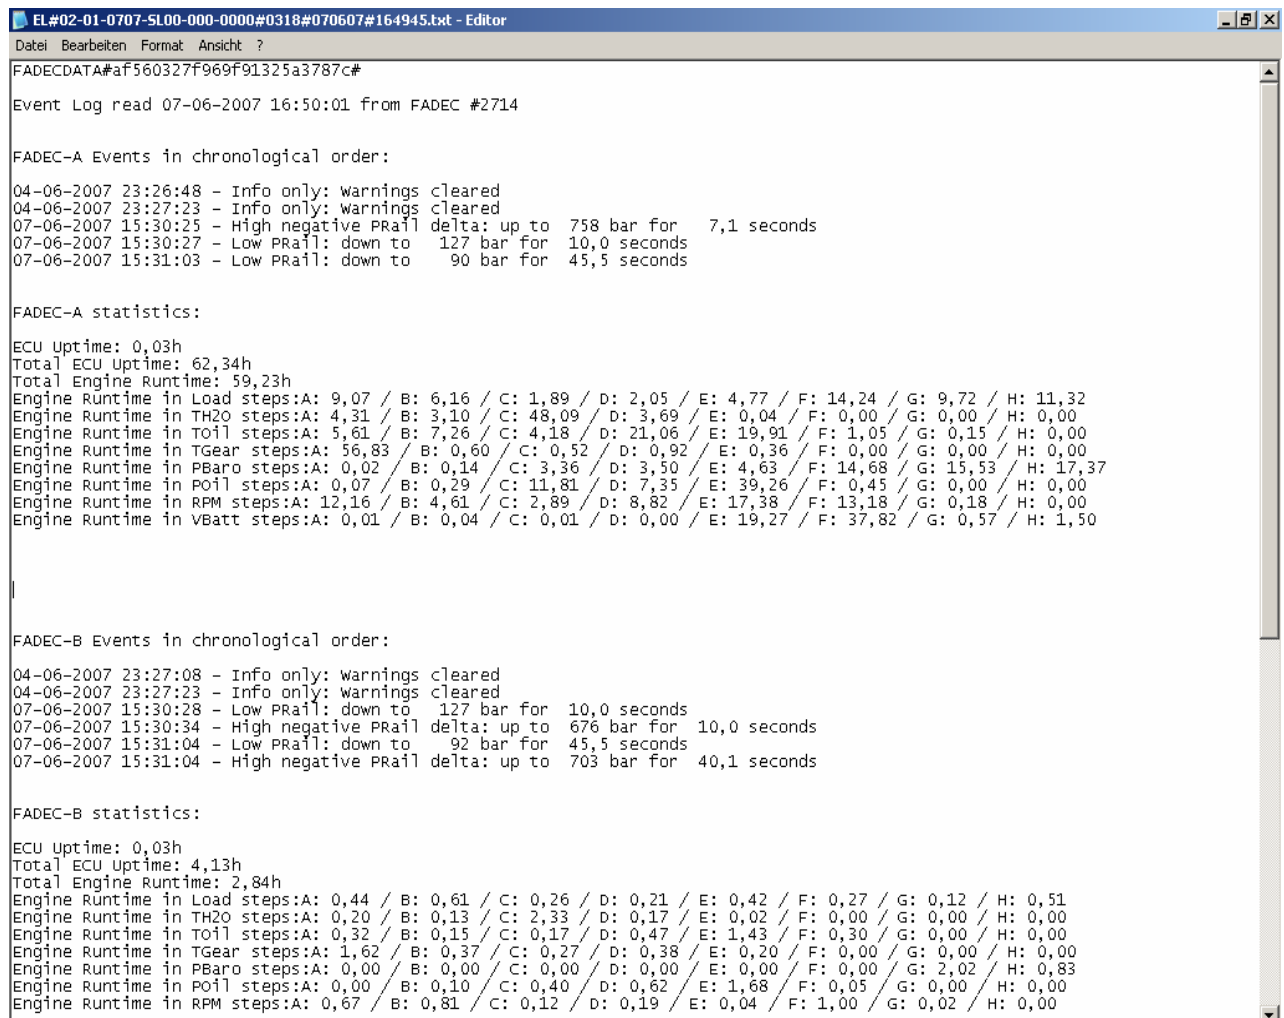
There were some remarks in the eventlog of the engine FADEC from June 7th. These were "Low Prail" and "High Negative Prail delta" which caused the engine warnings. See attachment 1 for details.

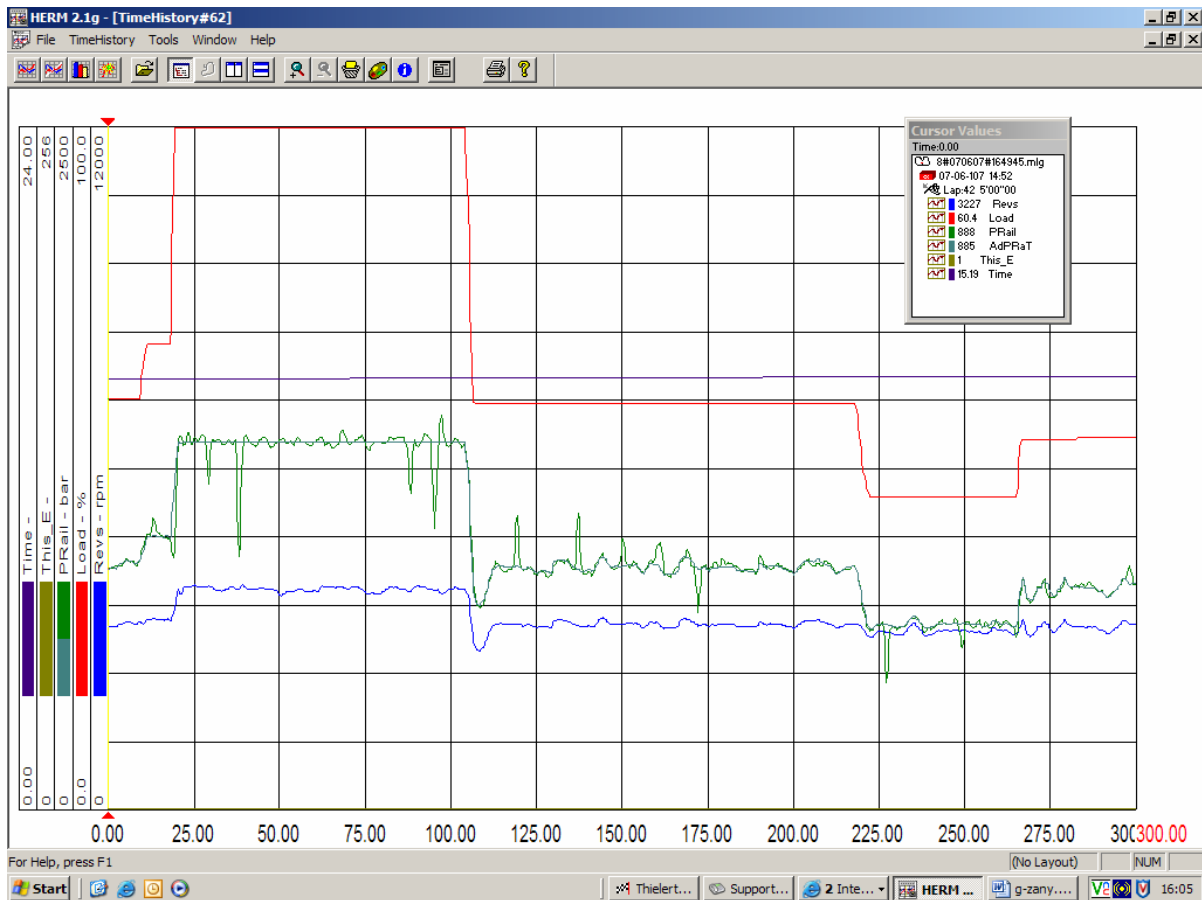
Graph 1: engine run 10 minutes before the power loss, nothing unusual noted by pilot, data shows fluctuations in the rail pressure

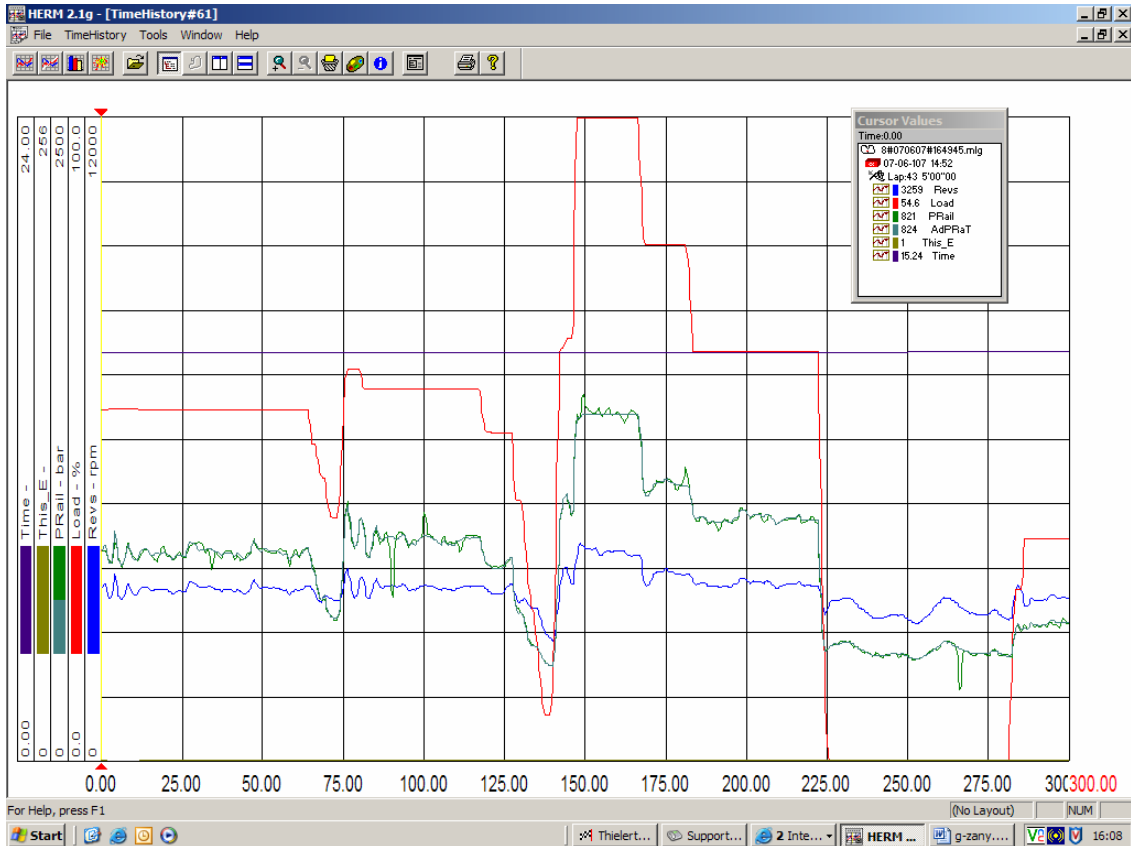
Graph 2: engine run 5 minutes before the power loss, nothing unusual noted by pilot, data shows fluctuations in the rail pressure

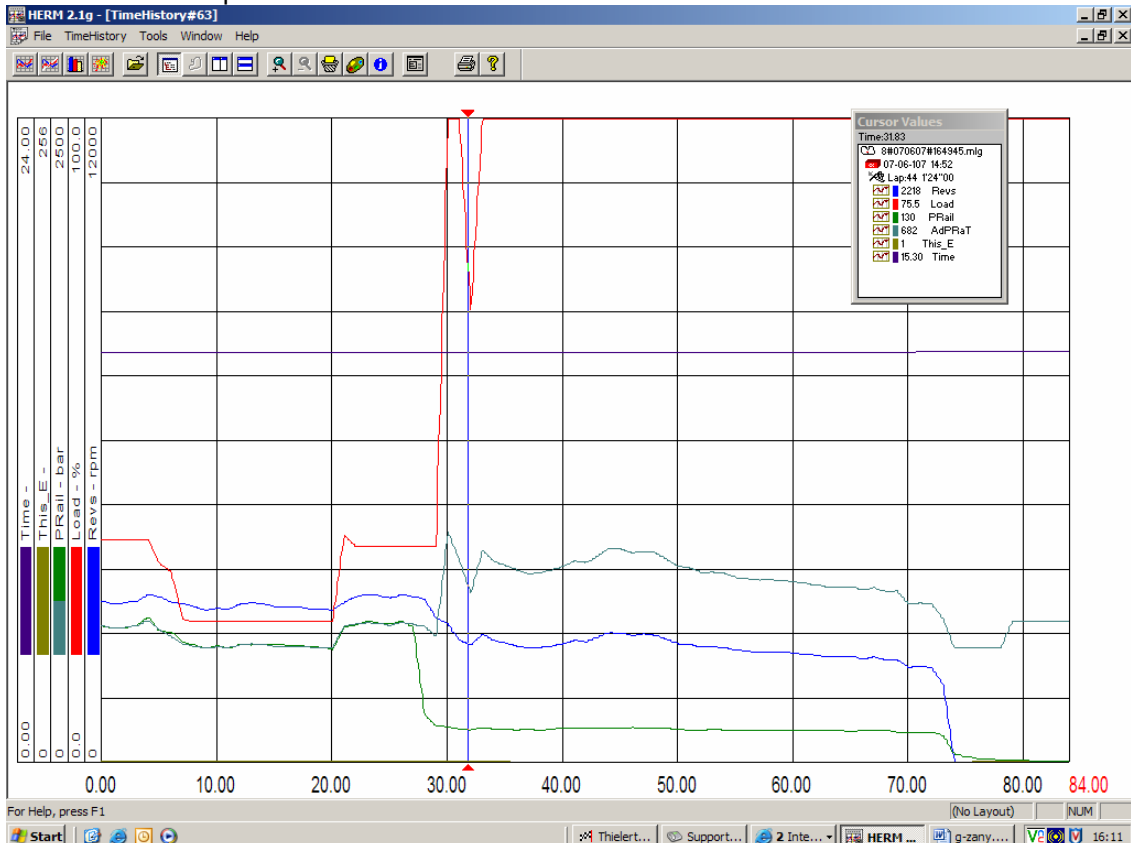
Graph 3: Rail pressure drops to a minimum of 130 bars, causes the engine to quit

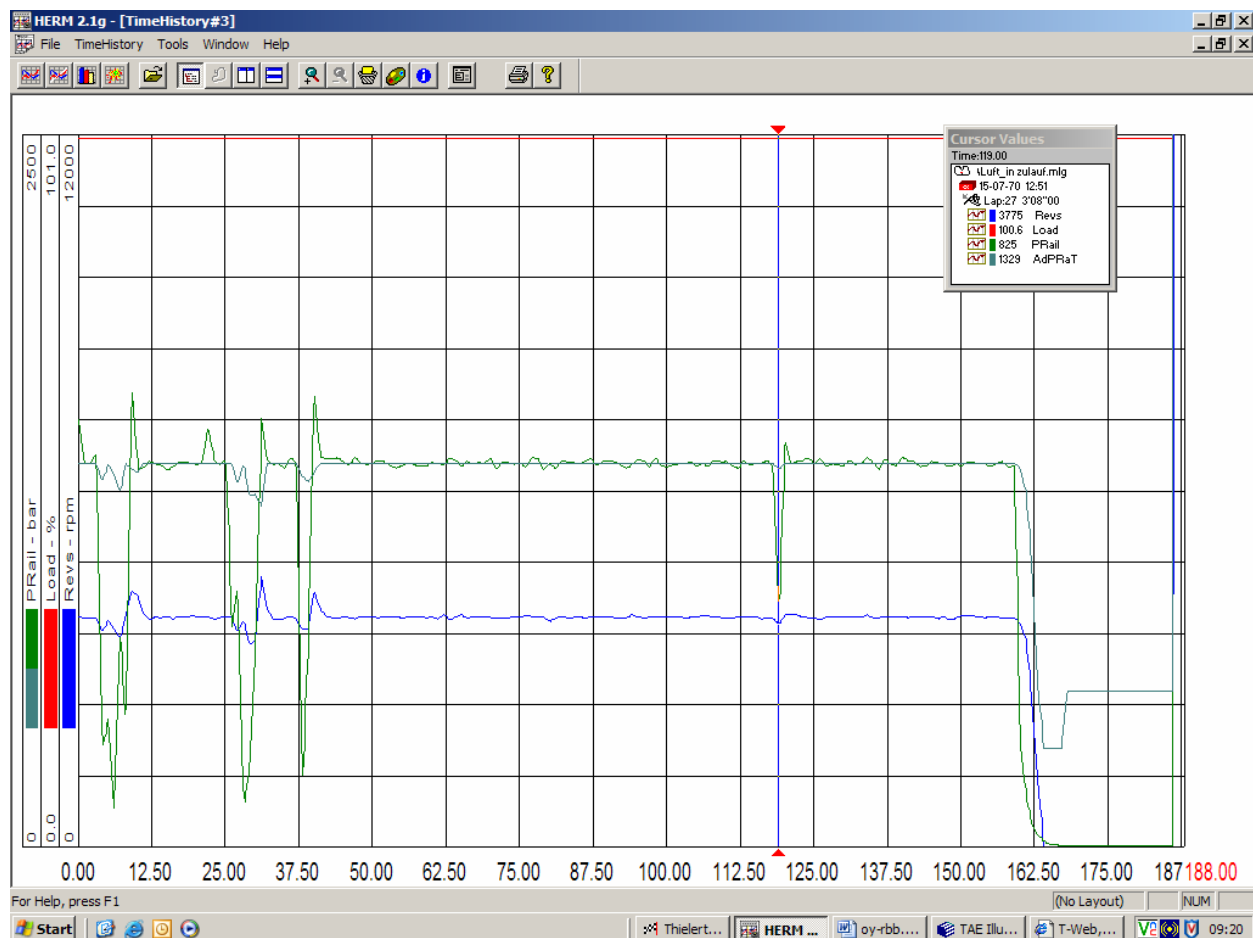
Earlier tests of the Centurion 1.7 engines, done with air in the fuel supply, show the similar rail pressure fluctuations than in this occurrence of the OY-RBB. This is visualized in graph 4.

Graph 4: Test of the Centurion 1.7 with air in the fuel supply system

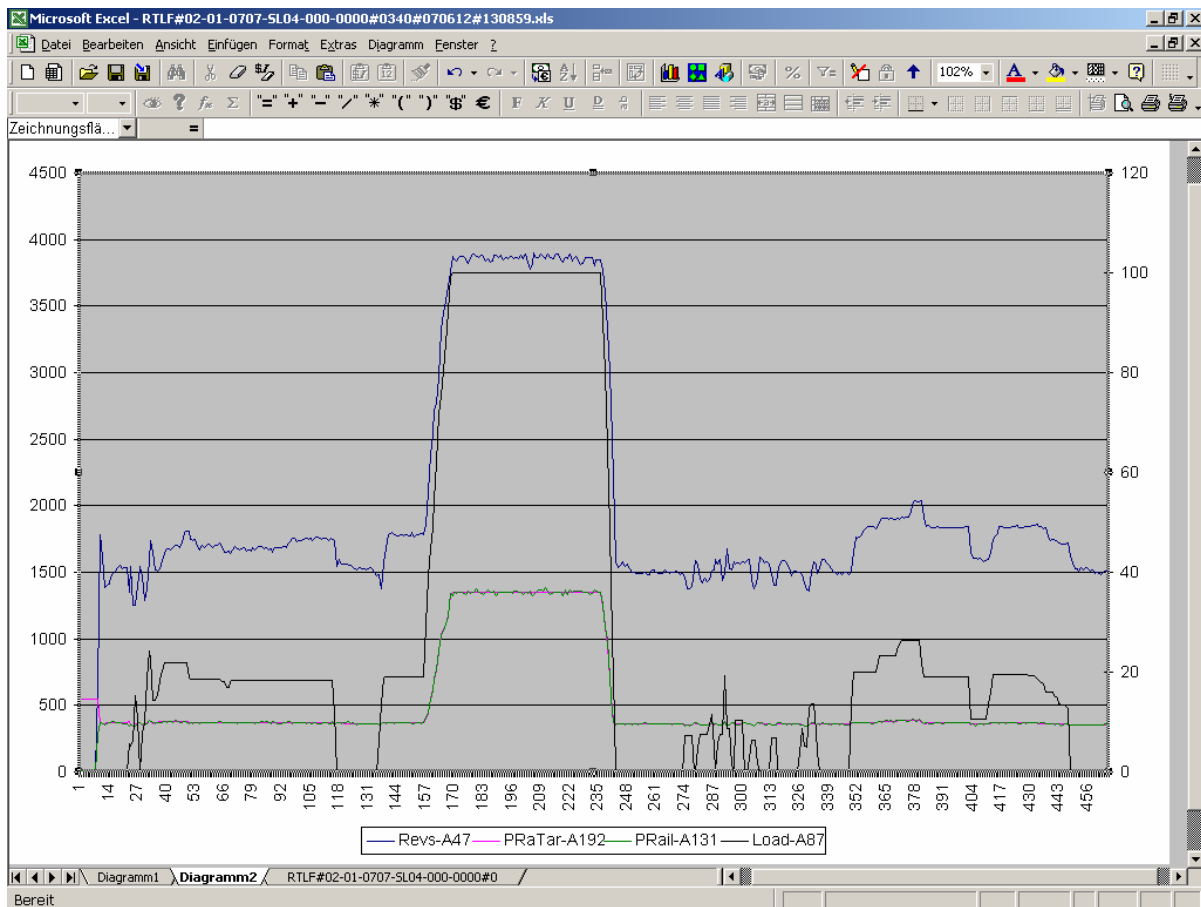
The investigation of the aircraft by a representative of Thielert Aircraft Engines showed no mechanical defects, nor any electrical failures. The fuel filter was placed back in the aircraft and the system was thoroughly bled with the use of an external pump. The engine started immediately after that and ran without any further problems. This is visualized in graph 5.

Graph 5: engine ground run after bleeding the fuel system

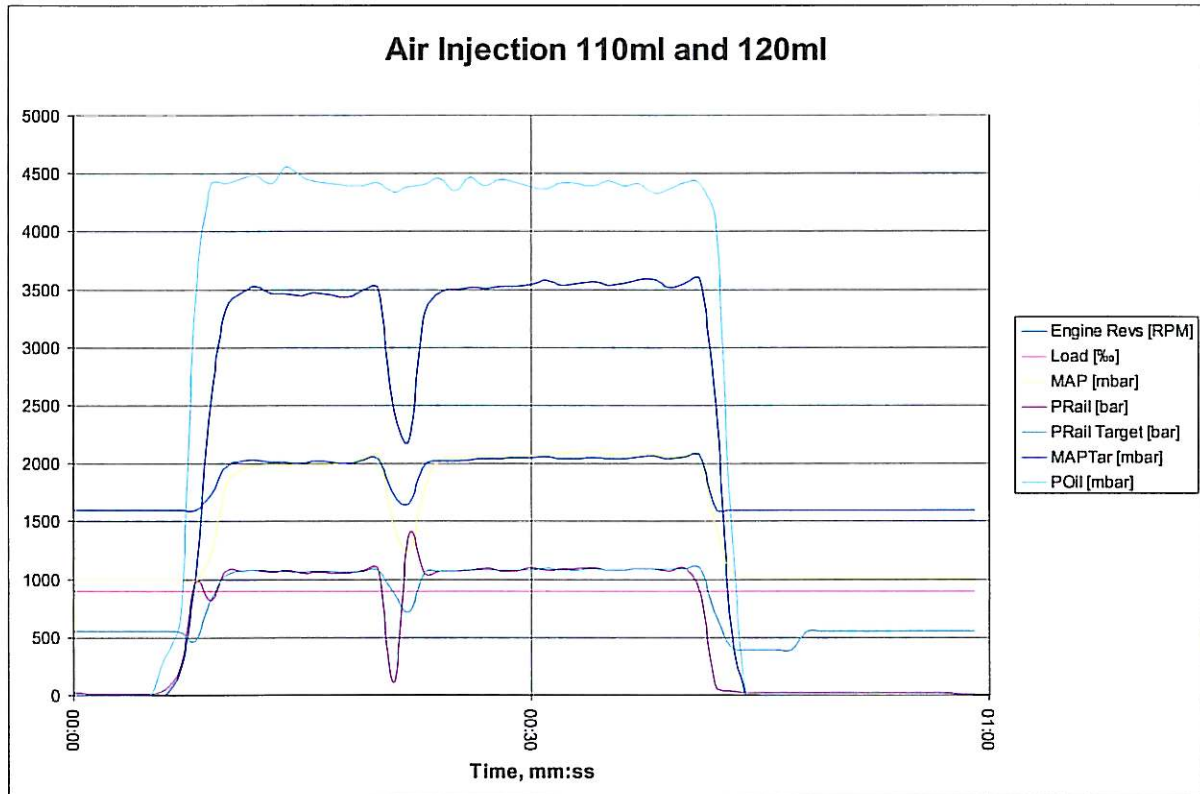
For a second test the arrangement of injectors in **Picture 4** was used. The amount of air has been increased up to 110ml air, with which the engine can cope barely. An injection of 120 ml air forces the engine to shut down. This is shown in **Picture 6**.

Picture 6 The engine is able to recover after an injection of 110 ml air. An injection of 120ml air forces the engine to shut down.

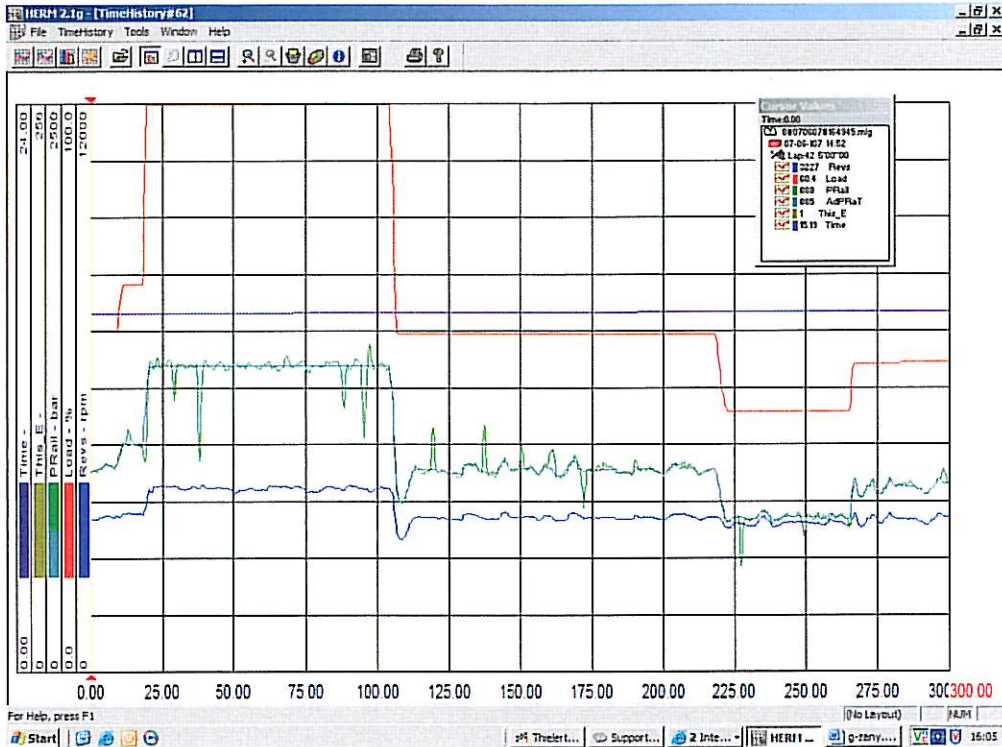
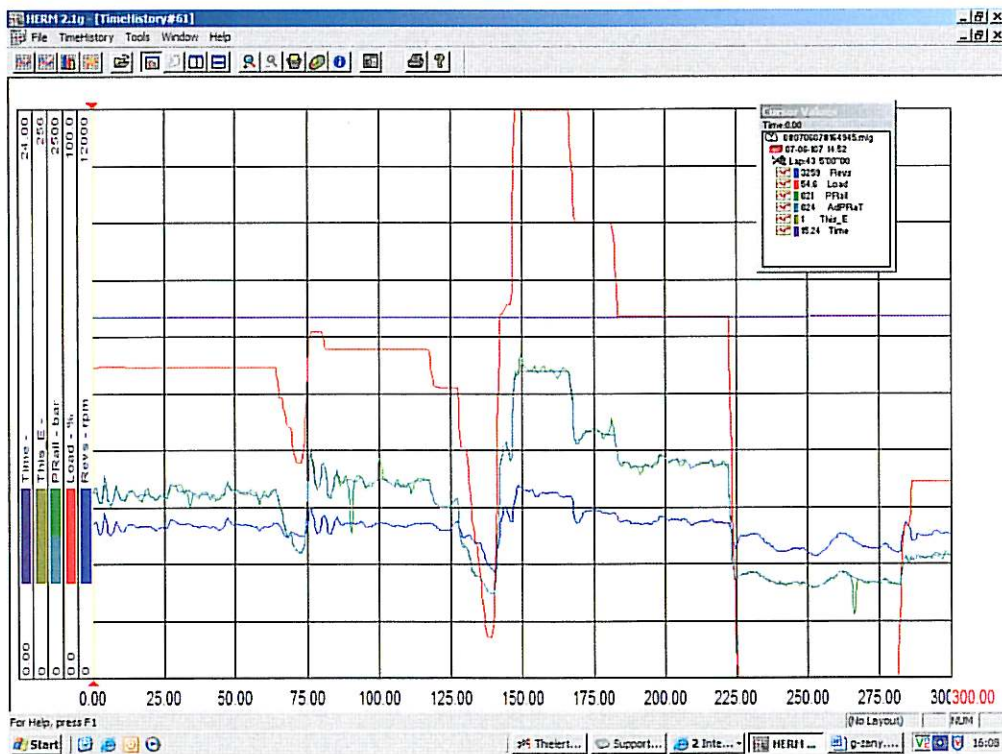
Picture 9 ECU charts of the OY-RBB shortly before the engine failure, taken from TAE Occurrence Investigation Report OY-RBB

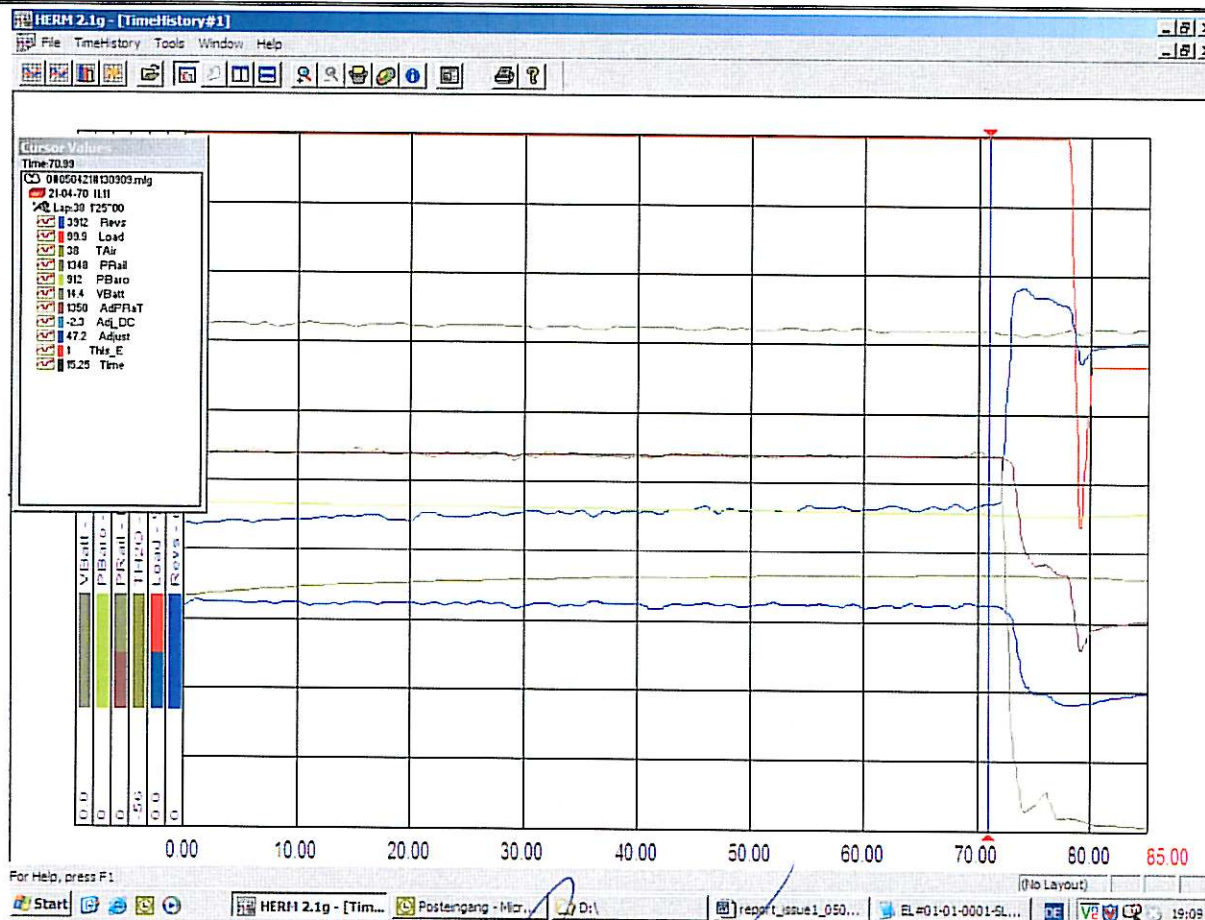
Comparing the drop of the rail pressure of this ECU chart with the ECU chart on page 7 it can be seen that due to an open fuel fitting on the engine the rail pressure drops more abruptly. The fuel filter works as a damper. In case of an open fuel filter inlet fitting the remaining fuel in the filter bowl mixes with air. Because the engine can cope with a high percentage of air in the fuel the decrease of the rail pressure in case of an open fuel filter inlet fitting occurs slower than it decreases in case of an open fuel fitting on the engine.

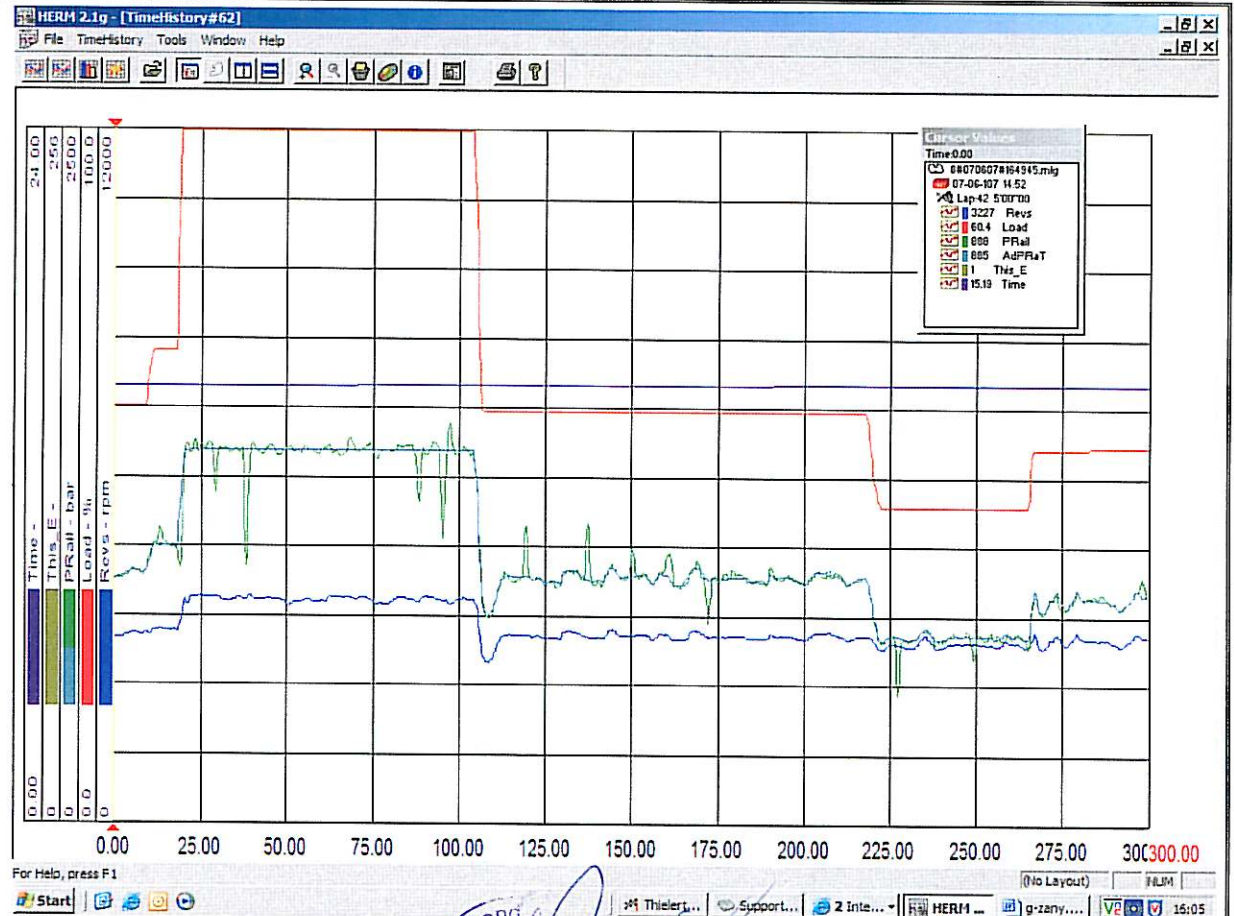
This chart shows Lap 42 of the ECU data of the OY-RBB, about 10 minutes prior to the engine shut down on 7-June-2008.

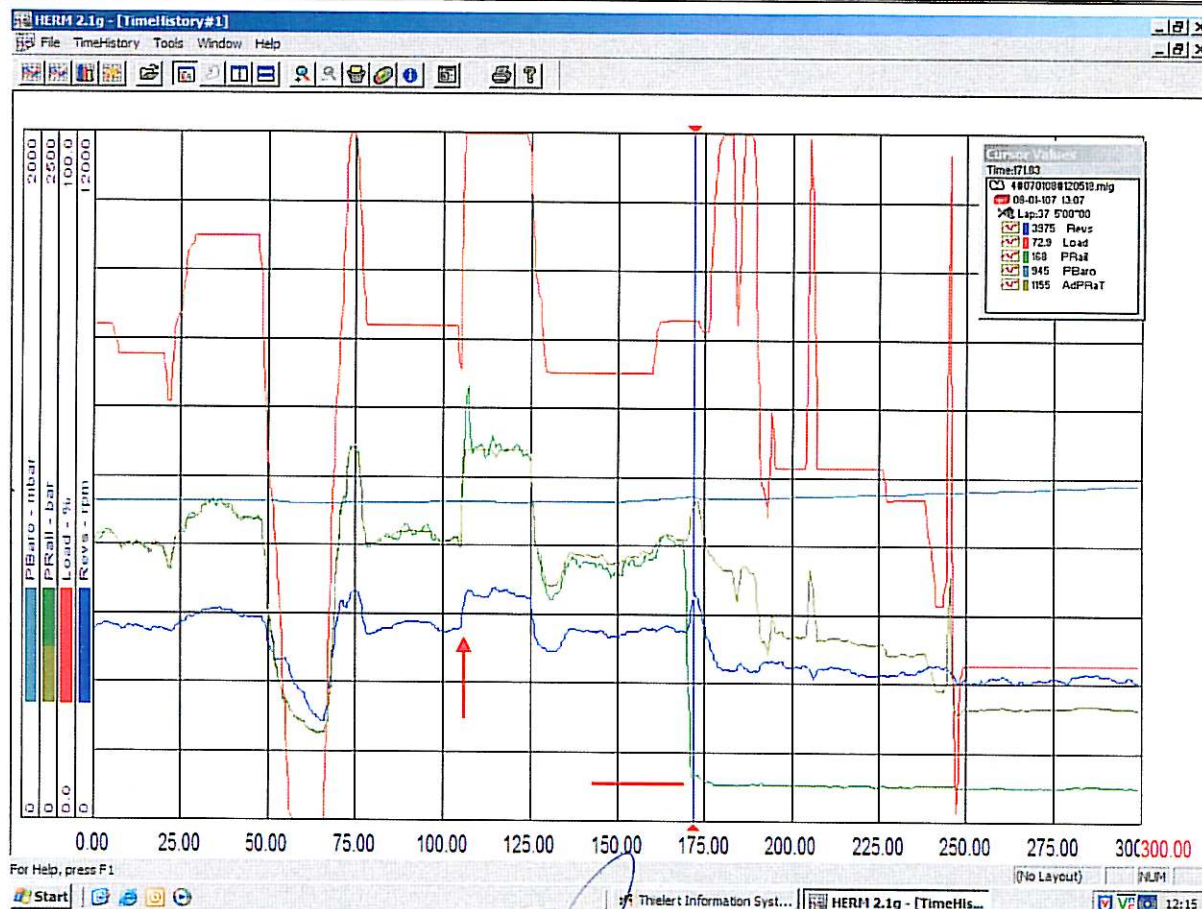
The red arrow shows a fluctuation of the rail pressure which might be one of the reported engine shudders.
