<b>HCLJ510-000617</b>	<b>Havari</b>		
Luftfartøj:	Cessna TR 182 RG	Registrering:	OY-SFU
Motor:	Lycoming 0-540-L3C5D	Flyvning:	Privatflyvning, VFR
Besætning:	1 – ingen tilskadekomst	Passagerer:	1 – ingen tilskadekomst
Sted:	Aversi ved Haslev	Dato og tidspunkt:	8.2.2009 kl. 0920 UTC

Havarikommissionen for Civil Luftfart og Jernbane (HCLJ) fik meddelelse om havariet fra fartøjschefen den 8.2.2009 kl. 0935 UTC.

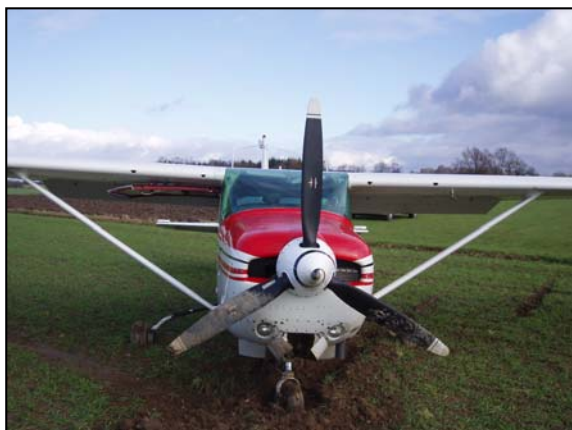
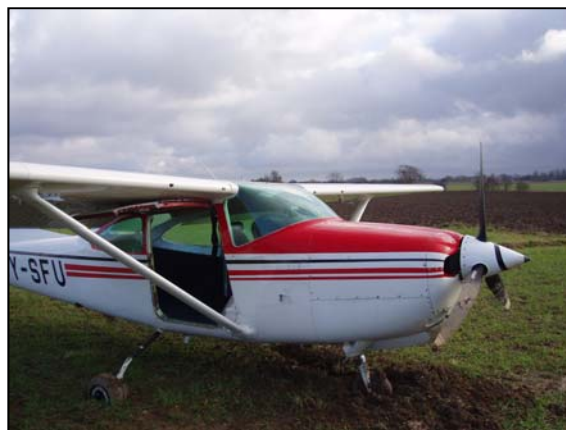
Luftfartøjet blev væsentligt beskadiget.

Der opstod skade på luftfartøjets propel samt landingsunderstel.

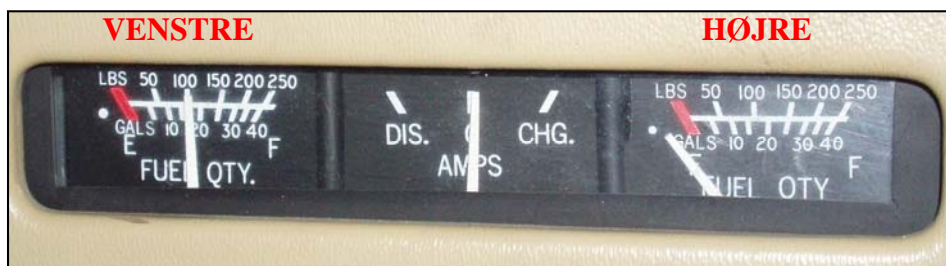
- Der konstateredes ingen tekniske fejl eller skader, der ikke kunne relateres til havariet.
- Der var ikke installeret et passagersæde til passageren.
- Begge brændstoftanke var intakte.
- En visuel inspektion af brændstofmængden i begge brændstoftanke afdækkede, at begge tanke var tomme.
- Ved dræning af venstre og højre brændstoftank var den tilbageværende brændstofmængde henholdsvis nul og en halv deciliter brændstof.
- Brændstofvælgeren var valgt til positionen "BOTH".
- Brændstofindikatorerne uden elektrisk spænding viste:

Det er HCLJs opfattelse ud fra den efterfølgende undersøgelse af luftfartøjet, at motoren umiddelbart efter start gik i stå grundet brændstofmangel.

Det er HCLJs vurdering, at fartøjschefen ved sin forberedelse af flyvningen alene lod brændstofindikatorernes visning indgå i beslutningsprocessen omkring den aktuelle brændstofmængde ombord. En visuel inspektion af brændstofmængden i tankene før start ville med stor sandsynlighed have afdækket den venstre brændstofindikator's fejlvisning. HCLJ vil gerne understrege vigtigheden af før hver flyvning at inspicere luftfartøjet i overensstemmelse med luftfartøjets AFM.

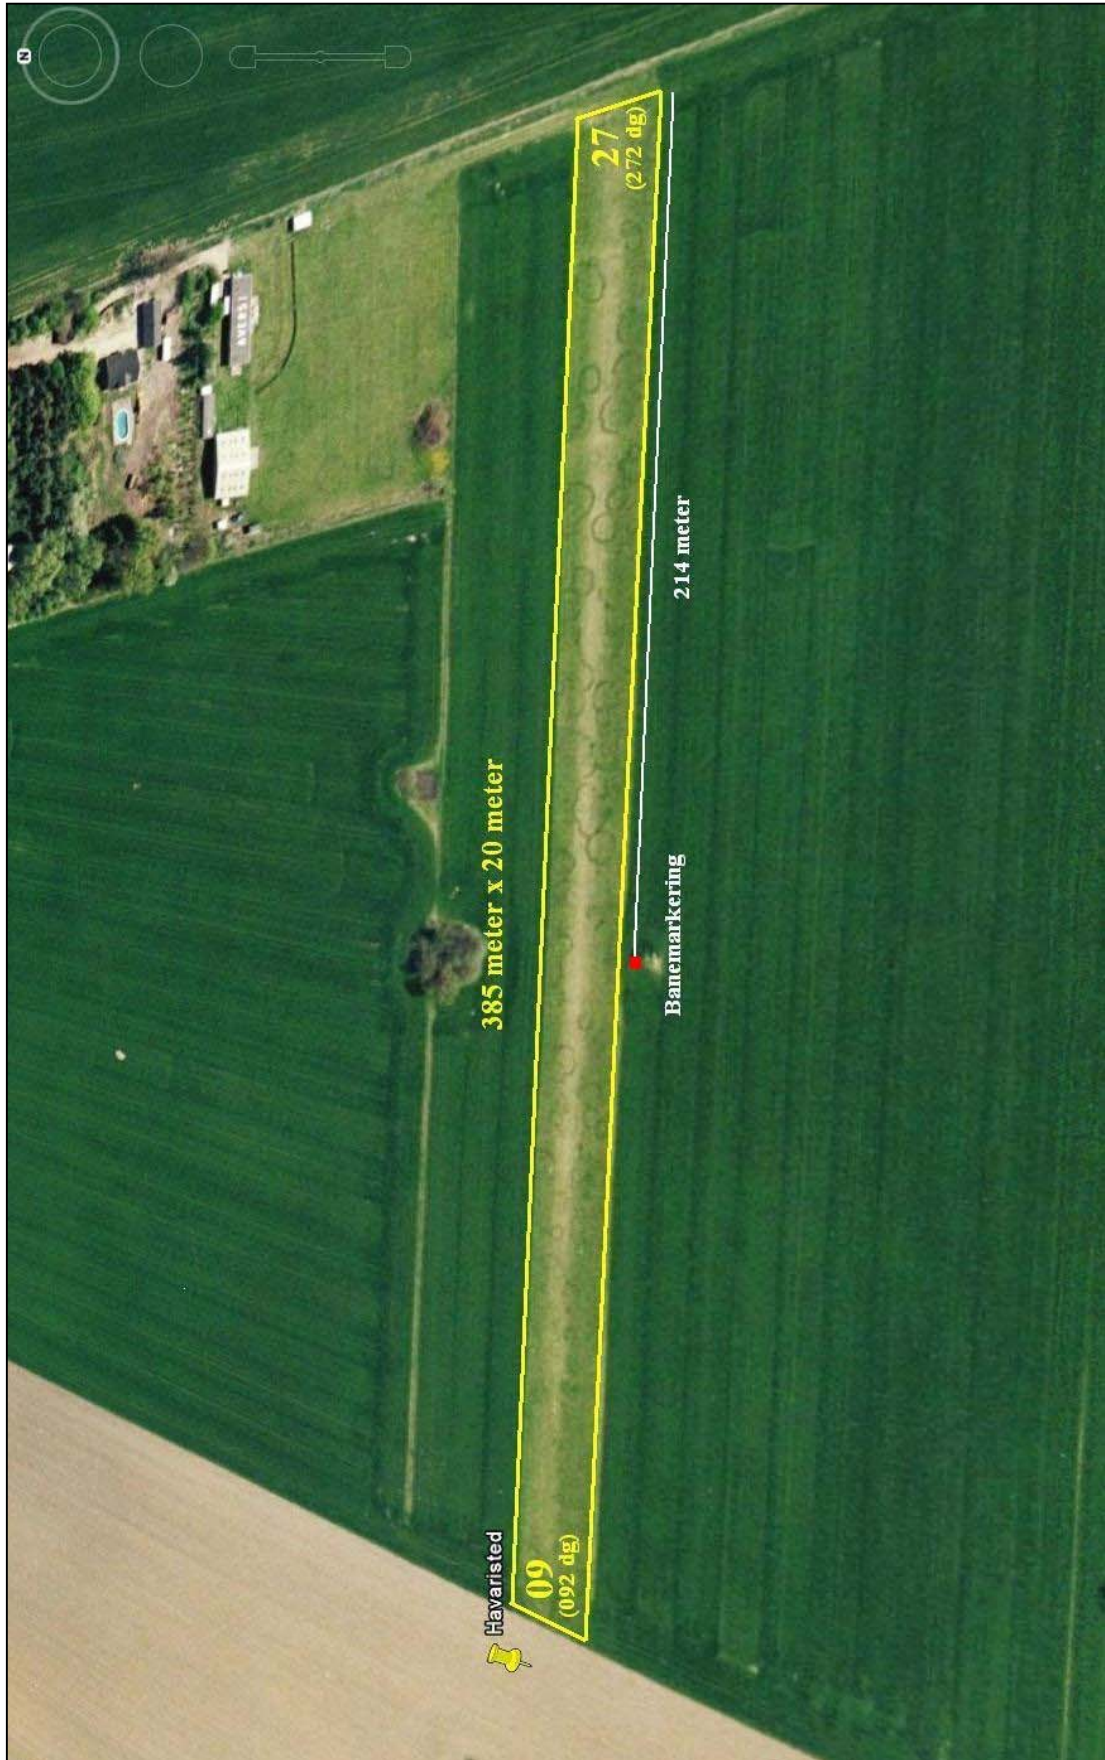
Bilag 1

Luftfartøjet kom i luften før banemarkeringen, der var placeret syd for startbanen. Se bilag 1. Da luftfartøjet fløj vandret ligeud i ground effecten for at opbygge flyvefart, gik motoren i stå. Fartøjschefen landede ligefrem og forsøgte at bremse luftfartøjet inden for den resterende til rådighed værende bane.
