History on the platform

Analysis

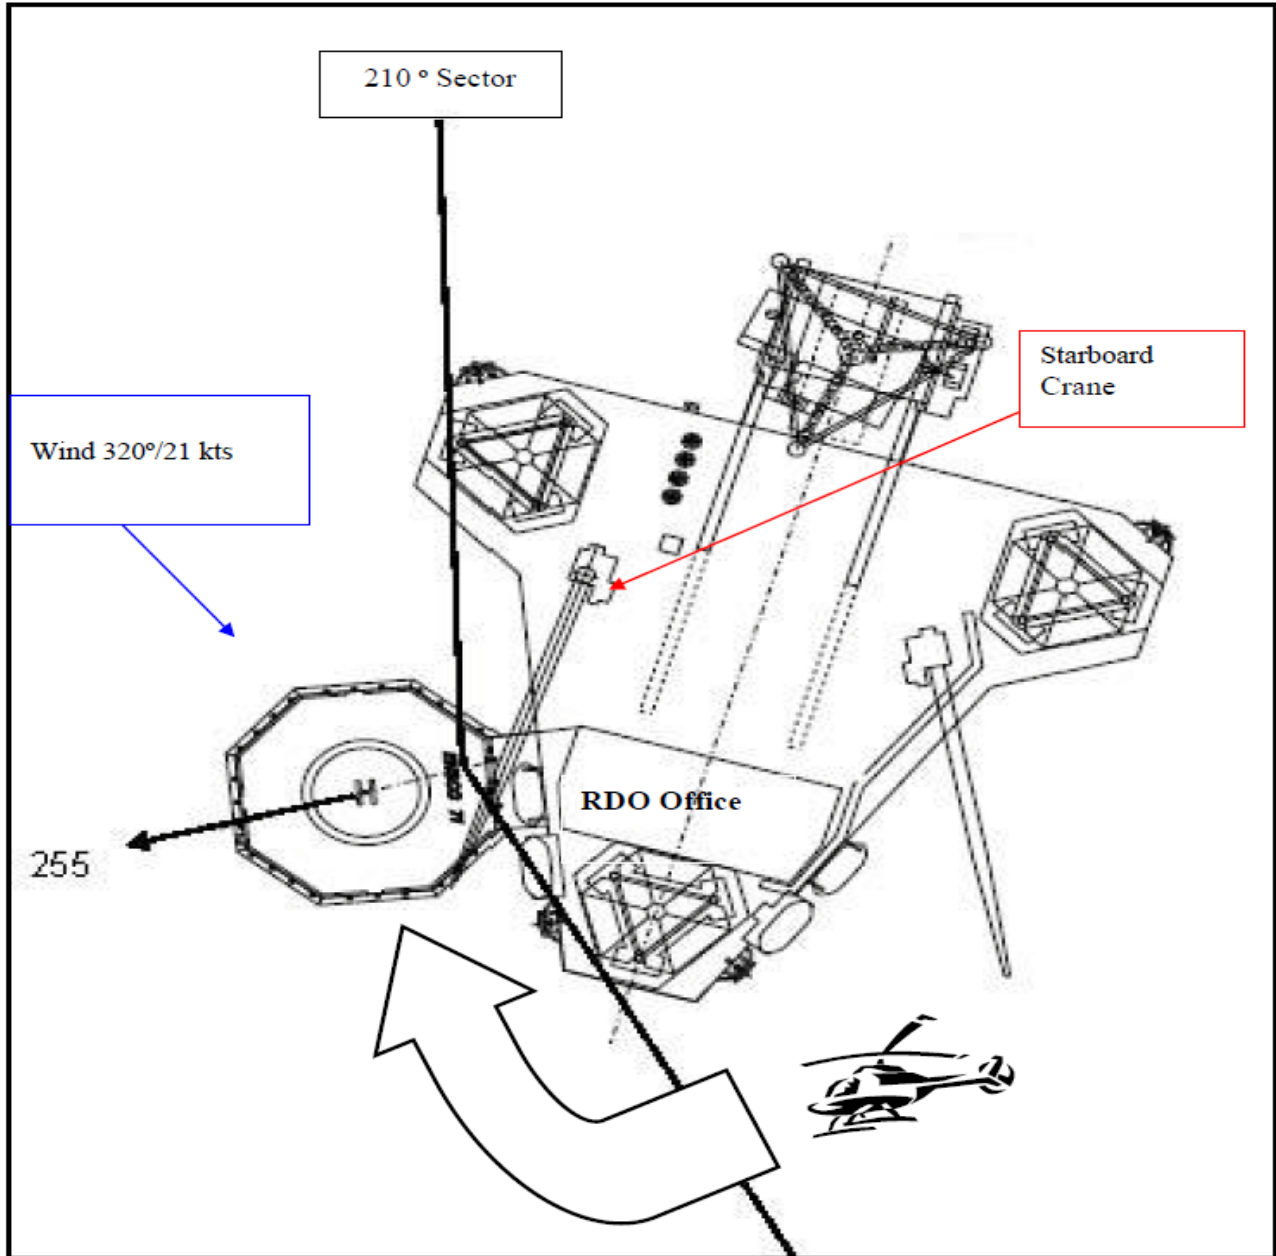
Schematic Platform Overview

The 210° flying sector was to the left of the solid black line.

The helicopter approached from a nearby platform and from behind the RDO office building.

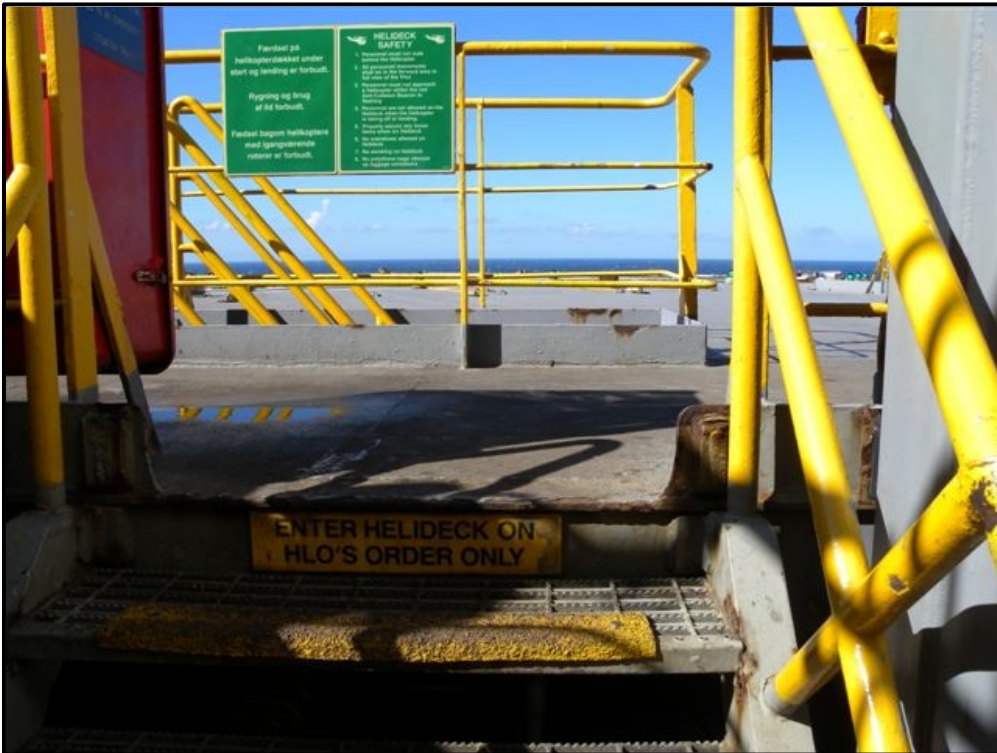
View from HLO safe position

No visual references of crane or approaching helicopter.

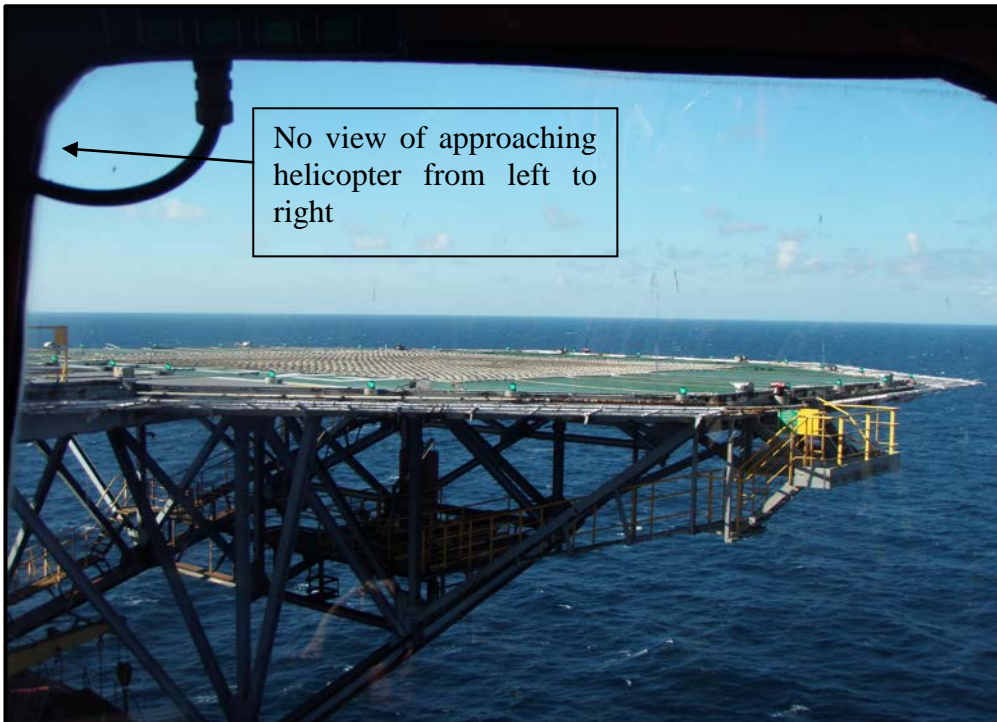
View from the crane operators seated position.

The helicopter approached from left and behind the office building giving no visual references to the crane operator.

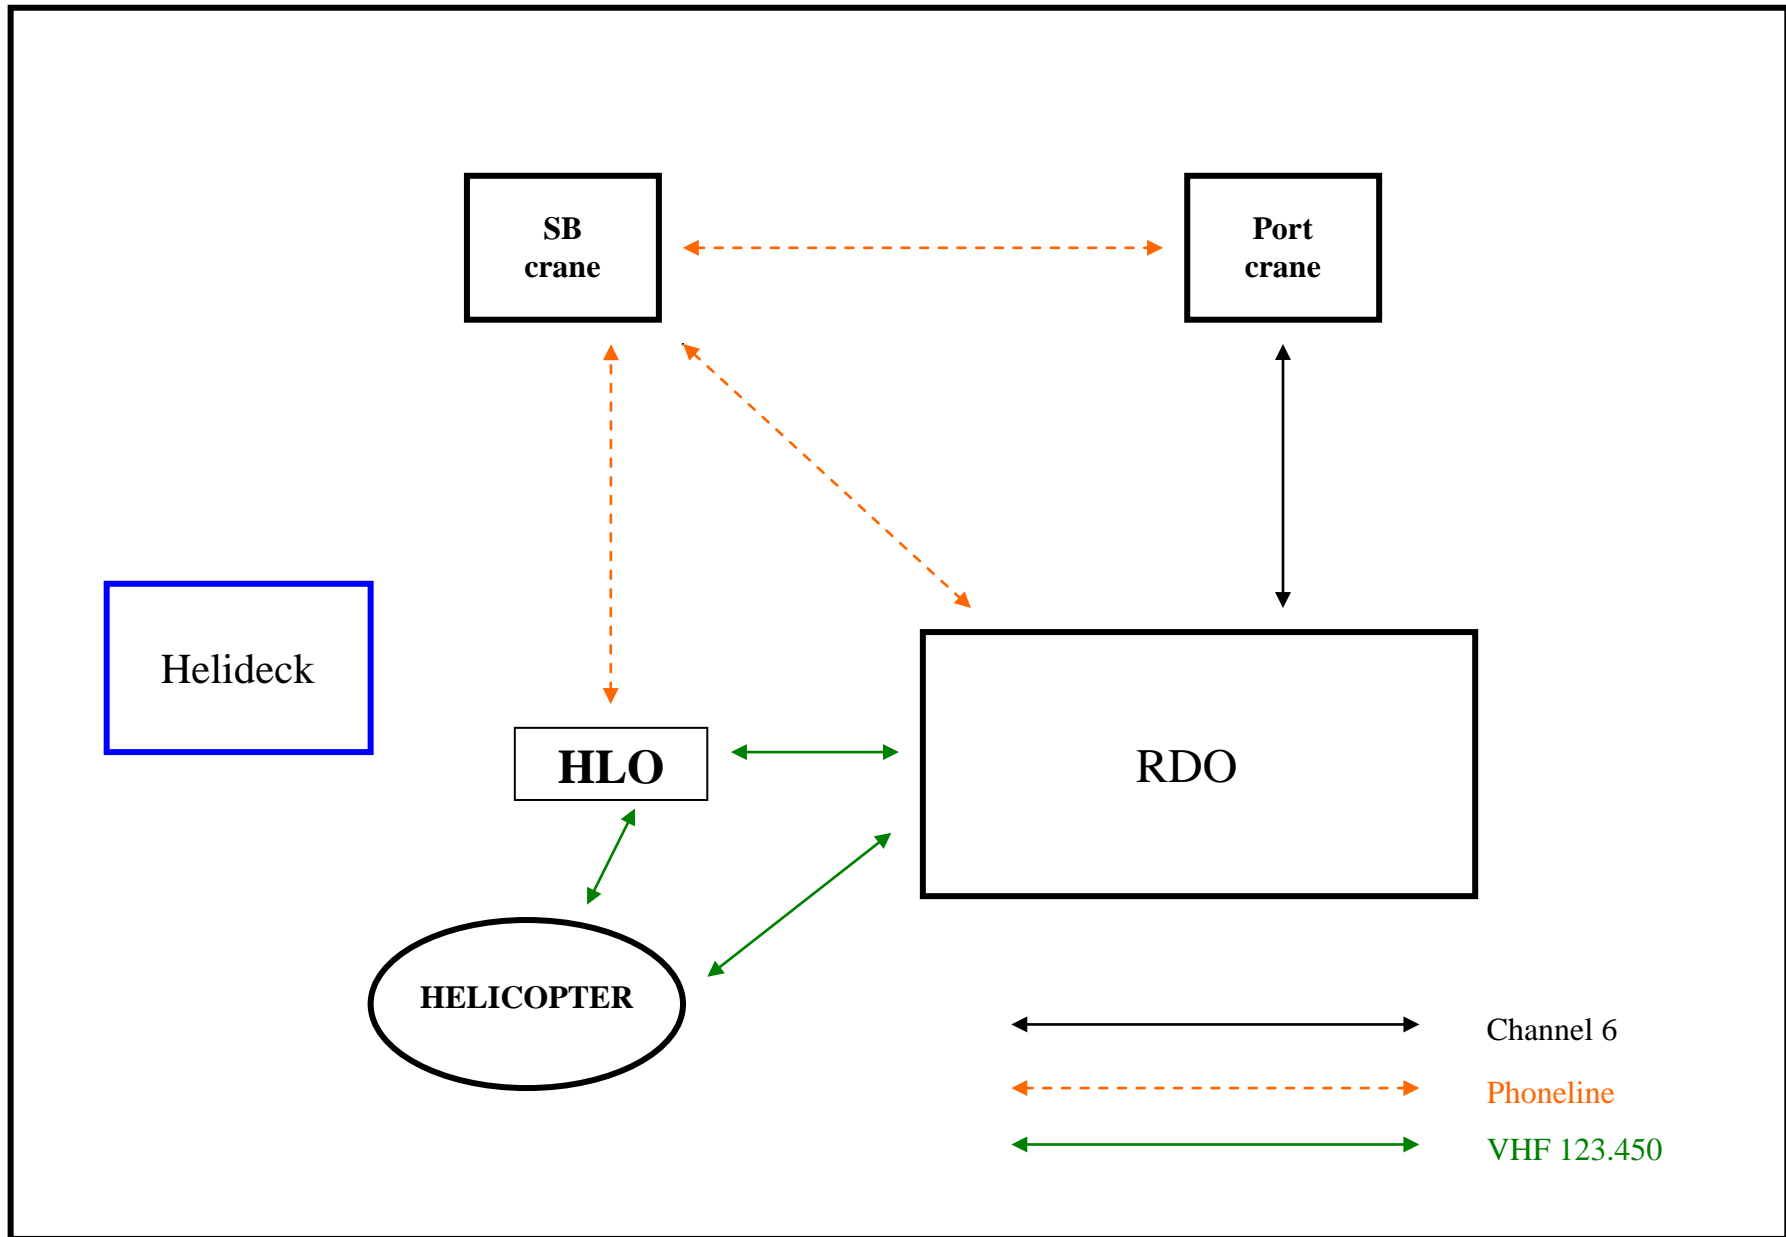
Flow chart - communication during helicopter operation

Appendix 1 is a flow chart of the available communication on the platform at the time of incident. Radio communication was possible between the RDO, HLO and the helicopter on VHF frequency 123.450 MHz, Communication between crane operator, HLO and RDO was only available with the means of a landline telephone - not an open line. In cases where both cranes were operating at the same time, the RDO could only communicate with one of the cranes at a time (radio channel 6).

The communication setup meant that only a “closed loop” between the helicopter, HLO and RDO could be maintained during the deck clearance and the landing phase. This meant that the CO could not maintain sufficient situational awareness.
