**THE DANISH  
ACCIDENT INVESTIGATION BOARD**  
The Aviation Unit

## **FINAL REPORT**

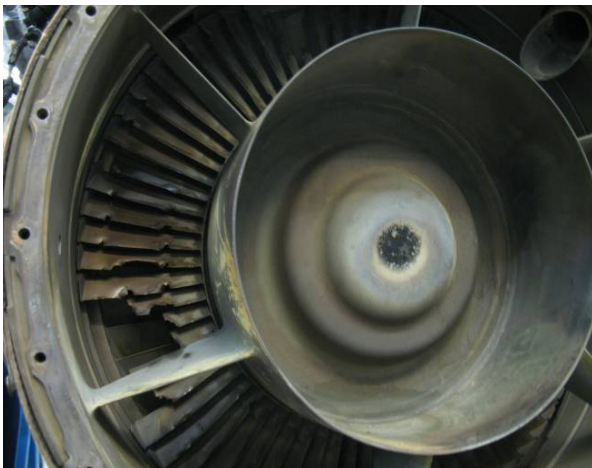
Fig. 1. Power Turbine (PT) stage 2.

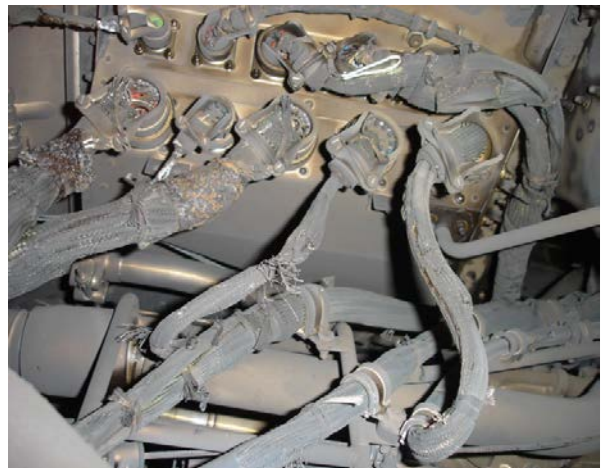
Fig. 2. Visible signs of fire and heat could be seen on the outside of the engine.

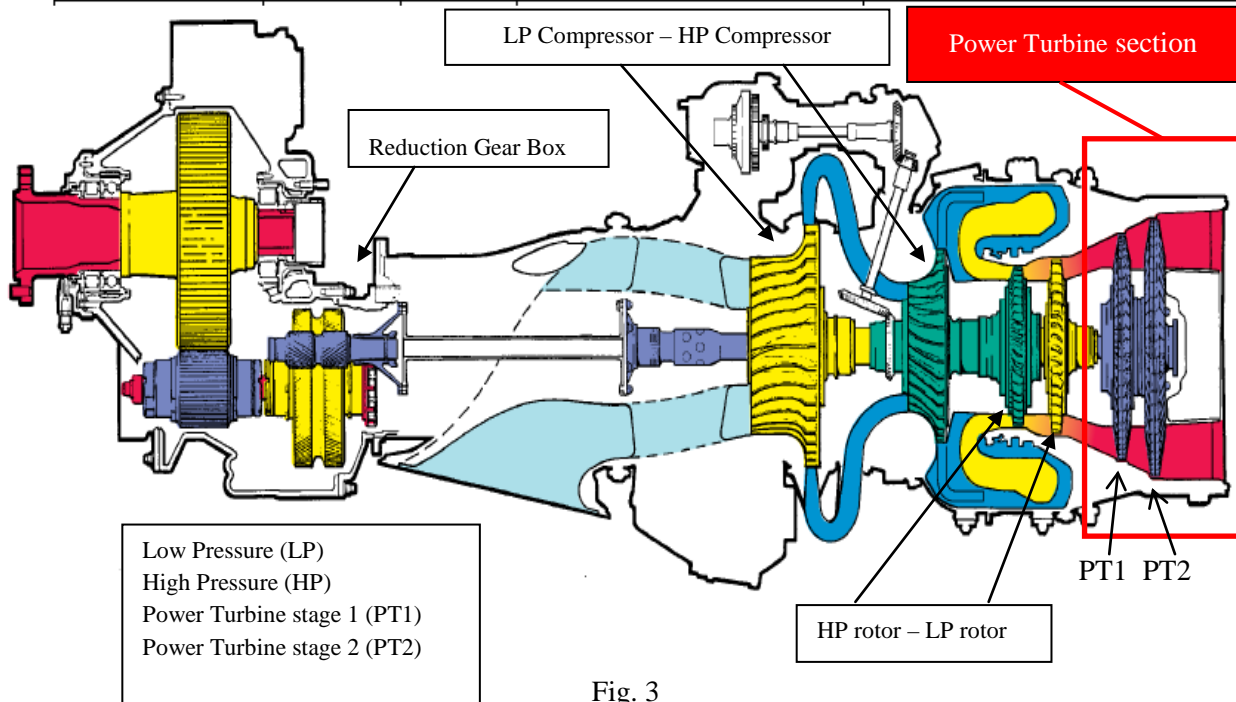
Removal Date	TSN	CSN	Workscope	Shop Info
<b>TM AV0098</b>				
05 Feb 2011	15832:07	23937	HS repair	w/o WT772345
02 Mar 2010	14830:31	22219	HSI	w/o WT772185
18 Jul 2008	13392:22	19200	Repair	w/o, WT589147
17 Feb 2006	10078:33	13608	TM overhaul	w/o WT983534
07 May 1999	0:00	0	New build PW127F	P&WC

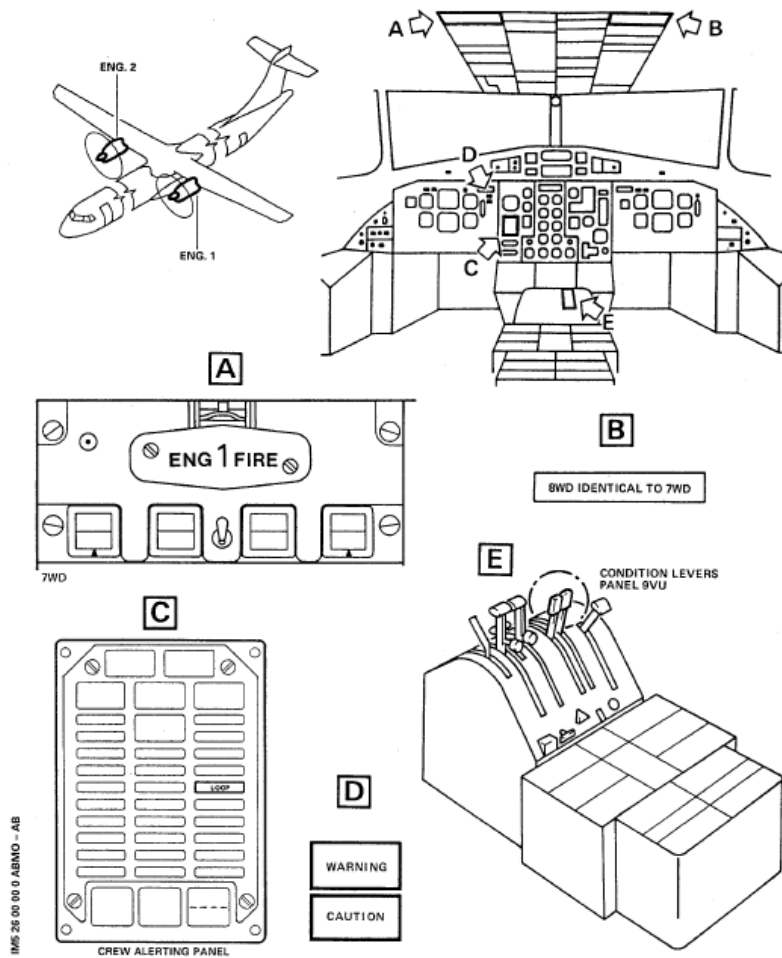
- Illuminate the engine fire warning light on T-handle, fig. 4 A and B.
- Illuminate the fire warning light on the Crew Alerting Panel, fig. 4 C.
- Illuminate master warning light on captain's main instrument panel, fig. 4 D.
- Illuminate fuel shut-off warning light on the condition lever, fig. 4 E.
- Trigger the aural warning.

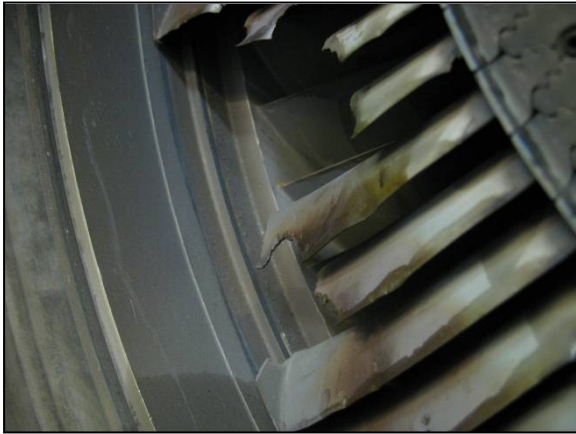
The PT2 was removed and the blades were inspected (fig. 9).

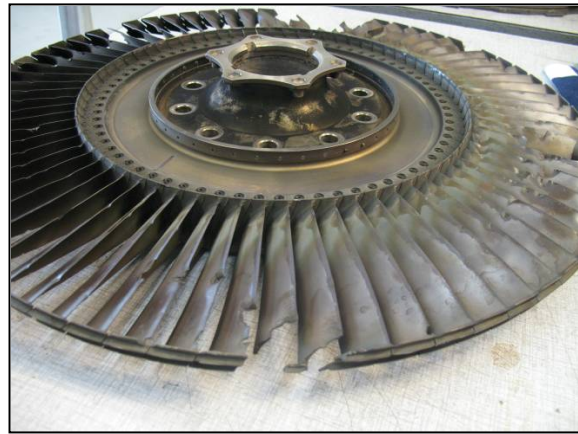
Fig. 9. PT2 after removal

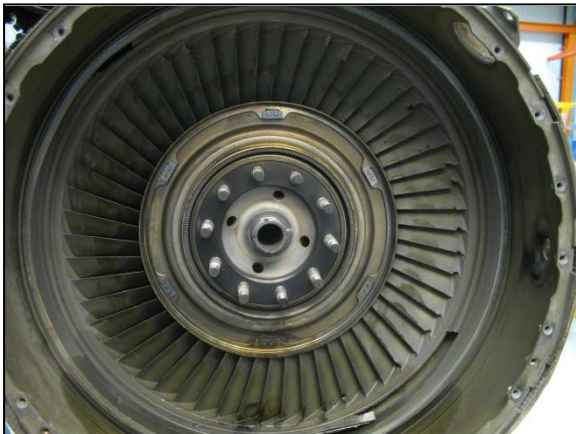
After removal of the PT2 it could be seen that PT2 stator and shroud was heavily damaged (fig. 10). A large piece of outer shroud was missing (fig. 11).

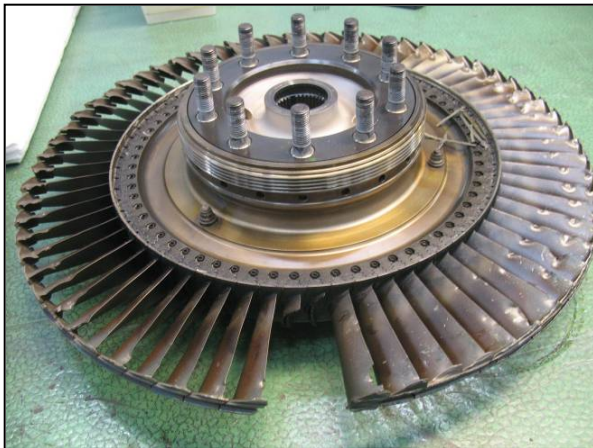
The PT1 was removed from the engine (fig. 12). The blades were heavily damaged and two blades were fractured almost at the root platform (fig. 13). All the PT1 blades had evidence sign of overheating. This was seen on the fracture surface and on the coating on all other blades.

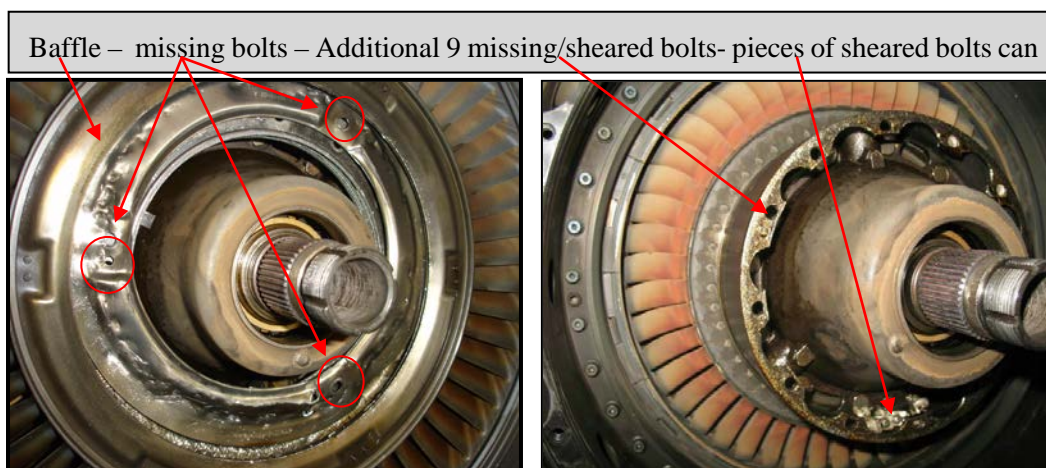
Fig. 14. Bearing baffle and PT1 stator

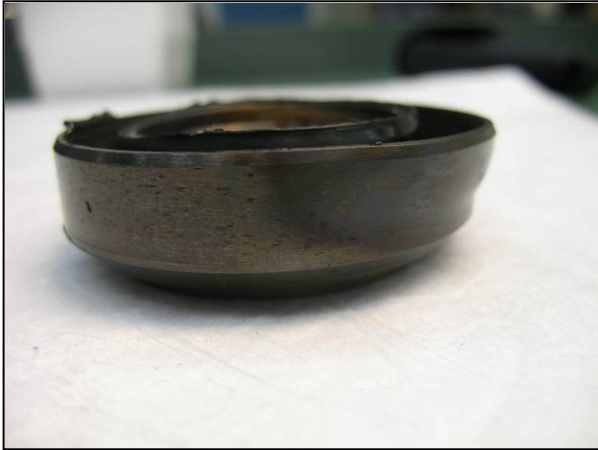
Fig. 18. Labyrinth Seal

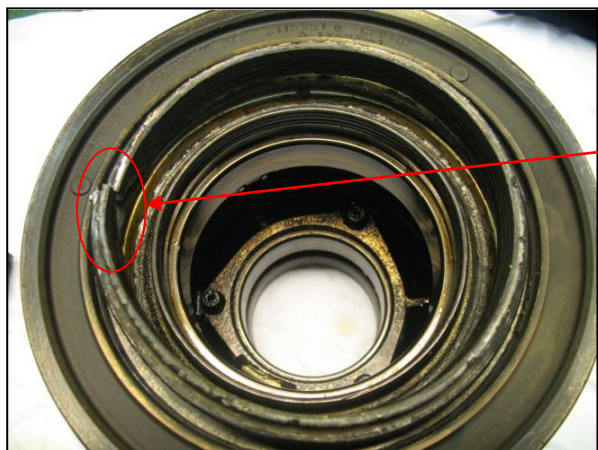
Broken seal assy  
(part of the housing).

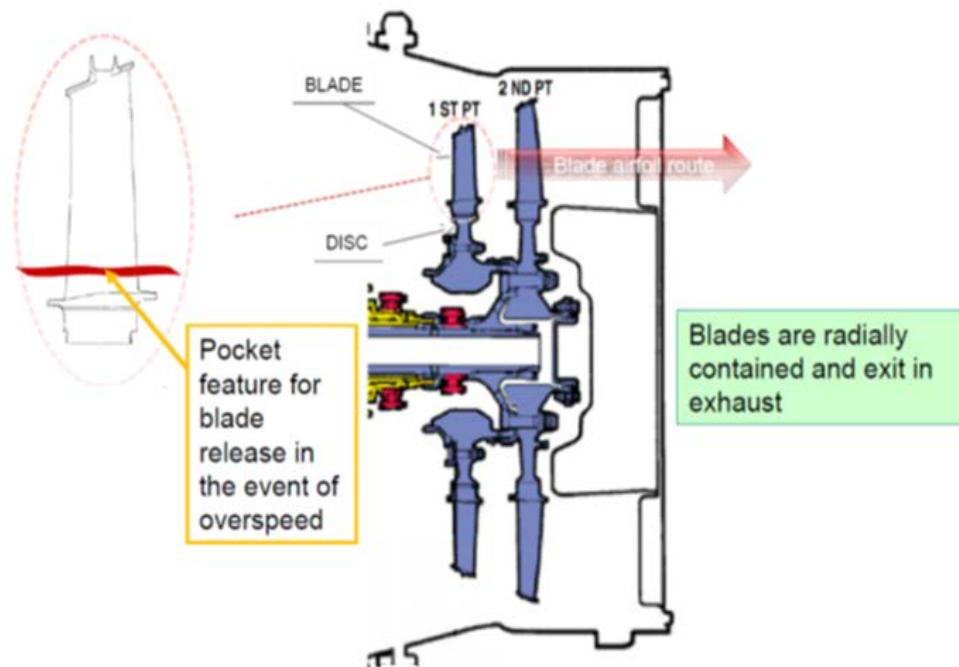
The blades were constructed to shear off at the blades core pocket in case of an overspeed of 120% to prevent a runaway disc in case of an engine failure (fig. 20).

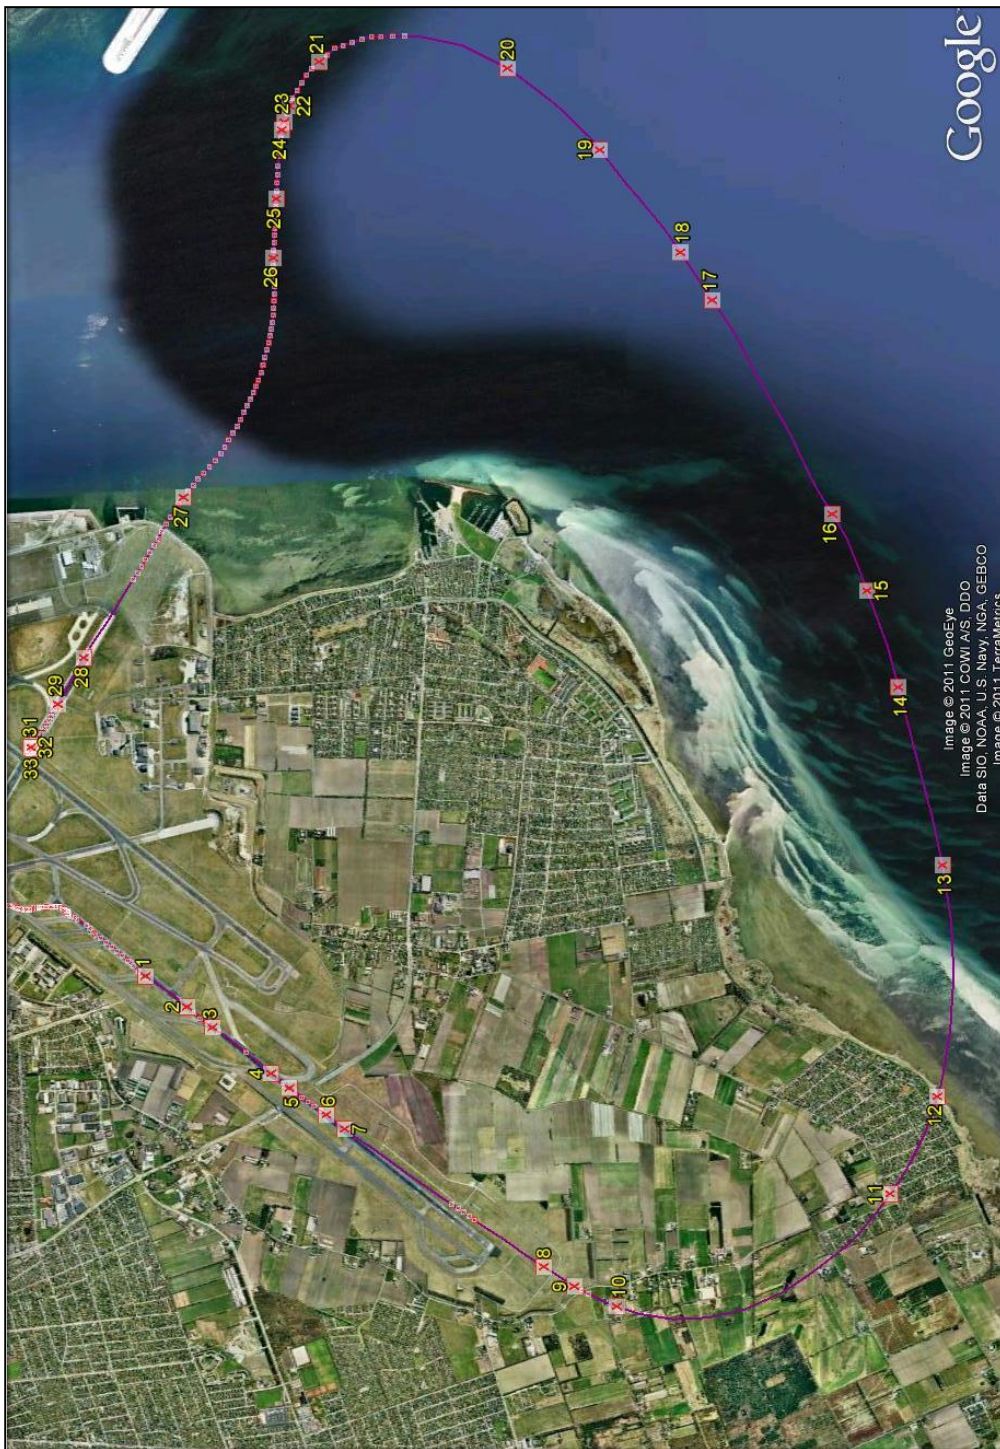
Enclosure 2 - The landing roll

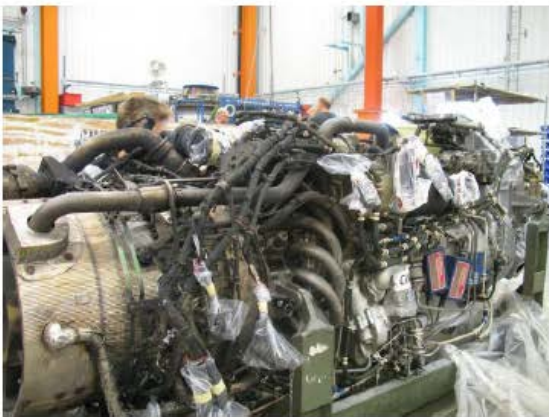
Photo No 1 Right hand side of engine

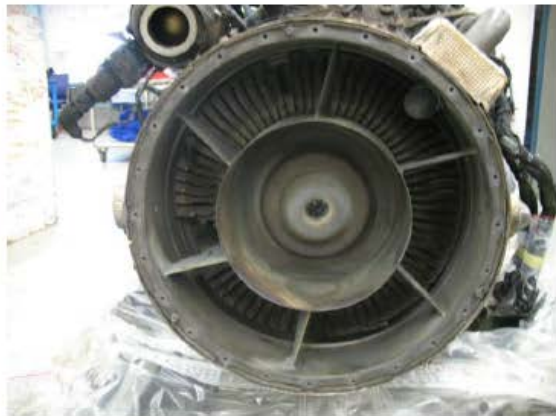
Photo No 4 Broken PT2 Blades

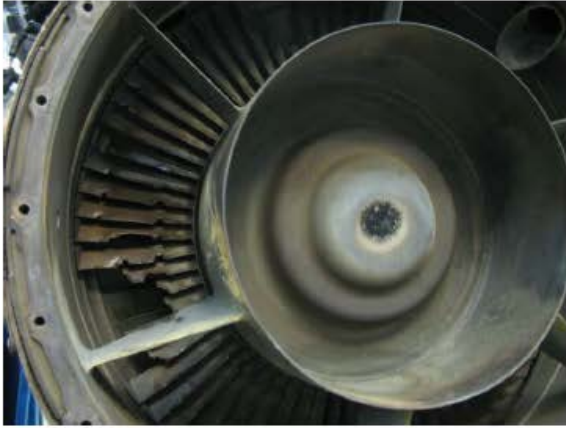
Photo No 11 PT Blade stage 2

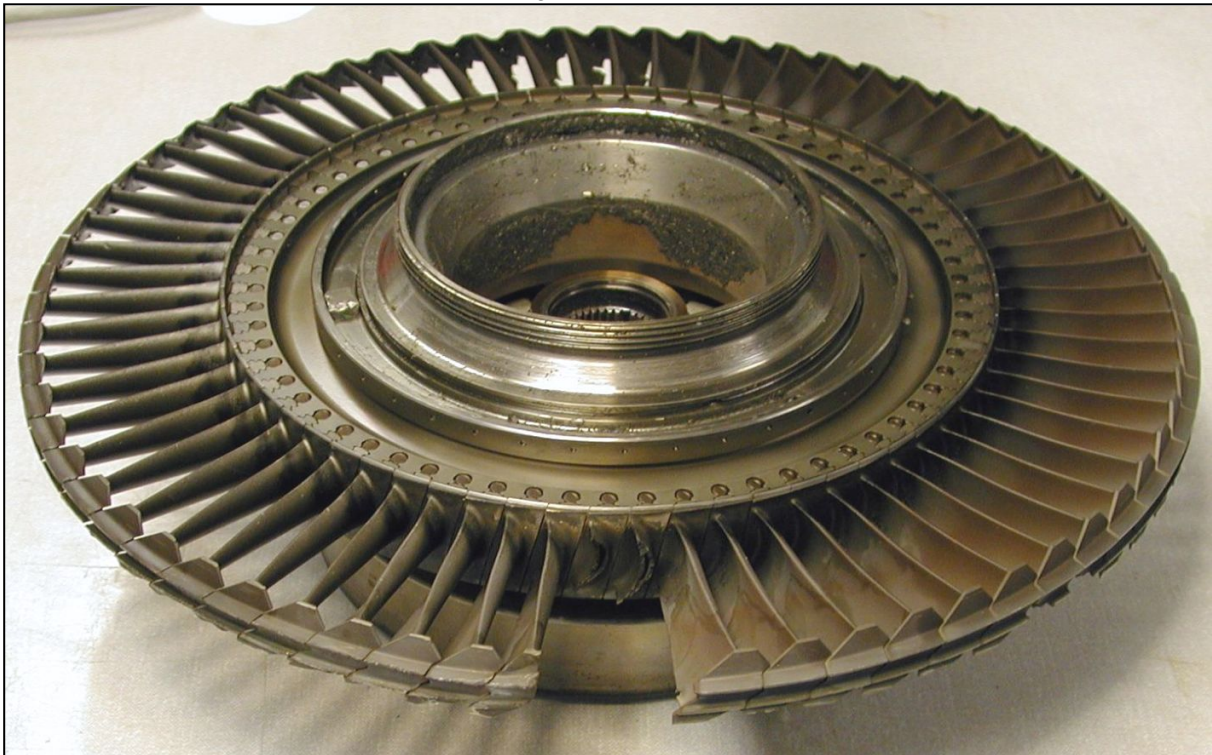
Photo No1. PT Disc 1 with two blades missing. FWD side.

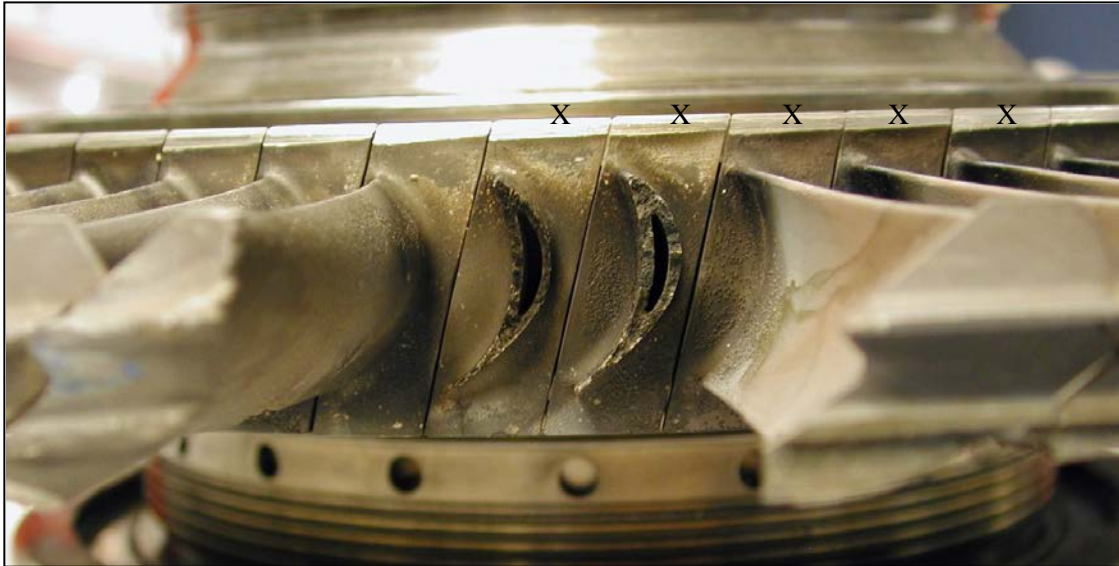
Photo No 2. A closer view of the fractured blades. The five (5) blades marked with X were removed from the disc for a closer investigation.

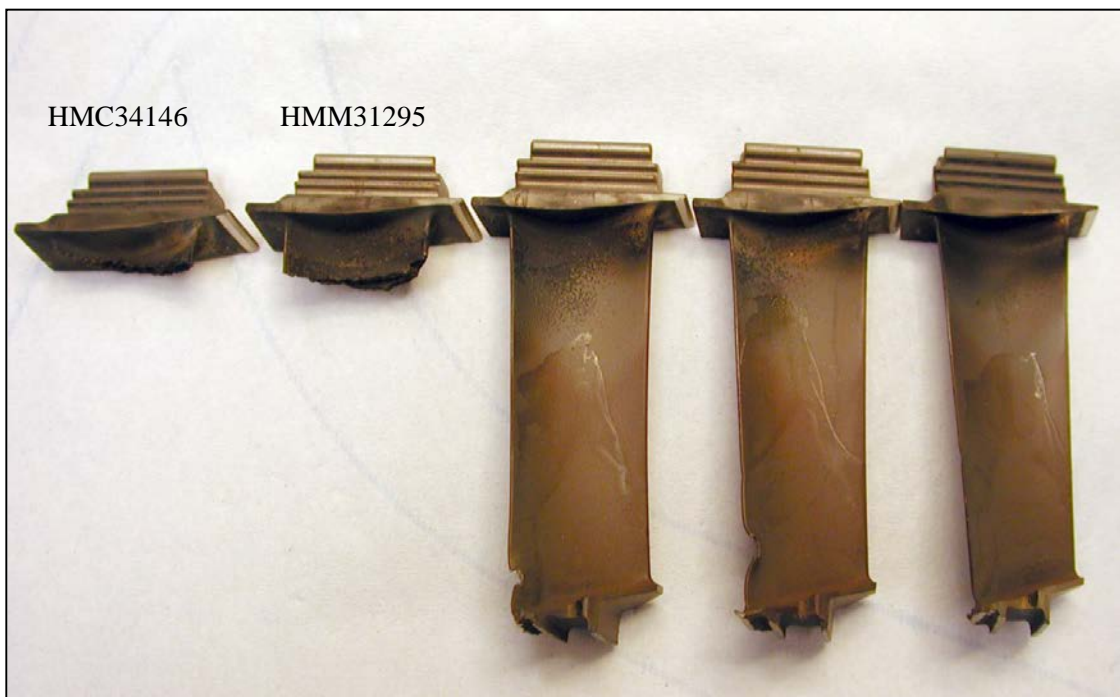
Photo No 3. The five blades after removal from disc. Visual inspection of the two fractured blades showed that S/N HMC34146 had a tensile overload fracture. Blade S/N HMM31295 was subjected to a fractographic investigation using a SEM. See page 69 to 72.

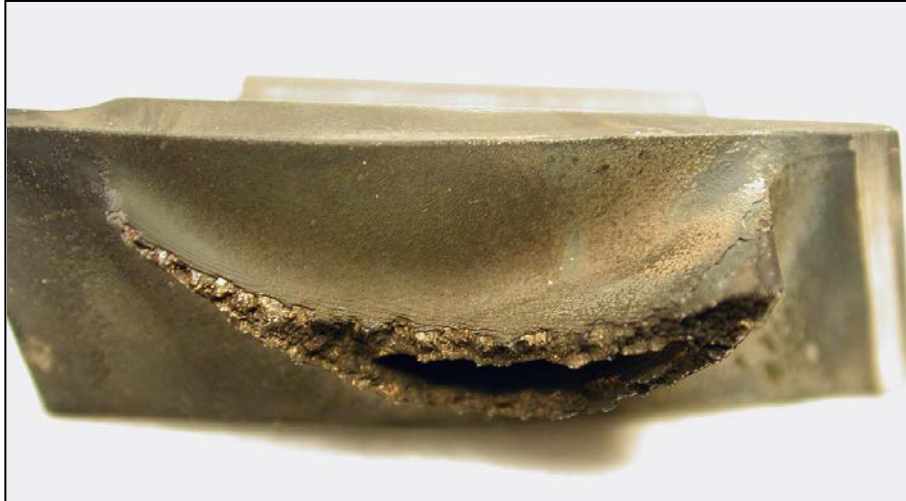
Photo No 4. blade S/N HMC34146 had a tensile overload fracture.

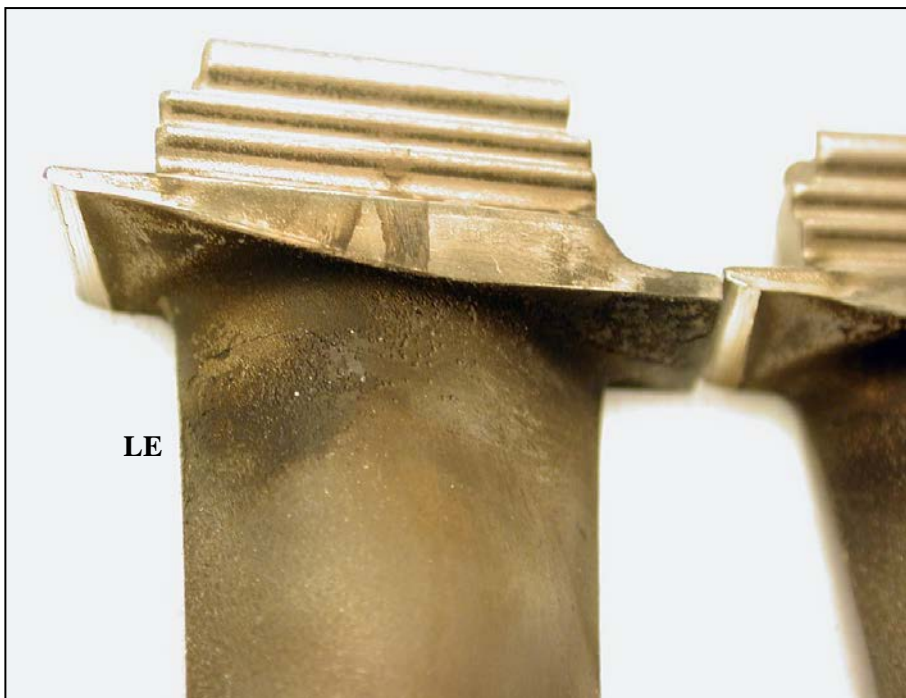
Photo No 5. All of the PT1 blades showed evidences of high temperature at the airfoil close to the root platform. This is probably a secondary damage since the two broken blades show evidences of high temperature on the fracture surfaces close to the leading edges.

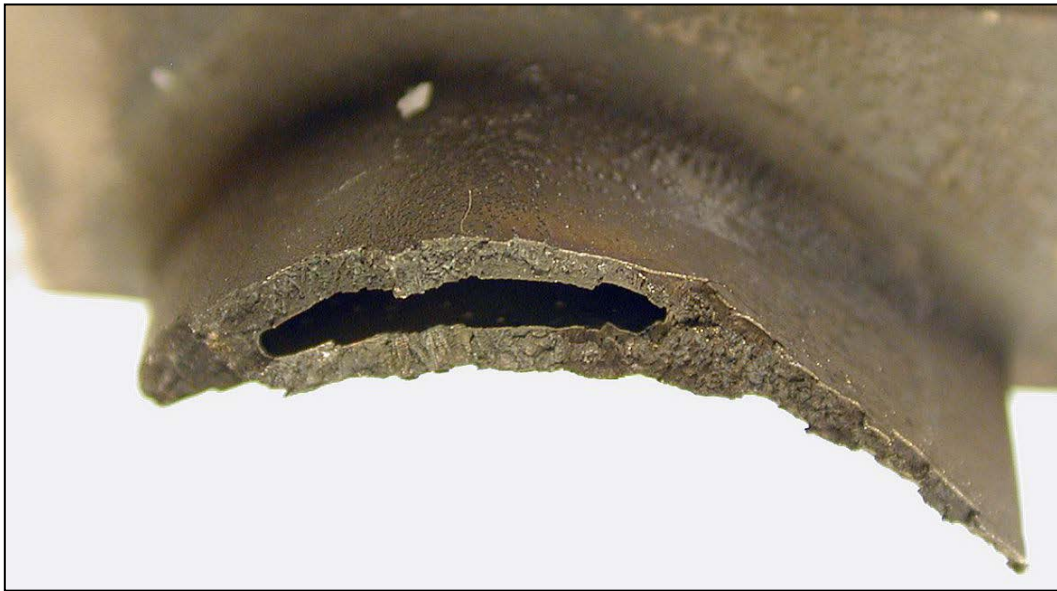
Photo No 6. The fracture surface of blade S/N HMM31295

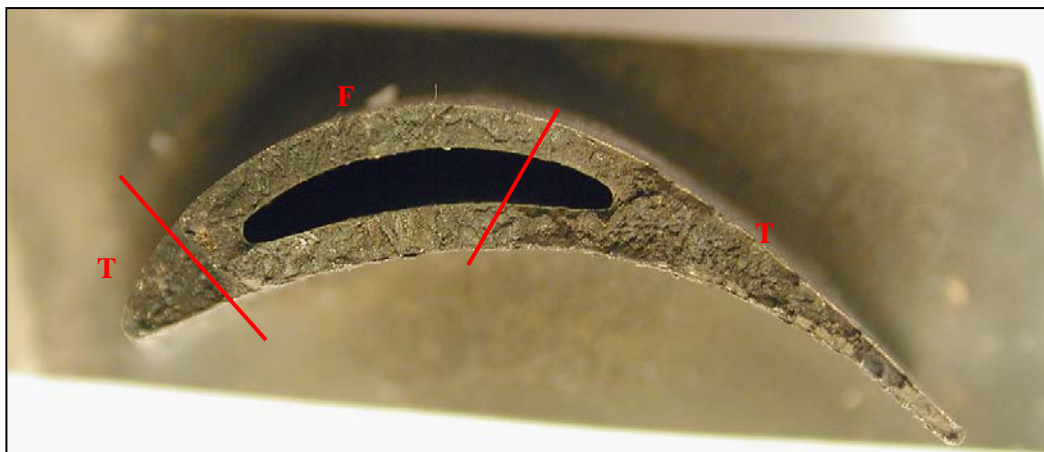
Photo No 7. S/N HMM31295. SEM-investigation (see the following pages) showed that area **F** is a fatigue surface, areas **T** are tensile fracture surfaces.

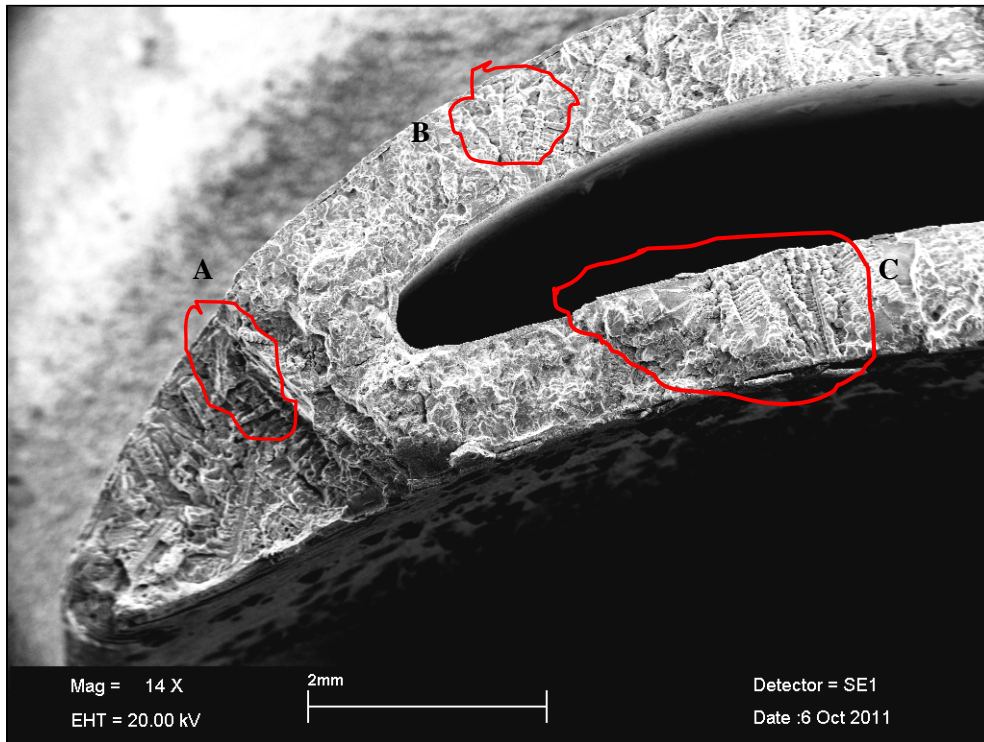
Photo No 8. Red lines show areas with shrinkage porosities where area C is the largest (photo no 10)

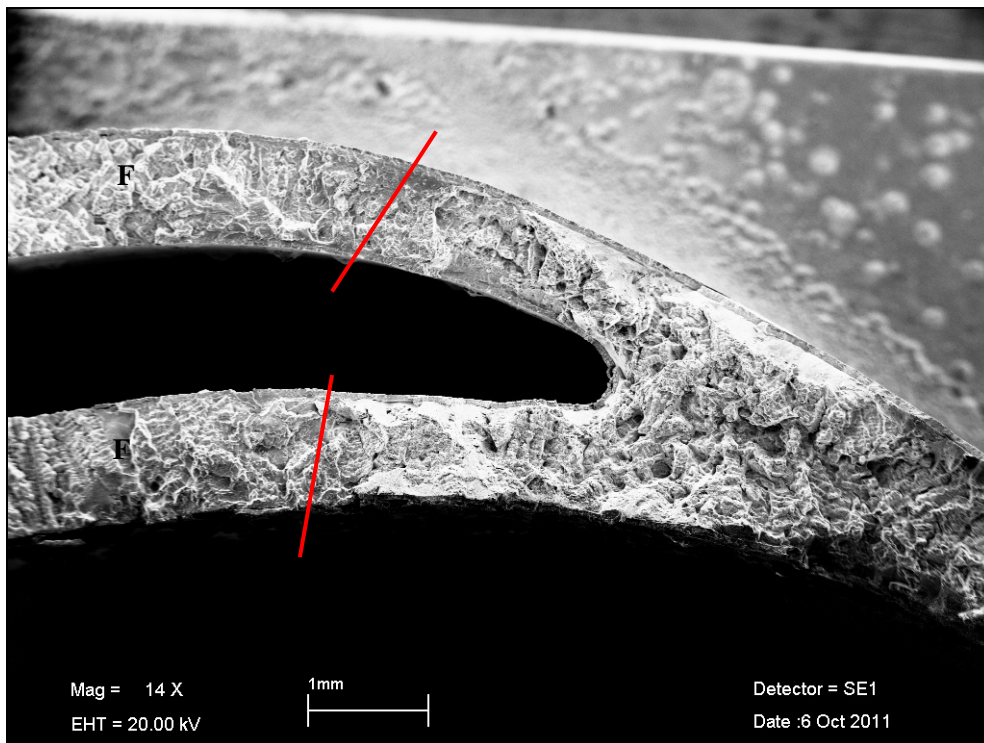
Photo No 9. Red lines show the limit between fatigue, F, and overload fracture.

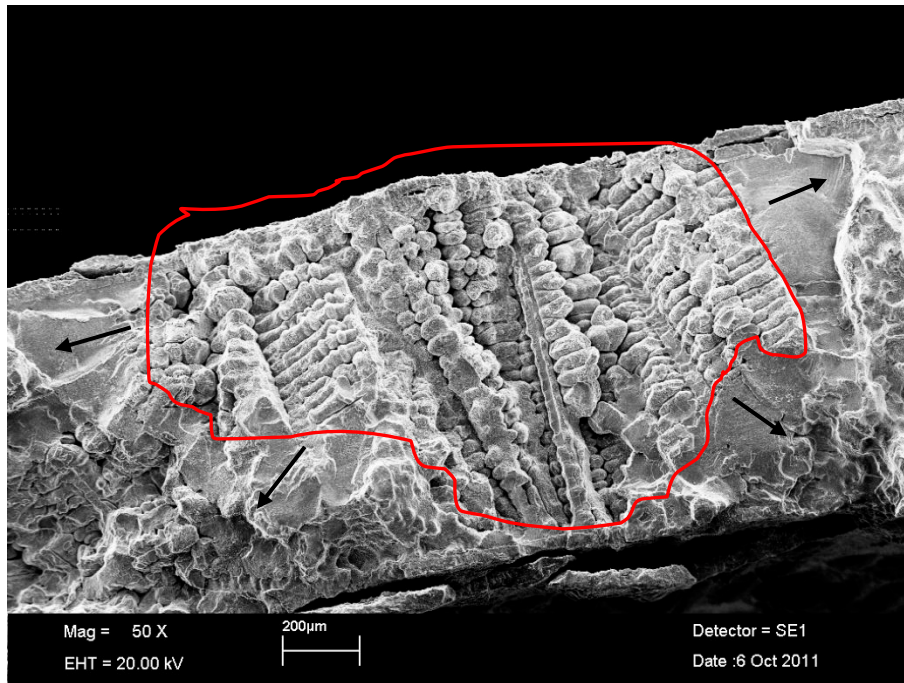
Photo No 10. Area C in photo no 8. The red line shows the extension of the shrinkage porosity. The arrows show the direction of fatigue propagation, away from the porosity.

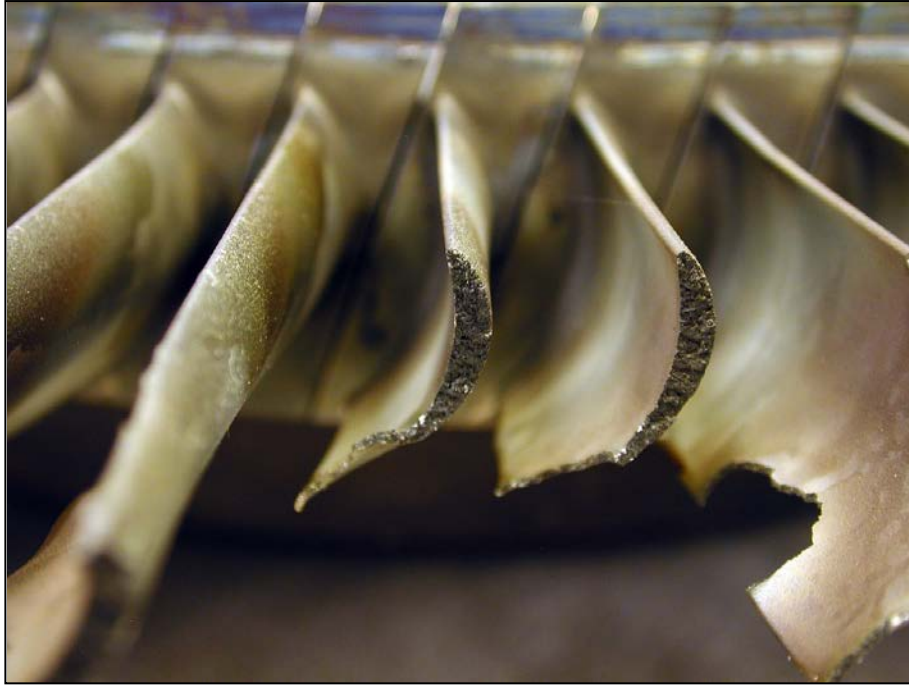
Photo No 15. All fracture surfaces were closely inspected and found to be tensile overload fractures, which mean they are a secondary event.
