**Havarikommisjonen**  
Accident Investigation Board Denmark

# **FINAL REPORT**

**Accident**

**AVIONS ROBIN DR400**

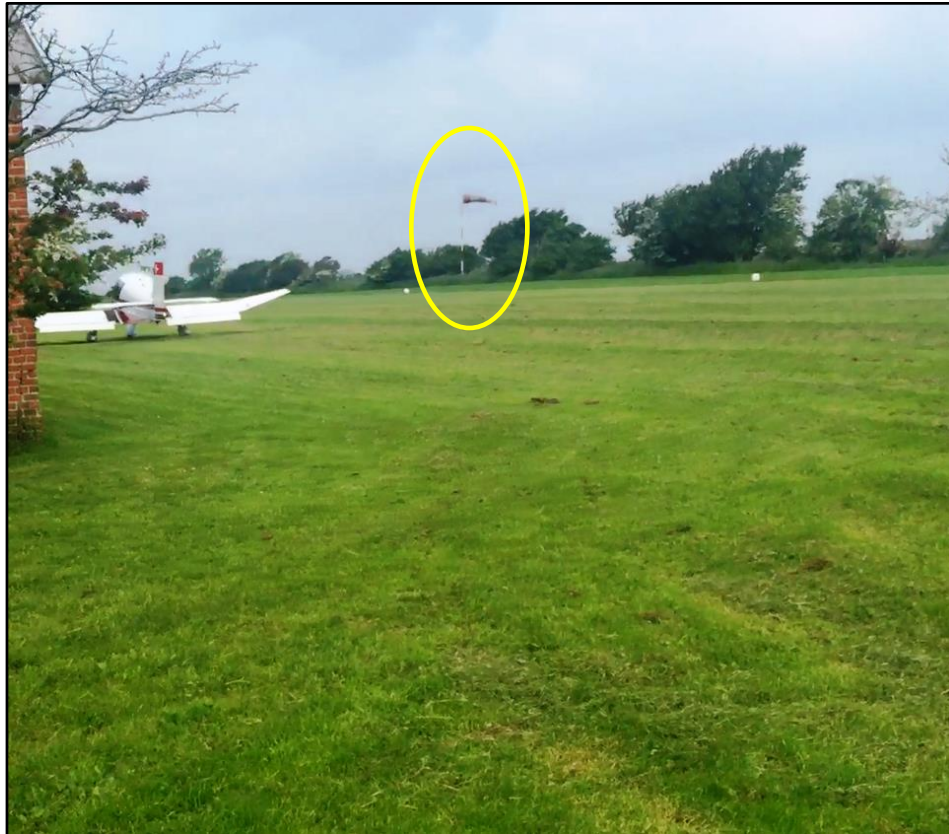
The windssock was located north of the airstrip.

The picture below is taken just before the aircraft impacted with windbreak trees in front of the aircraft and along the runway side.

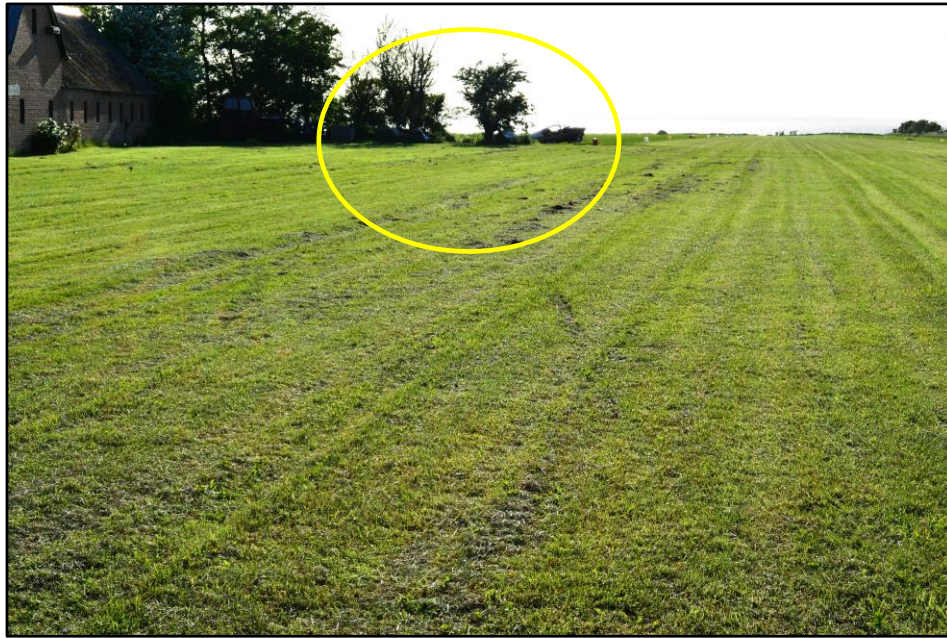
Accident site - direction towards the West

On an aircraft heading of approximately 280°, the aircraft rolled 97 meters until it impacted with windbreak trees and a parked runway roller (located 214 meters west of the threshold to runway 29) along the runway side.

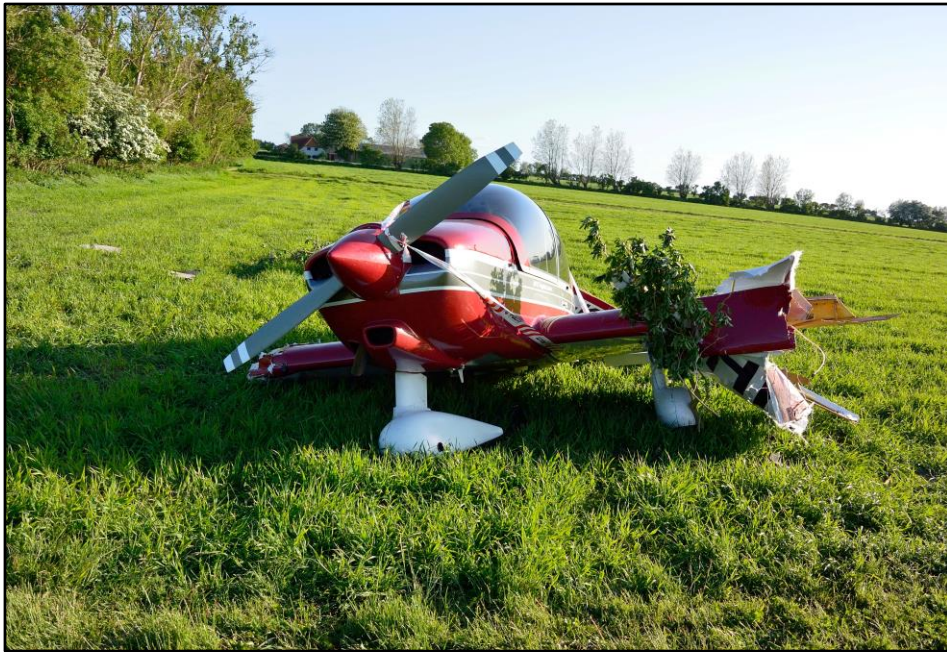
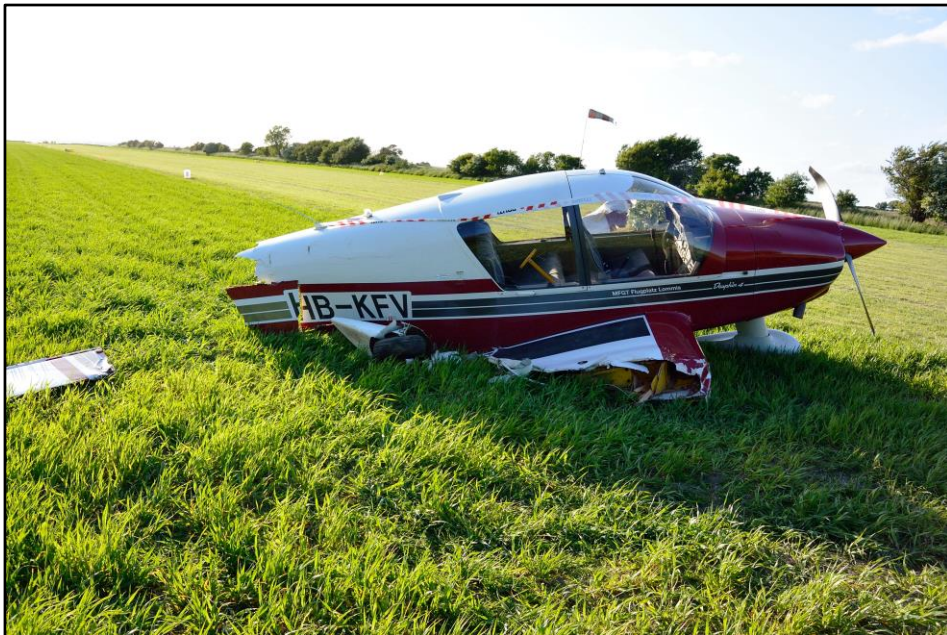
As a consequence of impacting with the windbreak trees along the runway side and a parked runway roller, the aircraft wings and tail section separated from the aircraft fuselage.

The forward part of the aircraft fuselage (cockpit) did not impact with the windbreak trees and the runway roller and remained intact.

The flaps at impact were in landing position (2<sup>nd</sup> notch).

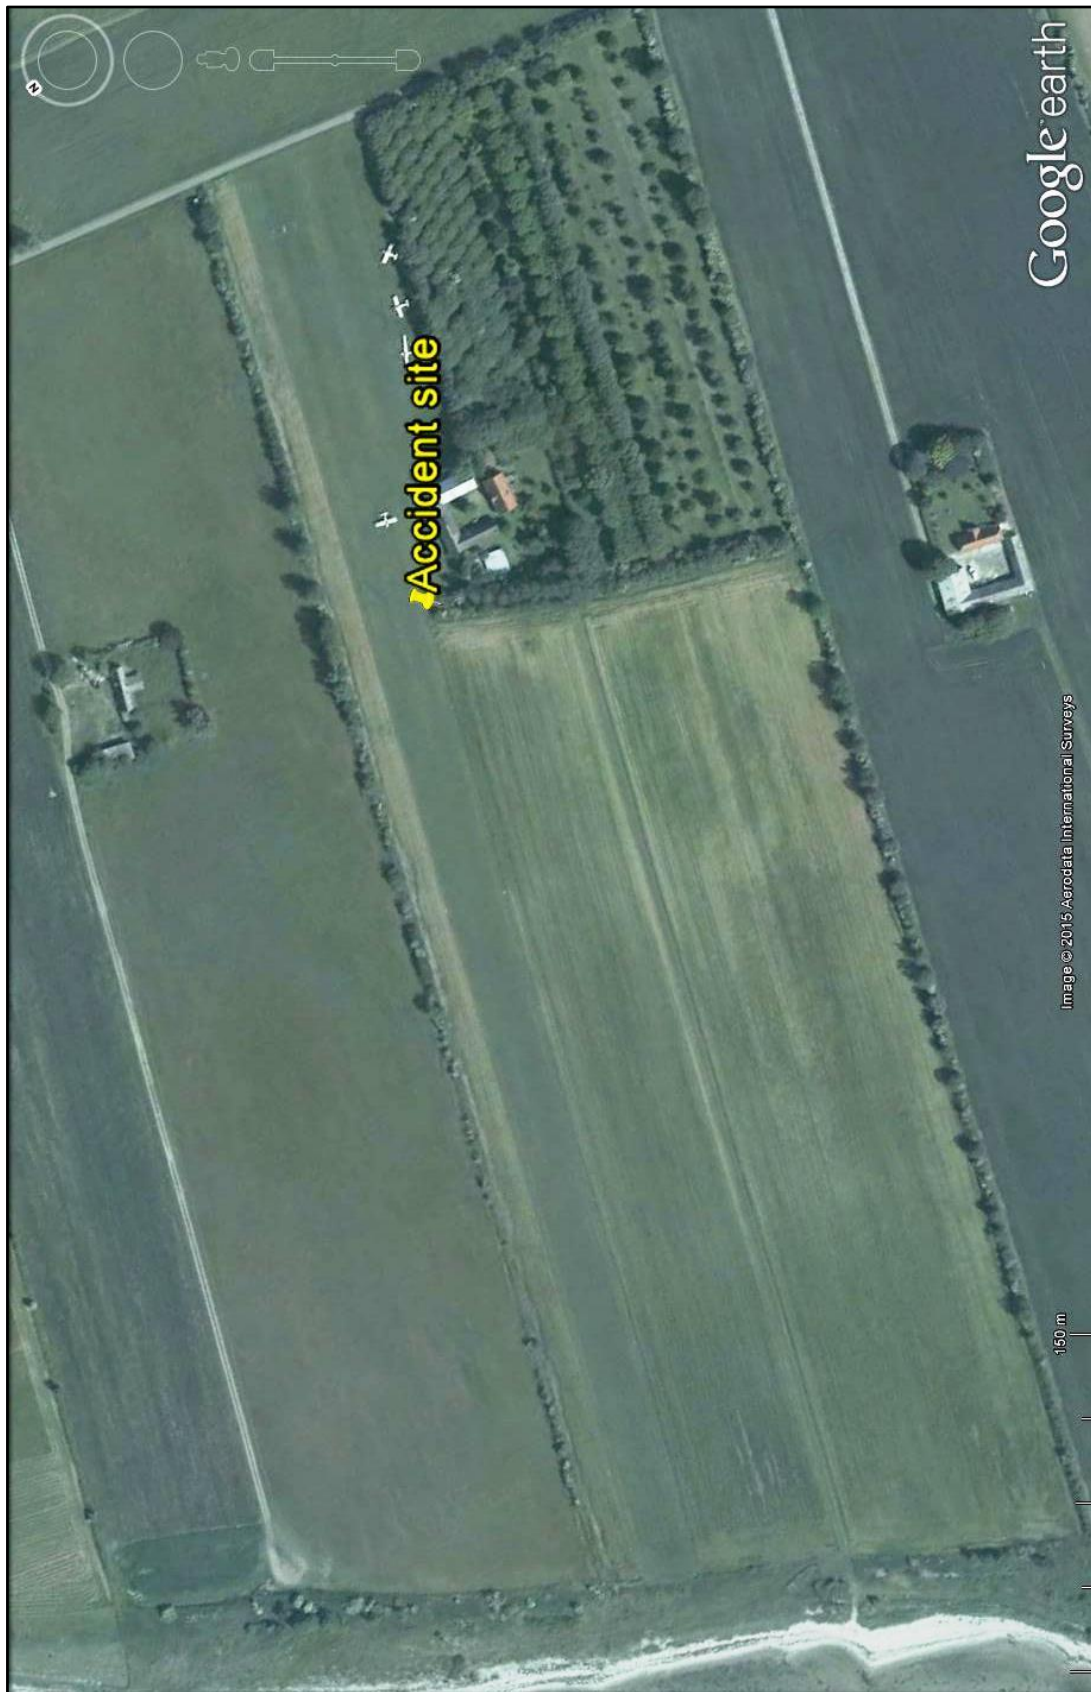
### 5.3 Accident site

The aircraft touched down 62 meters west of the threshold to runway 29 and got airborne. The aircraft flew approximately 55 meters before the second touchdown.

Upon the second touchdown, main wheel brake marks (approximately 4 meters) were observed.
