FINAL REPORT

510-000323	Incident		
Aircraft:	Boeing 757-200	A/C registration:	TF-FIR
Engines:	2 Rolls-Royce RB211-535	Type of Flight:	Scheduled, IFR
Crew:	8 – no injuries	Passengers:	144 – no injuries
Place:	Denmark N56°30,7 E010°07,7	Date and time:	11.01.2007 at 1642 hrs. UTC

Synopsis

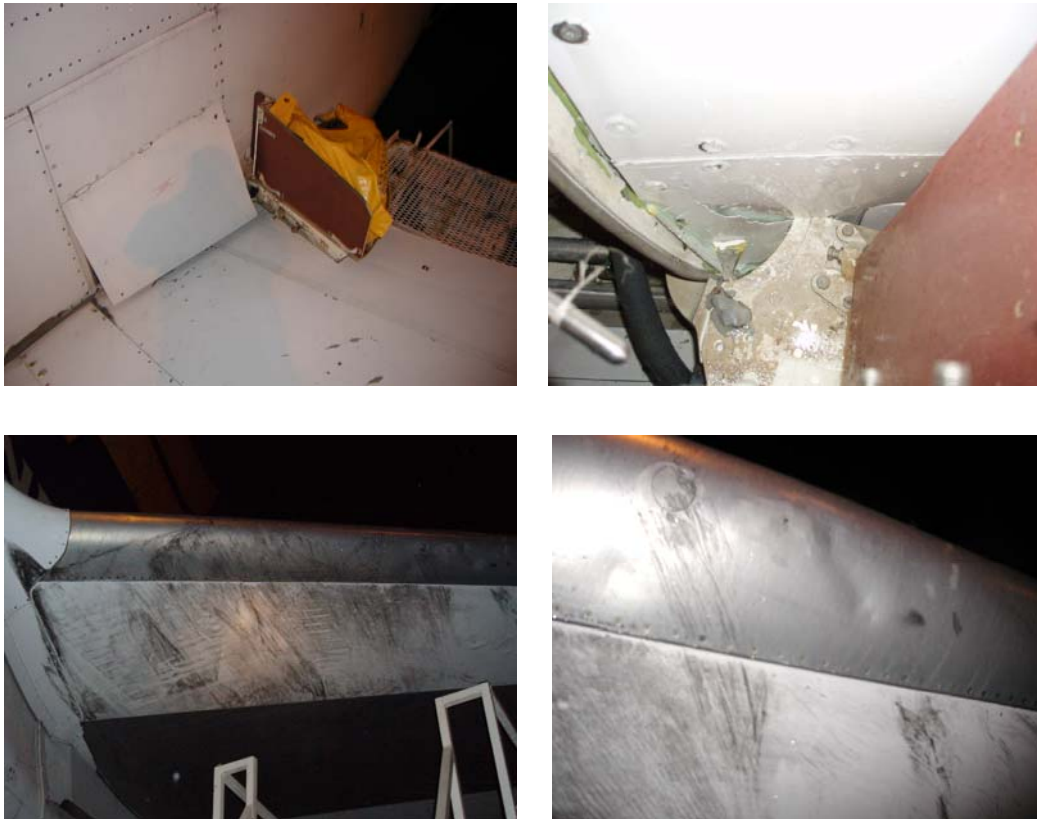
The structure around the off-wing escape slide compartment and the left stabilizer was substantially damaged.

The stabilizer had several impact marks on the leading edge. Also the white collared panel aft of the leading edge had several impact marks.

When the slide carrier deployed the slide carrier restraining hook was not able to resist the air stream forces. It broke up and caused the slide carrier to over-rotate. The aft outboard corner of the slide compartment structure was substantially damaged by the over-rotated slide carrier.

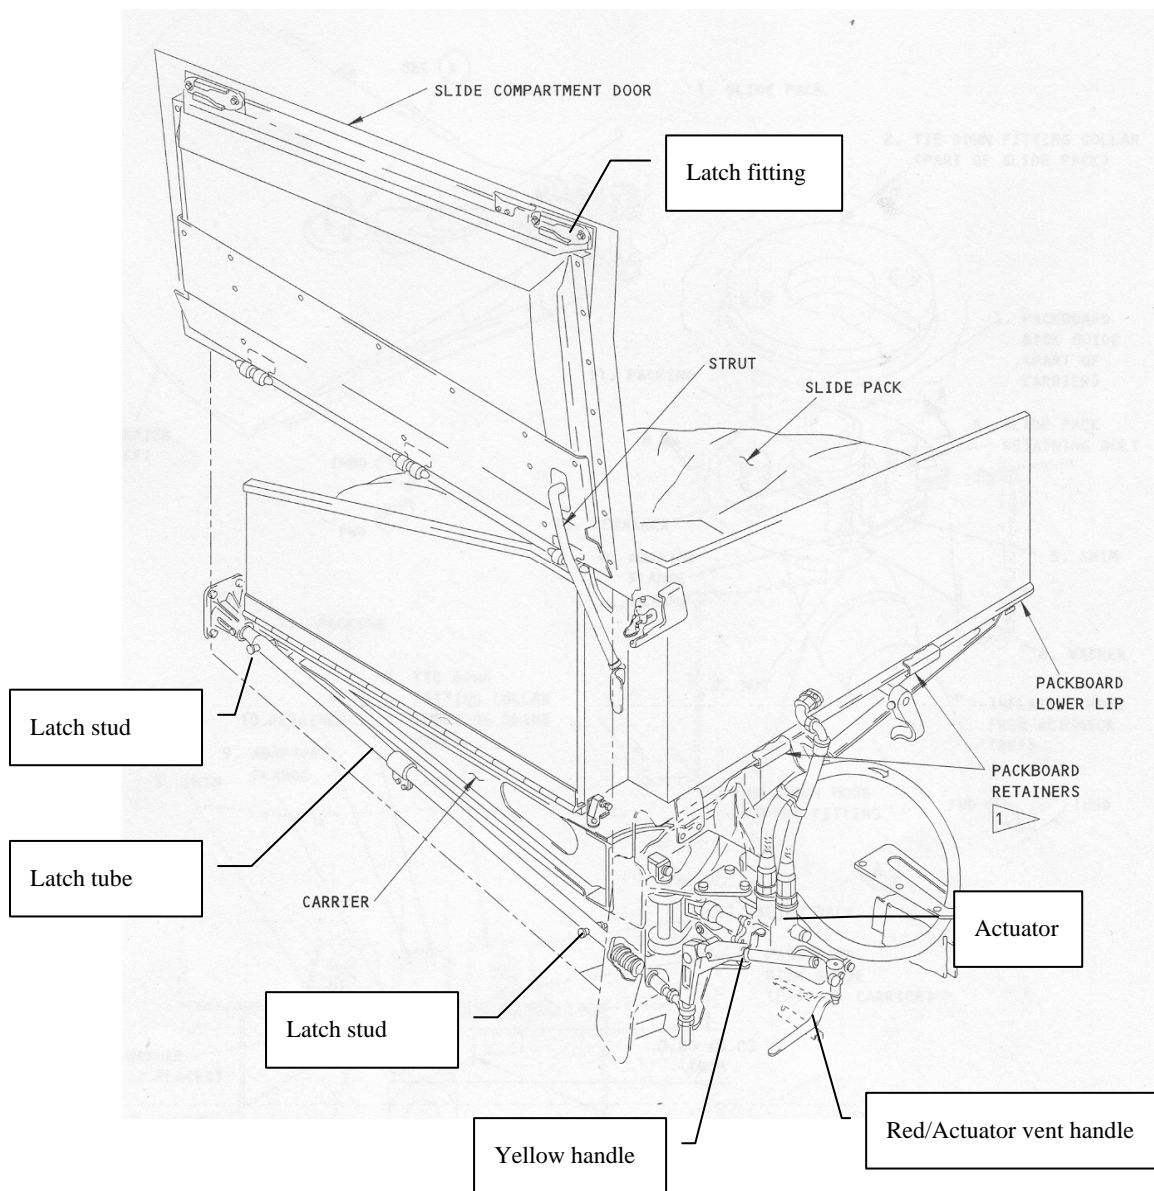
The slide carrier lock mechanism was intact and it was possible to lock the carrier into the carrier lock assembly operating the yellow/round crank handle.

The carrier lock fitting had scratch marks on its outer portion. Operating the yellow/round crank handle without pushing hard inwards on the carrier, allowed the carrier lock pin to scratch the outer portion of the carrier lock fitting. The right hand side carrier lock fitting was also examined and the same type of scratch marks was found. It was not possible to lock the carrier without pushing the slide compartment door hard inwards.

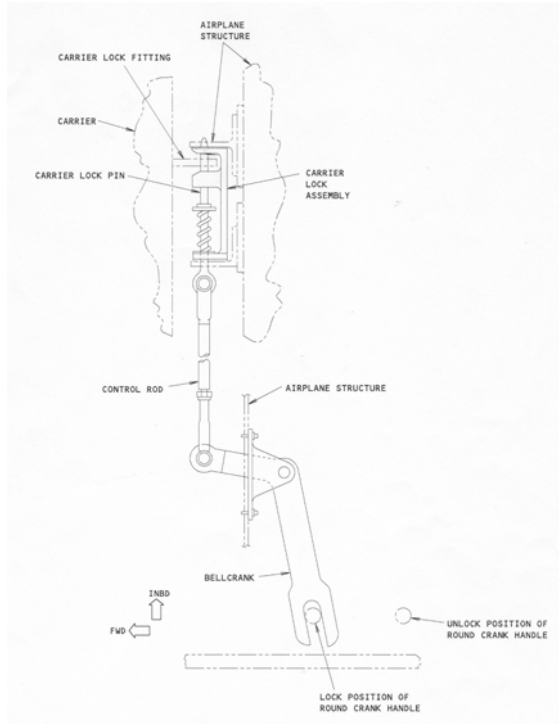
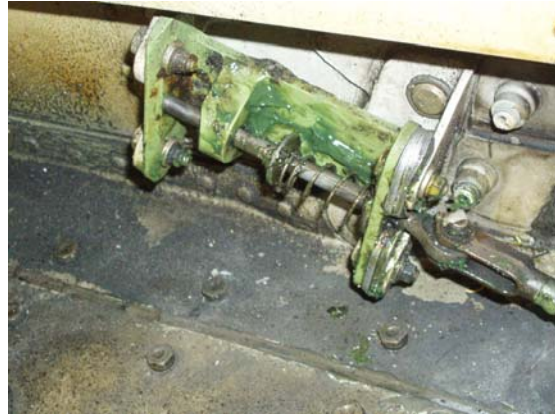
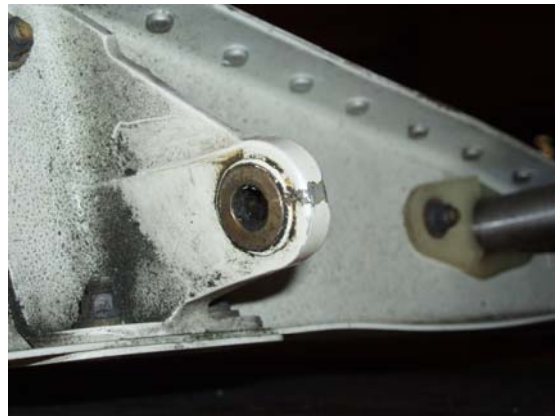
Investigators opened and closed the slide system several times according to the procedure described in the Boeing Aircraft Maintenance Manual (AMM) 25-65-09. The system functioned normally and the carrier and compartment door was found satisfactorily locked at all attempts.

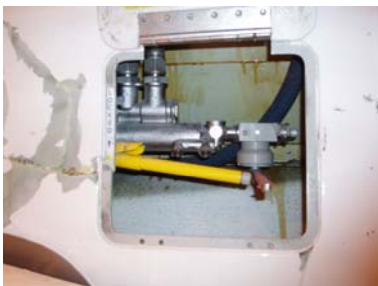
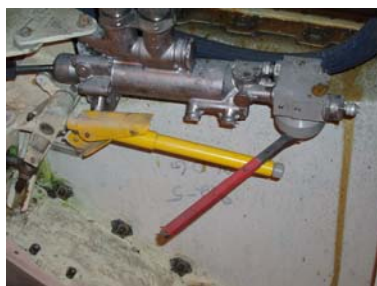
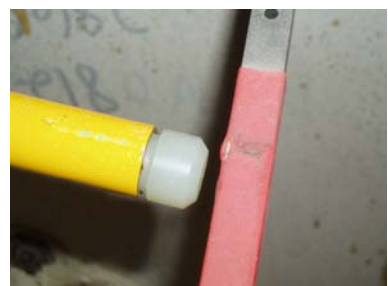
The down and locked position of the yellow/round crank handle in relation to the red/actuator vent handle was found inappropriate.

The red/actuator vent handle was turned 90 degrees outboard to the manual position to disarm the inflation system. It was necessary to raise the yellow/round crank handle to give the red/actuator vent handle space enough to be operated inwards.

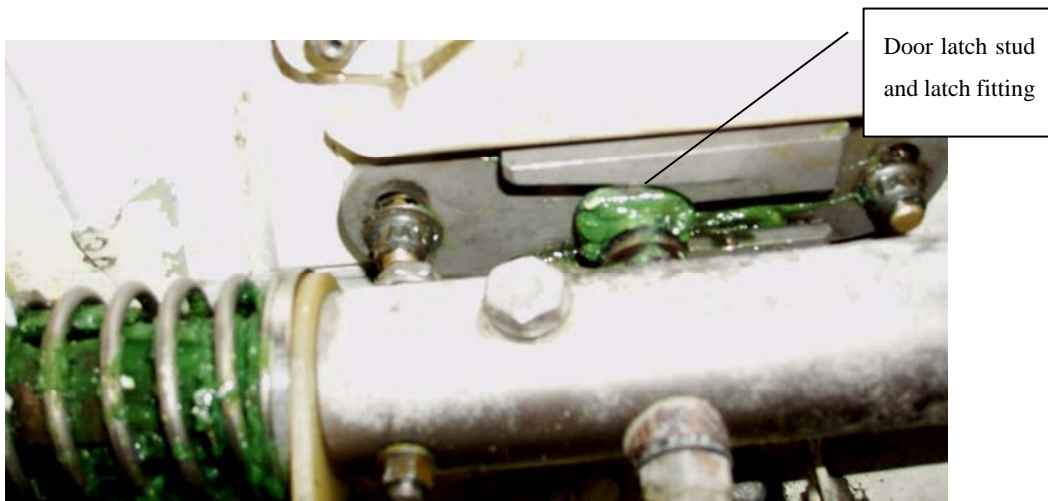
During this process, the investigators once observed, that the latch studs were not engaged properly in the latch fitting slots. The door was closed and the EICAS light “L Wing Slide” was out, indicating that the door was closed. The door was flush with the fuselage of the aircraft.

With the door in a closed position, it appeared visually to be locked, but the door was not properly locked. The picture below was taken from the main gear wheel well showing the above mentioned lock situation.

When the slide carrier was in place and the compartment door was closed it was physically and visually impossible to verify that the carrier lock pins were fully engaged and the latch studs were fully engaged in the latch fittings. It was only possible by using a borescope from the landing gear wheel well.

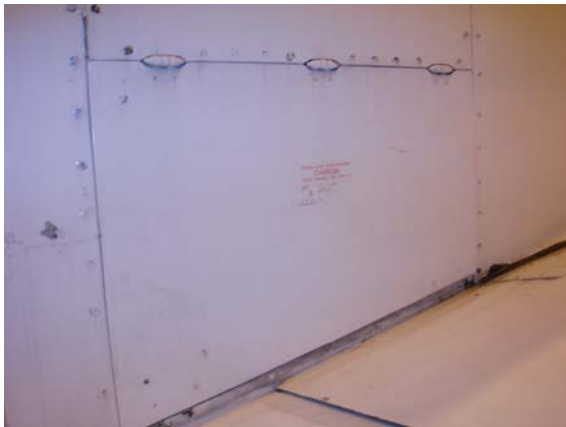
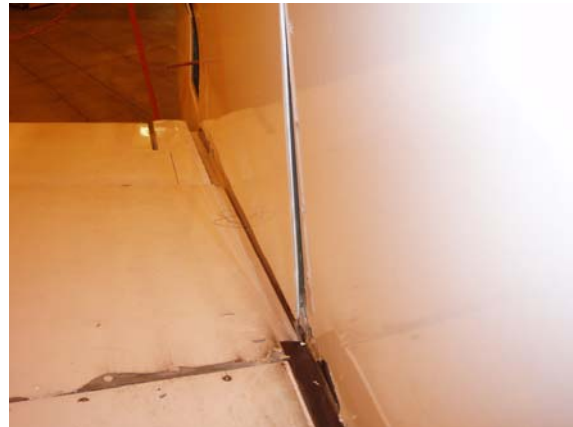
The investigators concluded that it was difficult to operate the yellow/round crank handle with one hand and pushing hard inwards on the compartment door with the other hand, particularly when the wing flap was down.

The door was not flush with the fuselage at the lower forward side.
