United Arab Emirates General Civil Aviation Authority Accident Final Report

(Accident Report N° 04/2010)
(Issued on 03/08/2010)

Hot Air Balloon Accident Cameron Z-425-LW A6-JBR Al Ain, UAE 25 April 2010

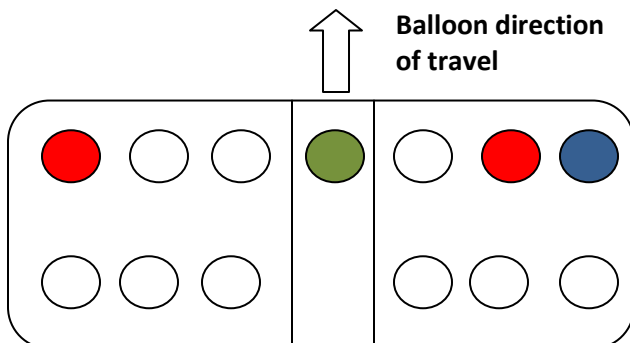
Passenger Injury Location Map:

RED - Fatal
BLUE - Serious Injury
GREEN - Pilot position

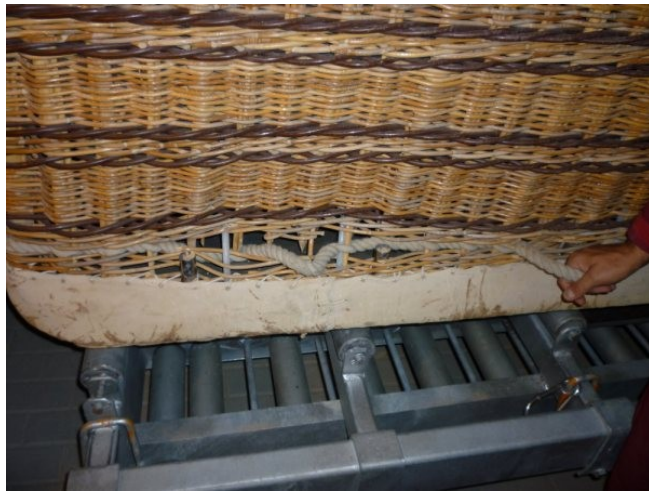
Balloon Basket Impact Damage

Damage on the lower right hand corner consistent with impact damage, probably contact with a tree on the descent, following RDS activation, prior to the hard landing

The upper left hand corner has tension/torsion induced damage, with multiple tension failures to the nylon webbing connected to the internal steel frame: all of the damage recorded is consistent with a severe hard landing.

The primary structure stainless steel load bearing frame was intact with no obvious damage following a detailed visual inspection.

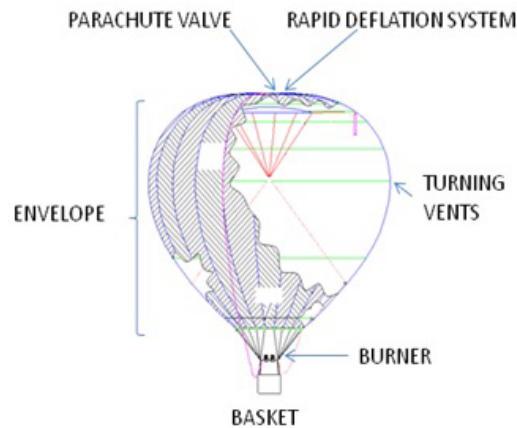
Balloon Rapid Deflation System (RDS) Information

The Rapid Deflation System (RDS) is a pilot actuated system which opens a section at the top of the balloon to vent the captured hot gases to atmosphere.

In the Cameron balloon design, the RDS is actuated by a rope in from the pilot's position via a pulley system to the RDS at the top of the balloon envelope.

The Cameron balloon uses a pulley system in the rope architecture which is prone to sand accumulation in the moving parts if not serviced regularly in desert conditions. This sand accumulation was recognised by the operator as factor in the Cameron balloon design for desert operations; the operator adopting a specific maintenance procedure for the pulley system.

The pilot of the accident balloon stated that Cameroon balloon RDS was slower to release envelope gas compared with other types of RDS design which use a simplified, non pulley actuation system

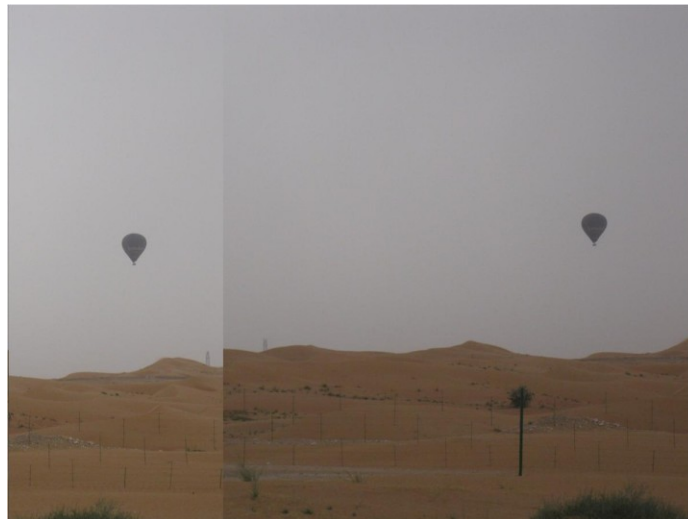
Composite photo A6-JBR Approach

These two time lapsed photos taken of the balloon on the approach to the landing site do not indicate any:

- (i) Abnormal envelope function
- (ii) Additional safety hazards such as envelope deformation, an onboard fire or structural anomalies or any other hazards to the conduct of safe flight

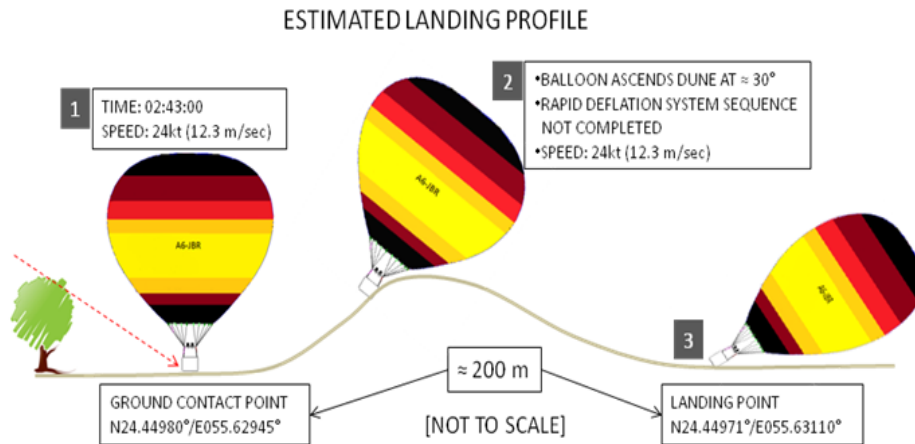
Phase 1: Approach and initial landing position.

Phase 2: Transition of the balloon over the sand dune

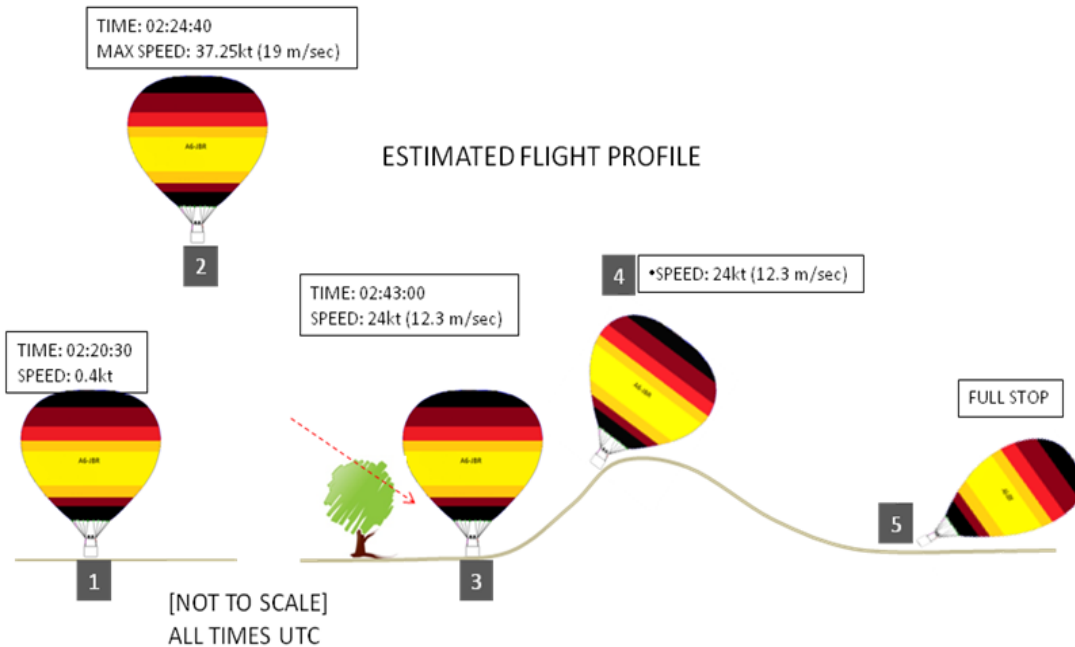
BALLOON FLIGHT PHASES

Note on accident phases #3,#4,#5:

#3: Unstable approach followed by a hard landing
