AIR ACCIDENT INVESTIGATION SECTOR

SERIOUS INCIDENT INVESTIGATION REPORT

LANDING WITHOUT GEAR EXTENSION

Diamond DA-42
A6-FTZ
Horizon International Flight Academy
Al Ain International Airport
United Arab Emirates
23rd February 2010

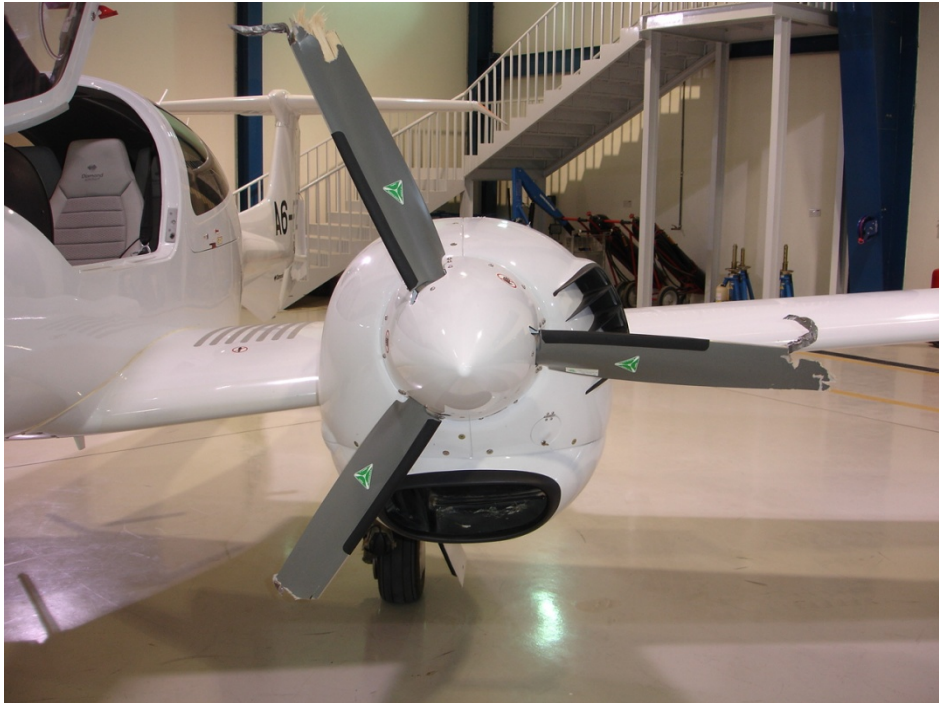
- Damaged left engine propeller blades (see Figure A1-1) :
 - o All blades fractured, from the original 78 cm length, the remaining length of the blades were respectively : 60, 51 and 53 cm

Figure A1-1 : Damaged Left Hand Engine Propeller Blades

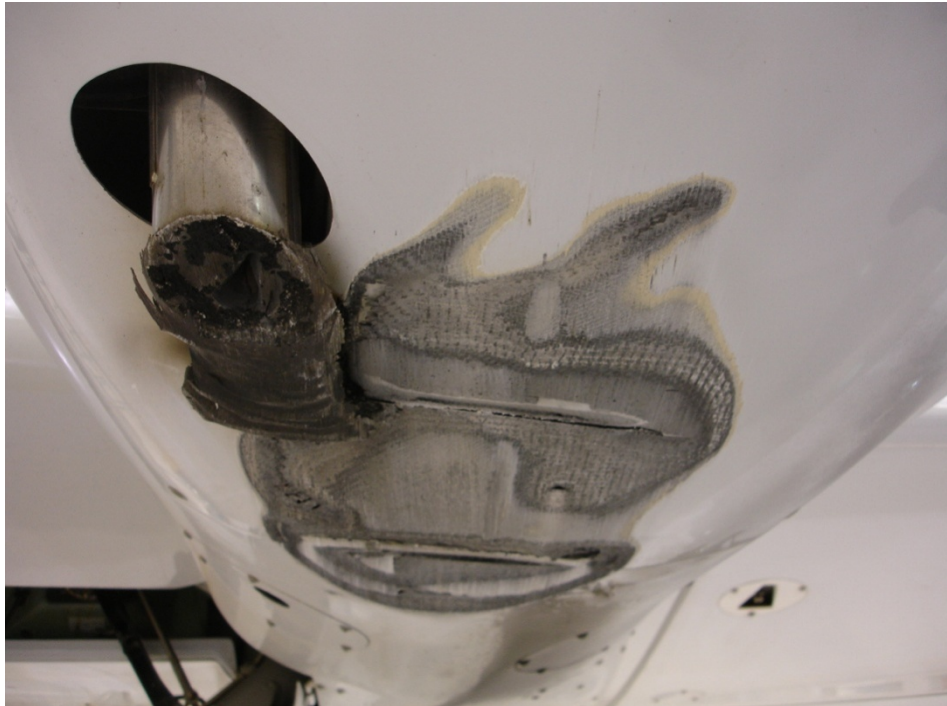
- Worn out damage on the exhaust tube of the left hand engine (see Figure A1-2)
- Worn out damage on the left hand foot step (see Figure A1-3). The remaining part was 29 cm of the original 36 cm. Fatigue marks and twisting were found on the footstep attachment on the aircraft skin (see Figure A1-4)

Figure A1-2 : Damaged Left Hand Exhaust Tube and Bottom Engine Cowling

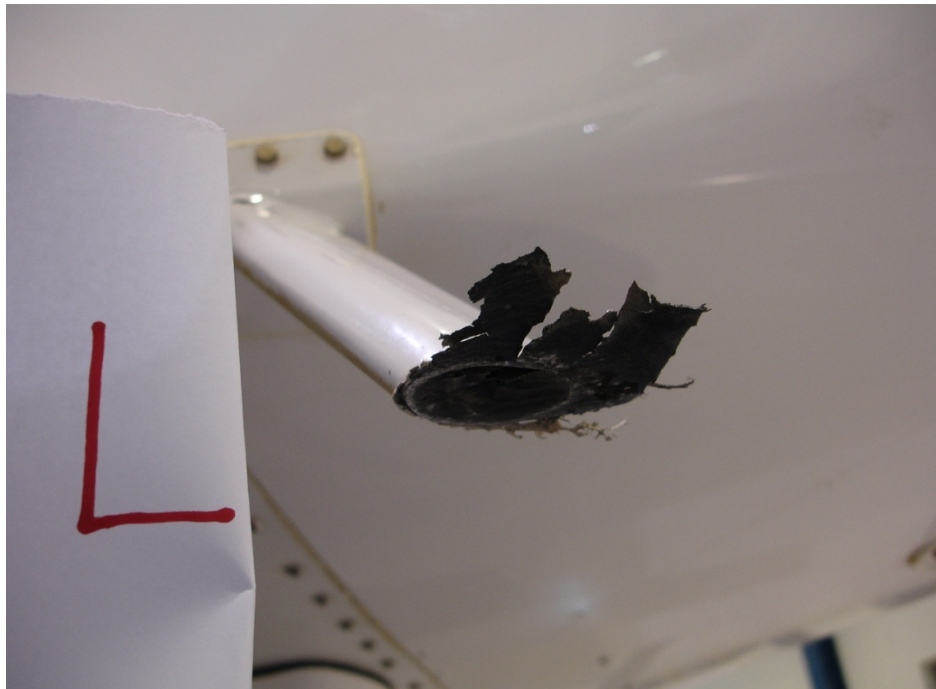
Figure A1-3 : Worn-out Damaged Left Hand Foot Step

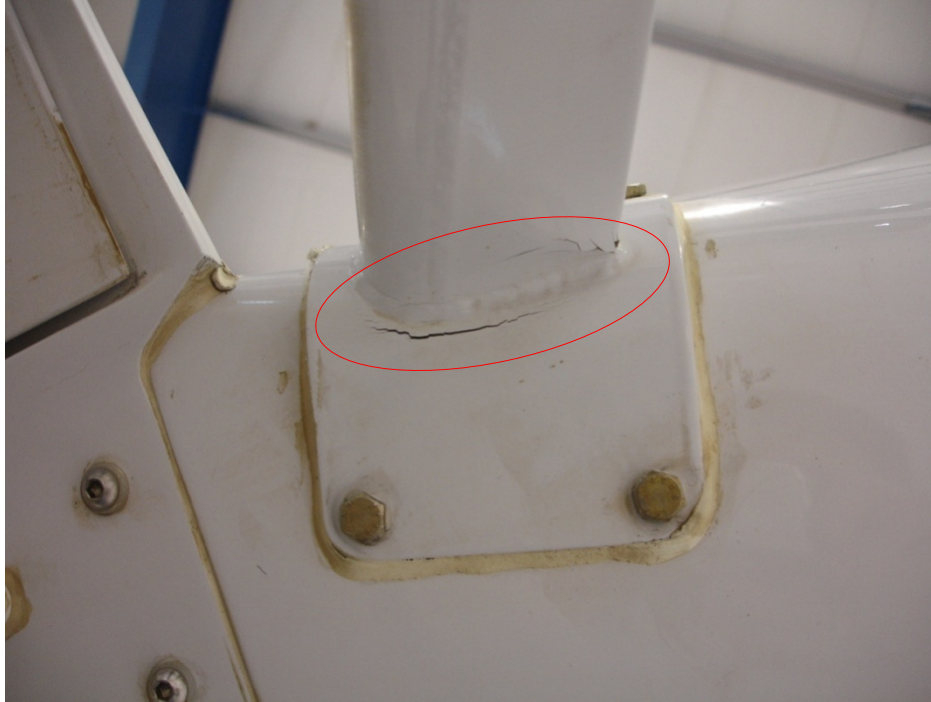
Figure A1-4 : Fatigue Damage on the Root of Left Hand Foot Step

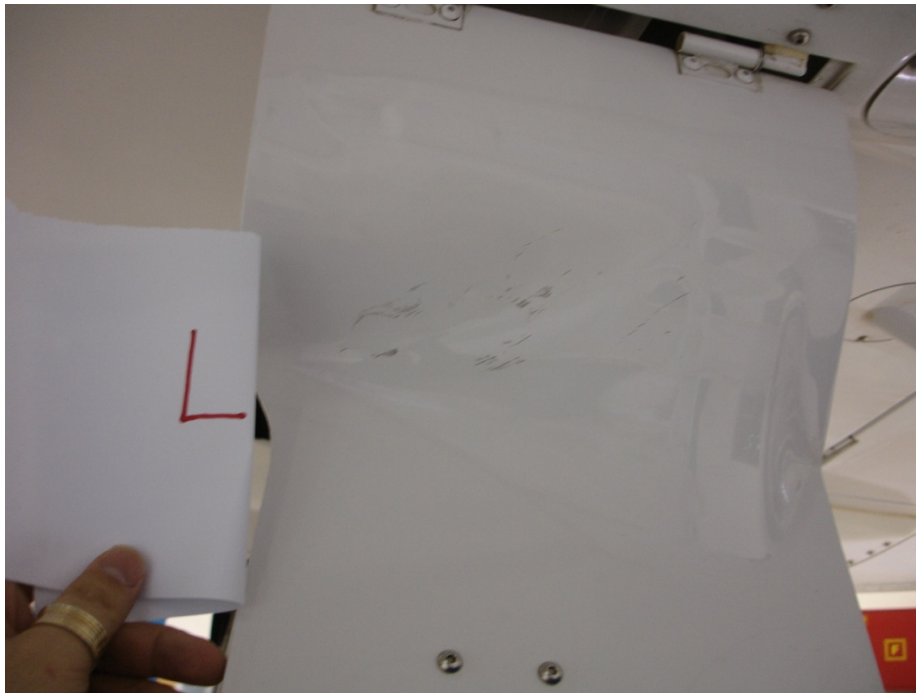
- Light scar mark on the left hand main landing gear door (see Figure A1-5)
- Damaged right engine propeller blades (see Figure A1-6), with the following details:

Figure A1-5 : Light Scar Mark on the Left Hand Main Landing Gear Door

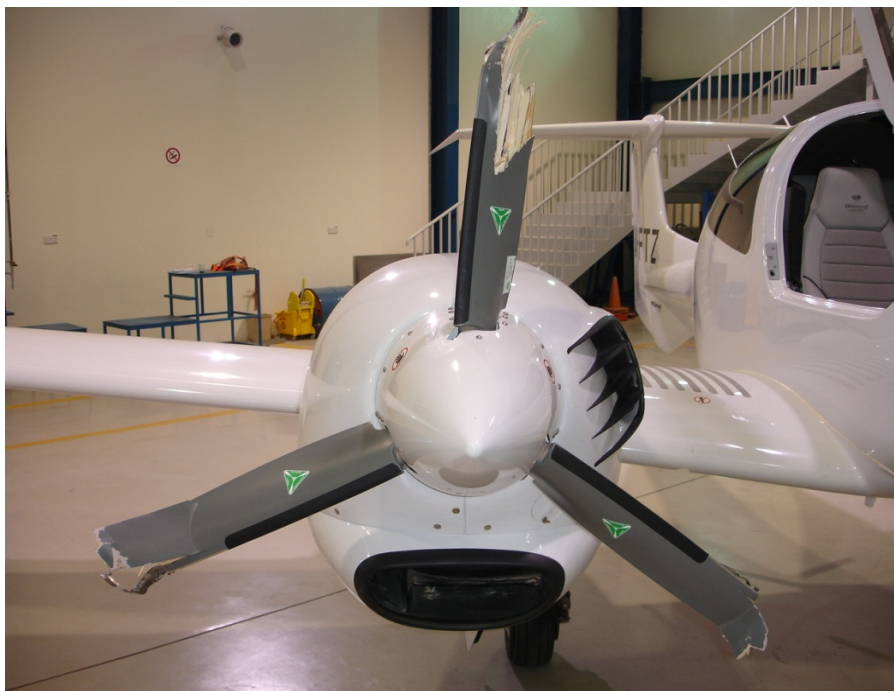
- o All blades were broken. From the original 78 cm length, the remaining length of the blades were respectively: 45, 47 & 50 cm
 - o All three propellers' rubber boots were still attached

Figure A1-6 : Damaged Right Hand Propeller Blades

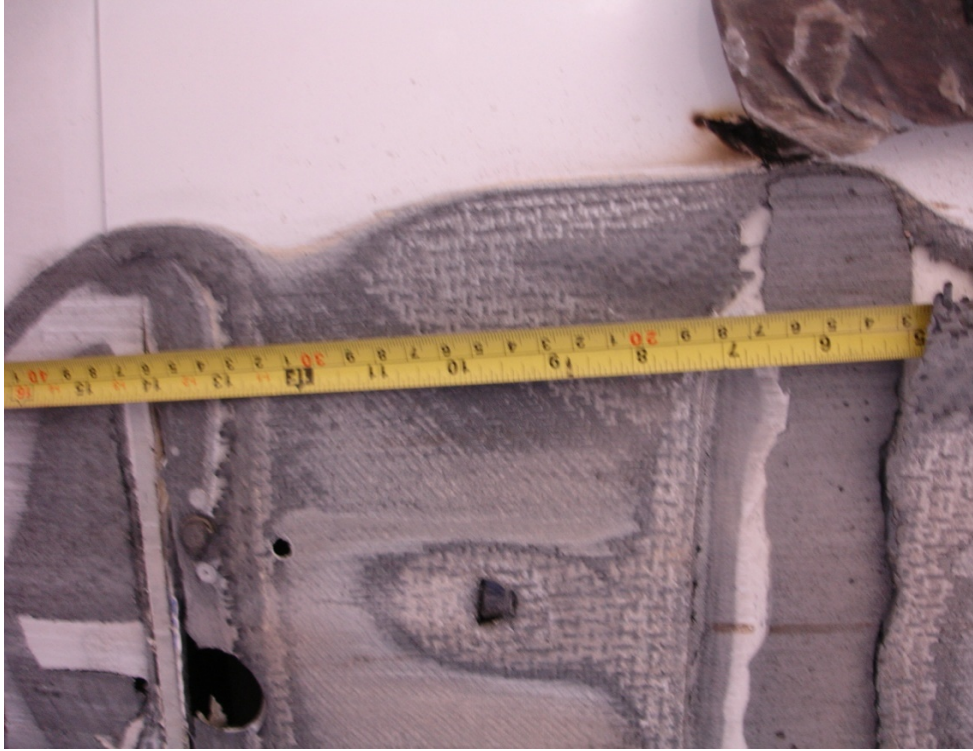
- Friction grit at the lower external surface of the right engine composite cowling (see Figure A1-7)
- Worn out damage on the right engine's exhaust tube. The exhaust had a flat cut of 15 cm long (see Figure A1-8a), 9 cm width (see Figure A1-8b), and the remaining tube length was 7 cm outside the engine casing (see Figure A1-8c).

Figure A1-7 : Damaged Right Hand Exhaust Tube and Bottom Engine Cowling

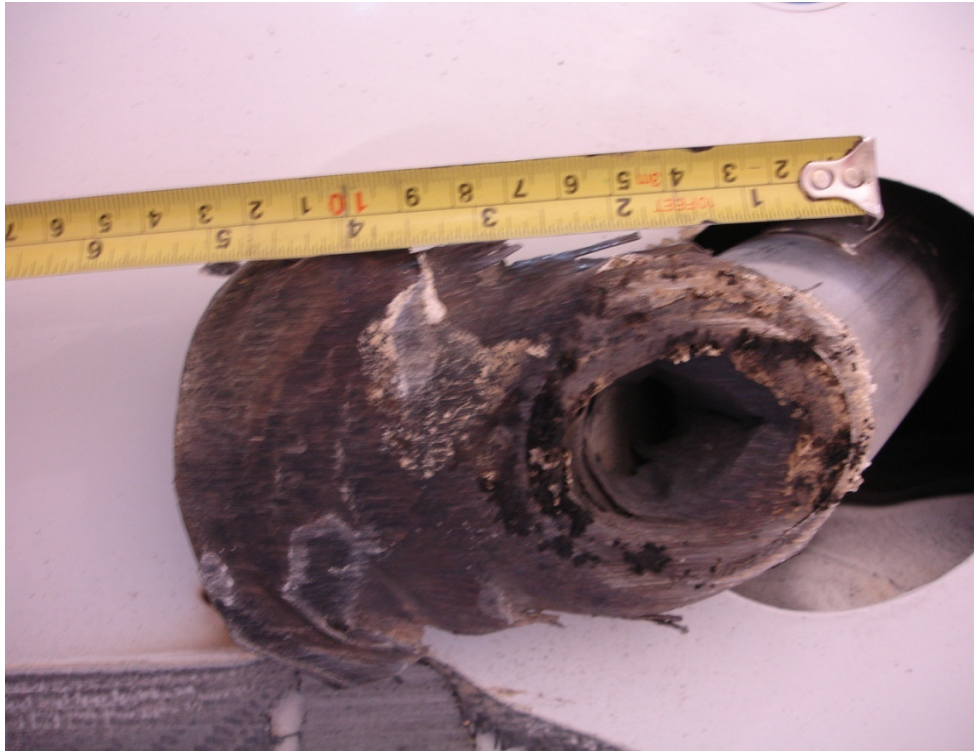
Figure A1-8a : Damaged Right Hand Exhaust Tube with a flat cut of 15 cm length

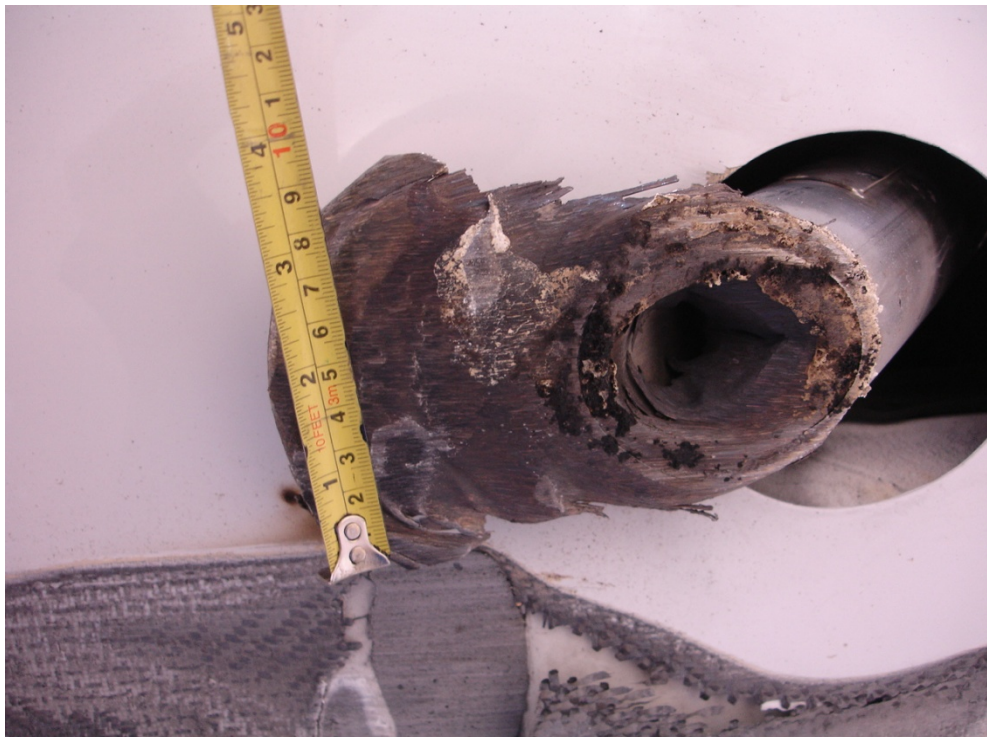
Figure A1-8b : Damaged Right Hand Exhaust Tube with a flat cut of 9 cm width

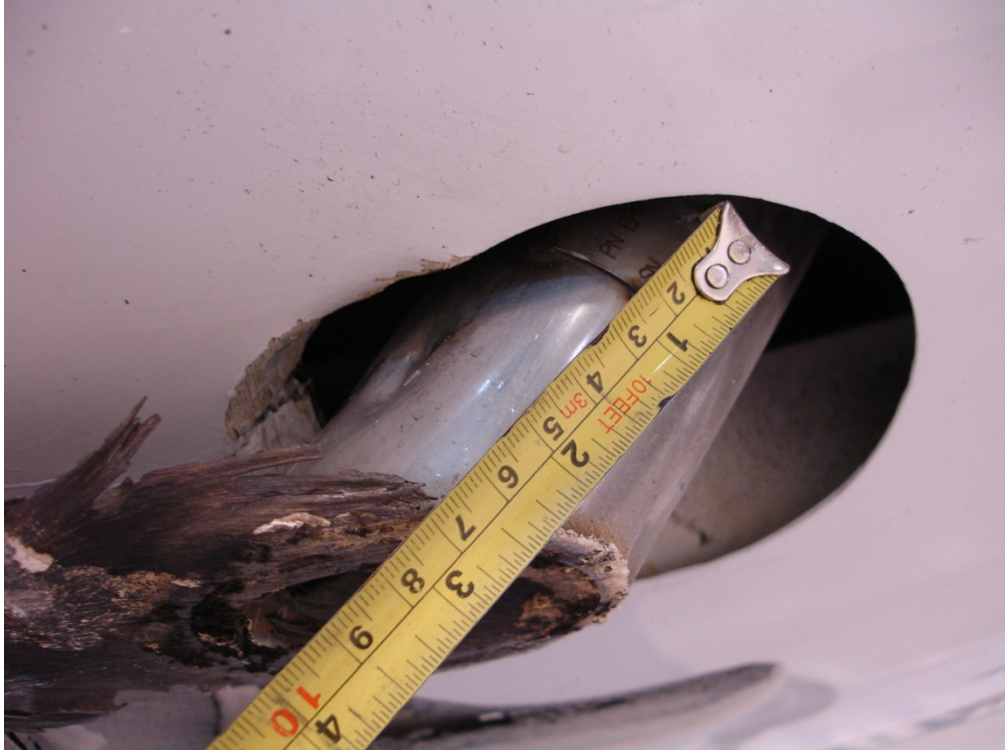
Figure A1-8c : Damaged Right Hand Exhaust Tube with remaining length of 7 cm outside the engine casing

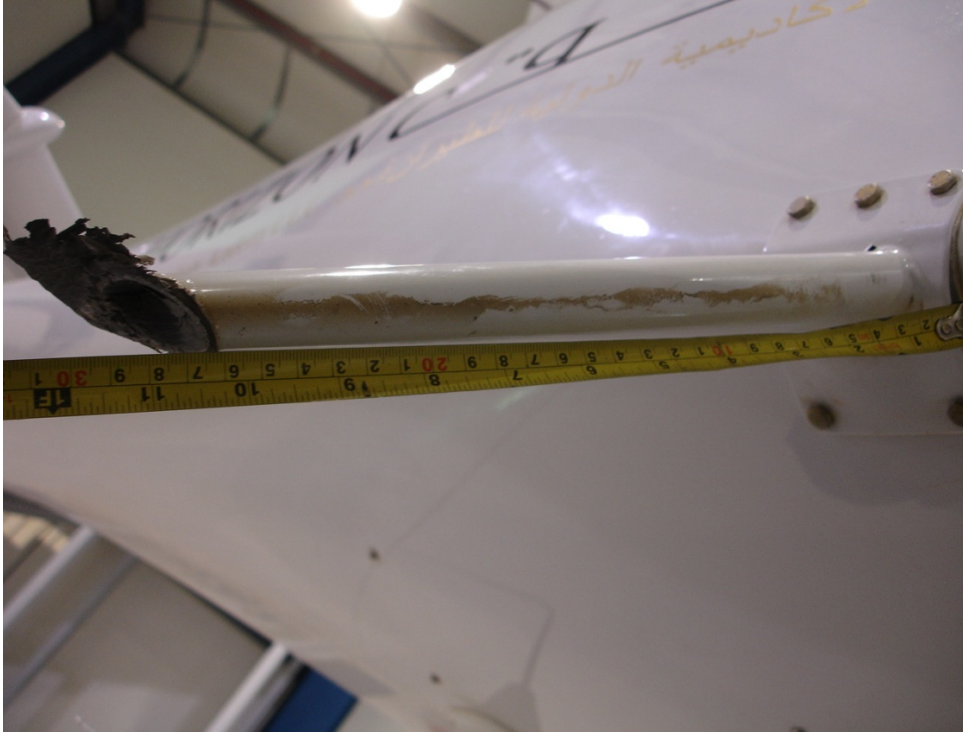
- Worn out damage on the right hand foot step, with a remaining part of 27 cm from the original 36 cm (see Figure A1-9), and sign of fatigue was found on the attachment with the aircraft skin.

Figure A1-9 : Worn-out Damage Right Hand Foot Step

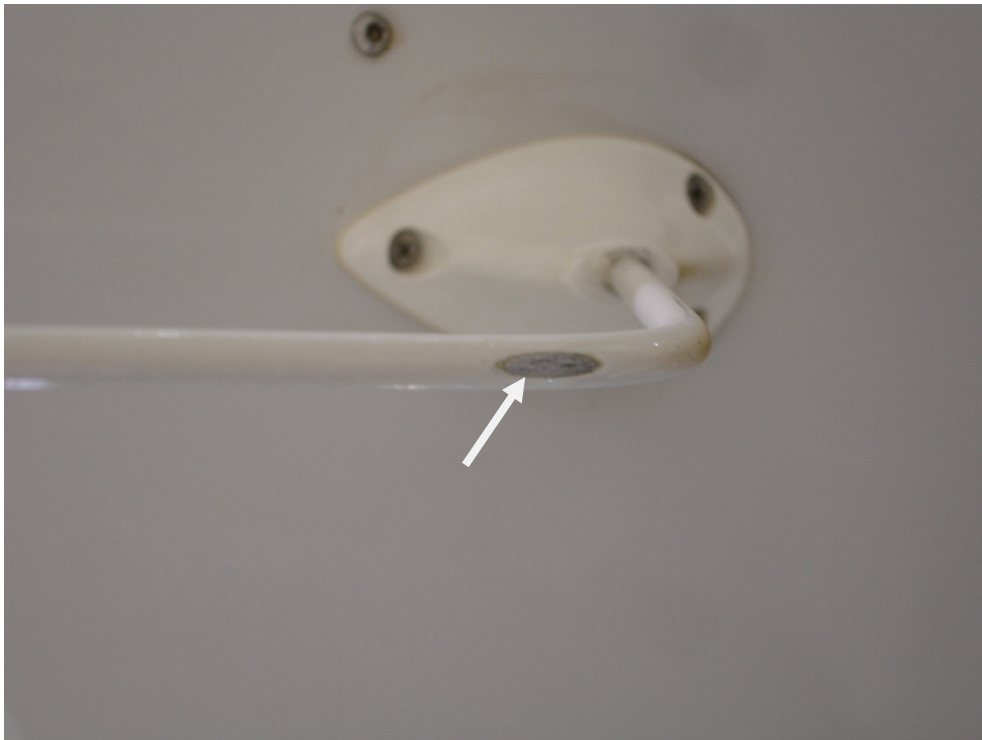
- No visible scar mark was found on the right hand main landing gear door.
- Lower central COM 2 Antenna had a light scar about 2 cm long (see Figure A1-10).

Figure A1-10 : Light Scar of Lower Central COM 2 Antenna

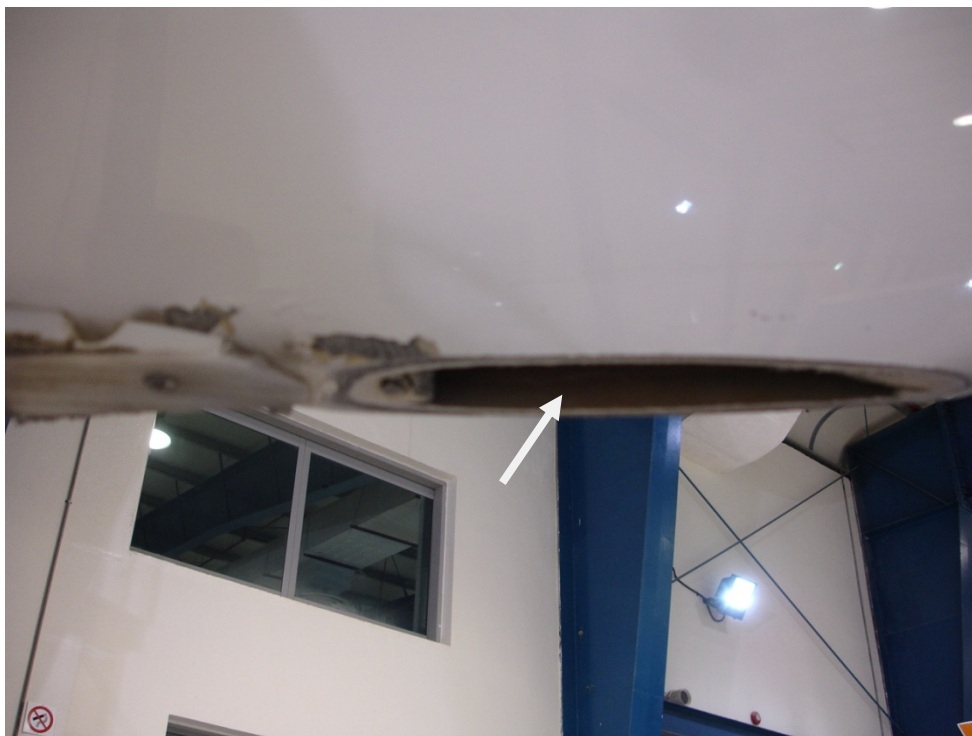
As illustrated by the photograph shown in Figure A1-11, the airplane's area that touched the runway was also in front of the tail skid, the plastic addition of the Aircraft which is there to protect it. Calculations indicate that the position of the tail skid will only protect the aircraft when the landing gear is extended. But in this event the landing gear wasn't extended and the aircraft was damaged behind the skid. In case the skid was extended further towards the fin, have a better protection might be availed.

Figure A1-11 : Destruction/Grit of Lower Part of The Fin

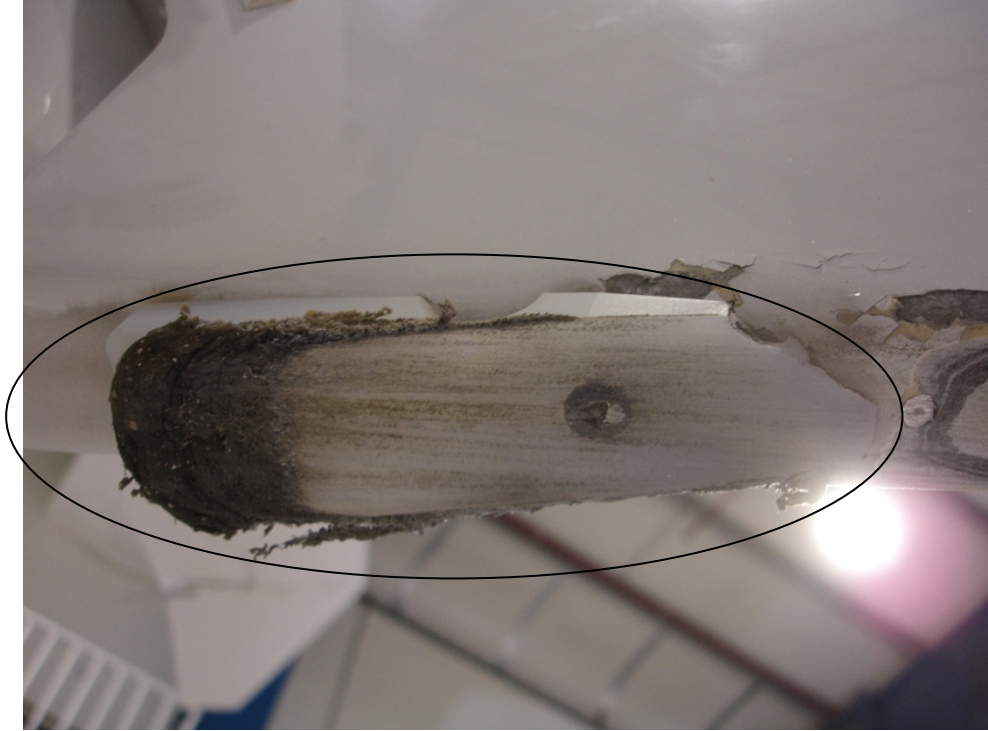
Figure A1-12 : Tail Skid Destruction

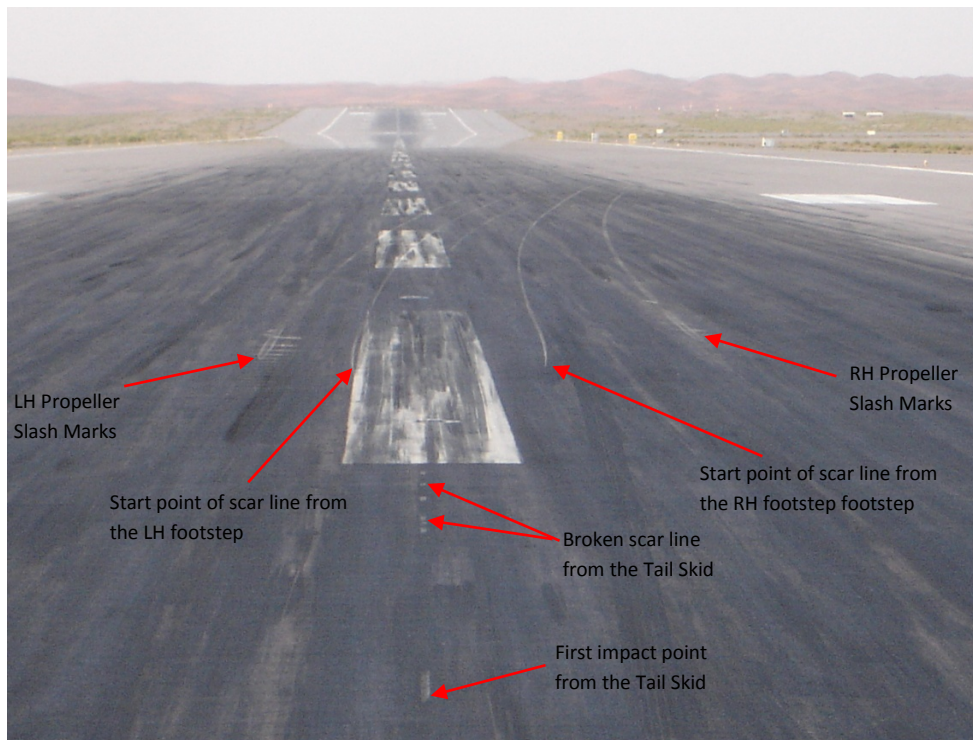
Figure A1-13

- The first impact point on the runway was from the Aircraft's tail skid, and the Aircraft floated for a while above the centre line which can be seen from the distance of the broken scars line after the first impact point as shown in Figure A1-13.

First Impact Points and scars lines on the runway

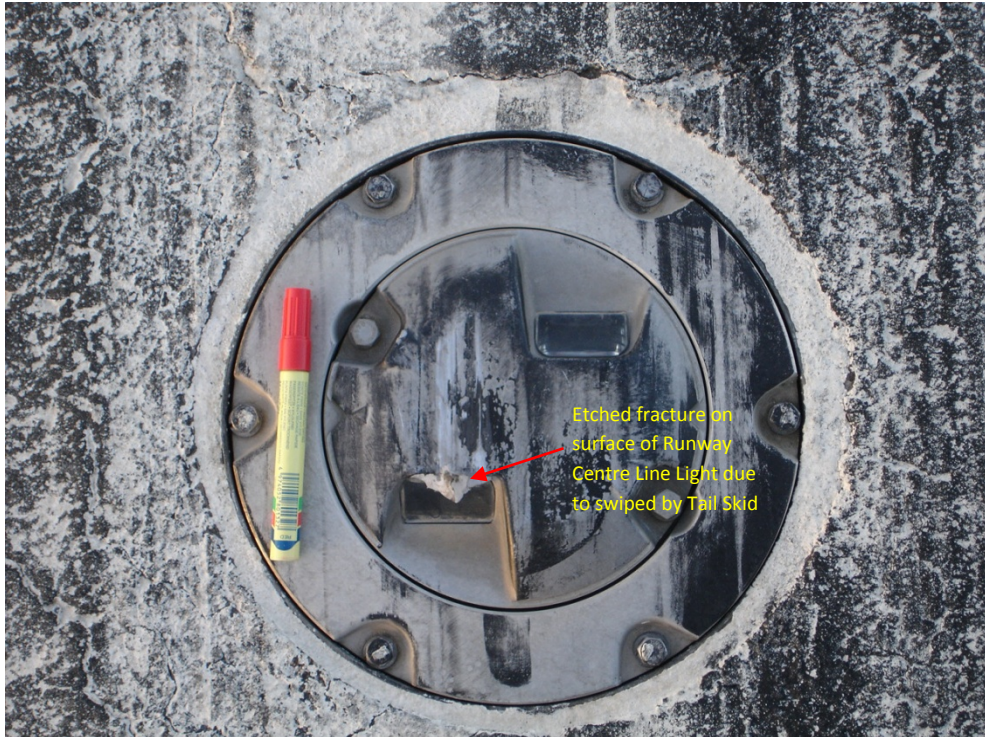
Figure A1-14

- Smears/scars on the runway surface were found where the Aircraft contacted the runway from the first point of contact until it came to complete stop (see Figure A1-13 up to A1-19, A1-23, and A1-24)
- One runway centerline light was scared on the surface having residual debris from the aircraft tail skid (see Figure A1-14).

Fracture and Scar Line on the Runway Centre Line Light

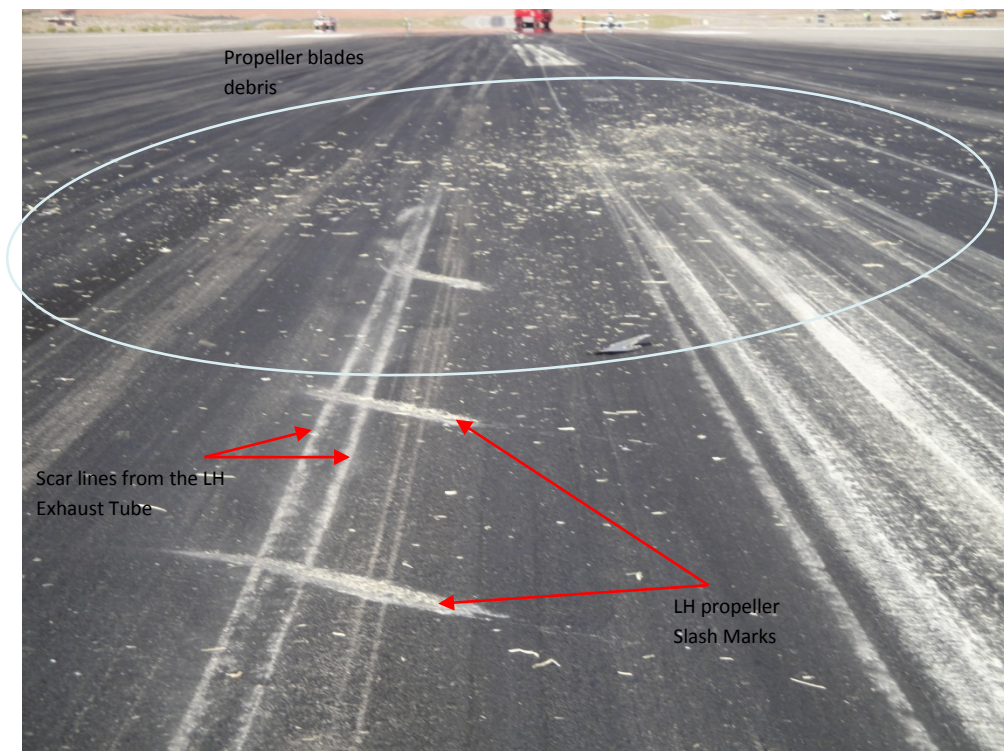
Figure A1-15

Scars lines on the Runway from the Left Side Parts of the Aircraft and Debris of the propeller blades

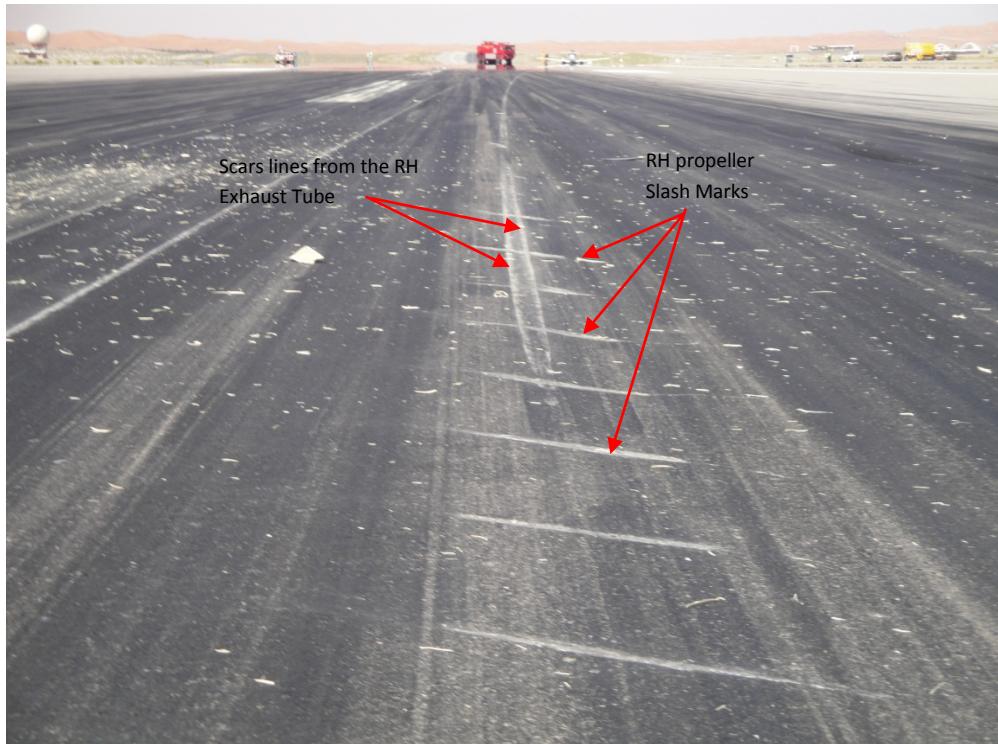
Figure A1-16

Scars on the Runway from the Right Side Parts of the Aircraft

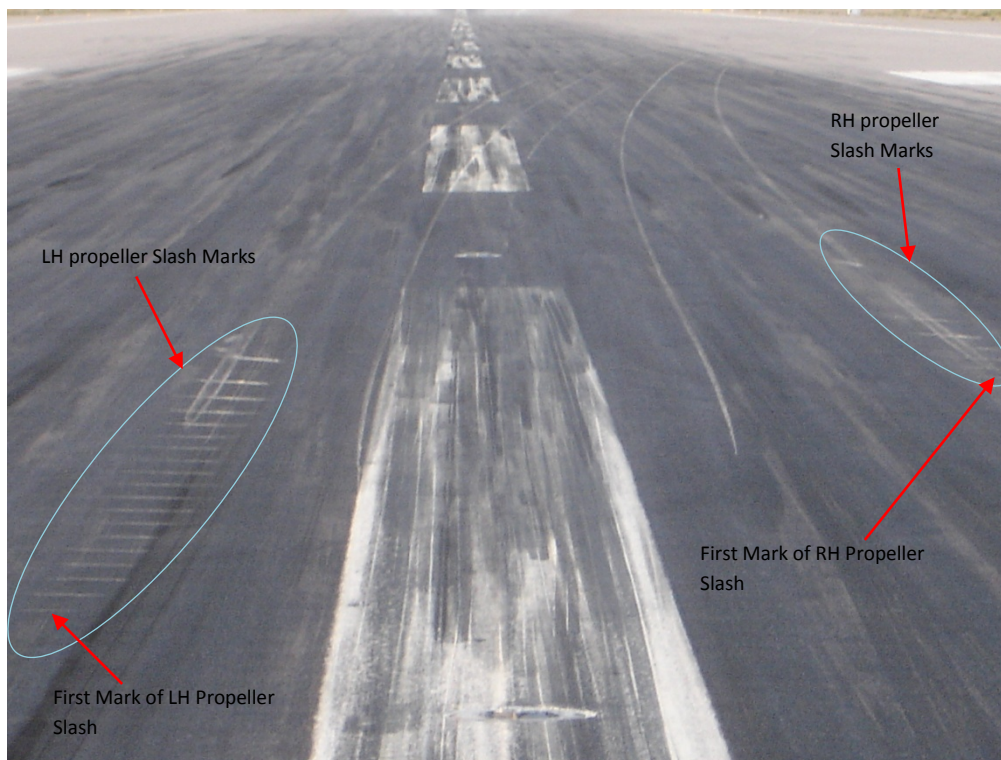
Figure A1-17

- Then, the LH propeller started touching the ground (see Figure A1-17) leaving slashes and damaged the blades' tips,
- Thereafter, the LH footstep and almost in the same time the RH footstep touched the ground. Then, while LH Propeller was still rotating and becoming shorter, after 15 consequent slashes, the LH exhaust tube started touching the ground (Figure A1-17).

Slashes from the Rotating Propellers

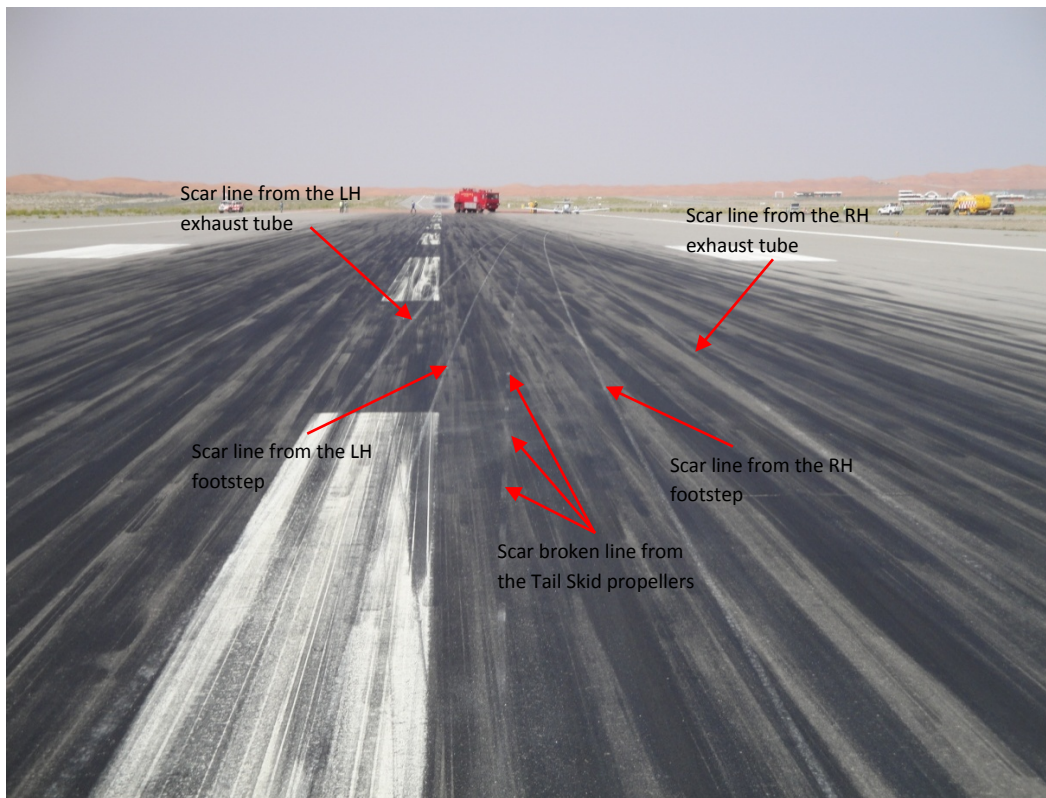
Figure A1-18

Scars lines on the Runway

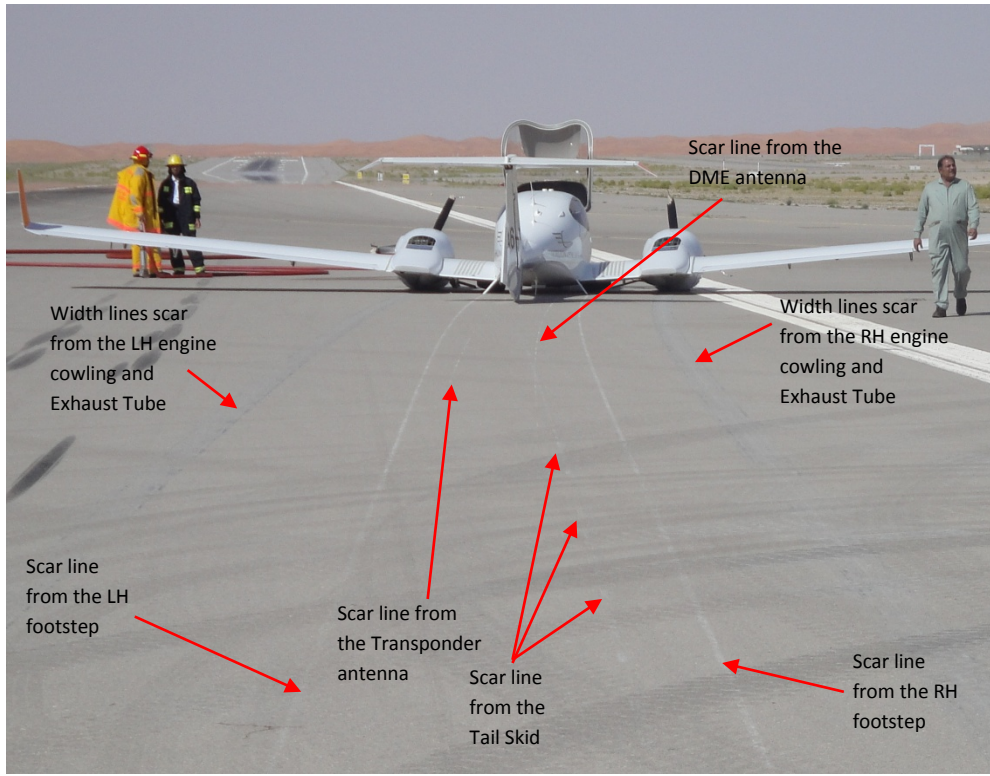
Figure A1-19

Scars lines on the Runway before the Aircraft stopped

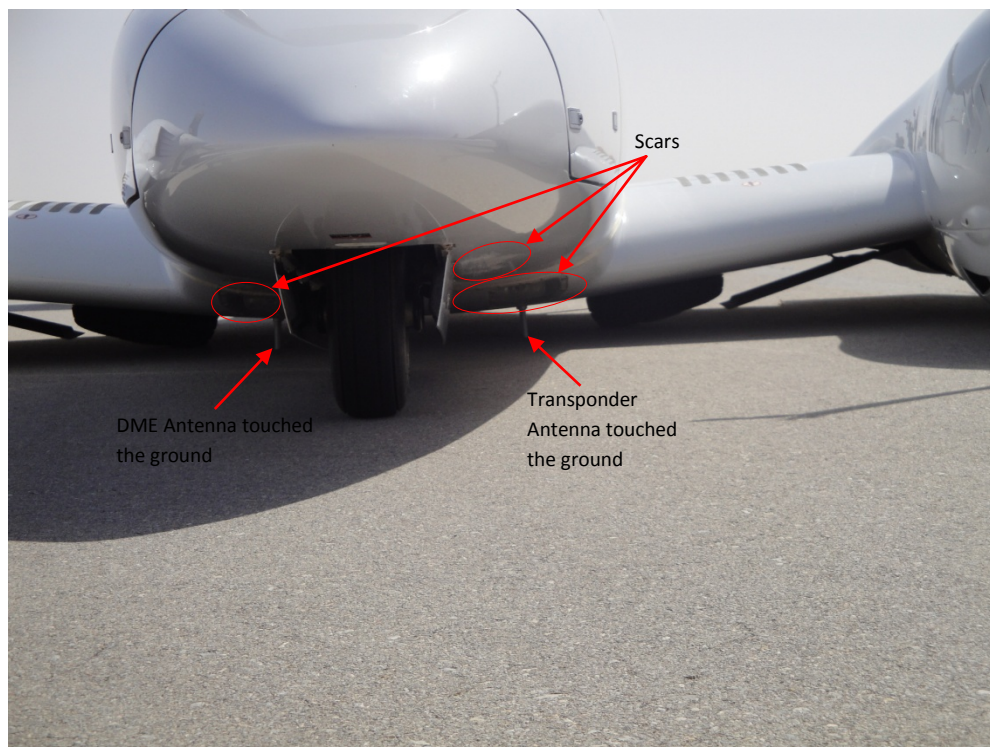
- Condition of the aircraft at full stop on the runway where the gears were in extended but not locked position as shown in Figure A1-20 and A1-21. Scars were found on the bottom surface of the front cockpit as shown in Figure A1-20;
- No obvious worn-out marks or scars were found on the sidewall of the RH main tire as shown in Figure A1-22;
- Marks on the runway came from the LH and RH main tires as shown in Figure A1-23 and A1-24. These curve scars lines from both main tires were formed when the Aircraft was lifting up. Because of the gravity forces of both main landing gears while the Aircraft was lifting up, both main tires suppressed the runway surface and leaved these tire marks behind.

Nose and Main Landing Gear condition when the aircraft at full stop on the runway

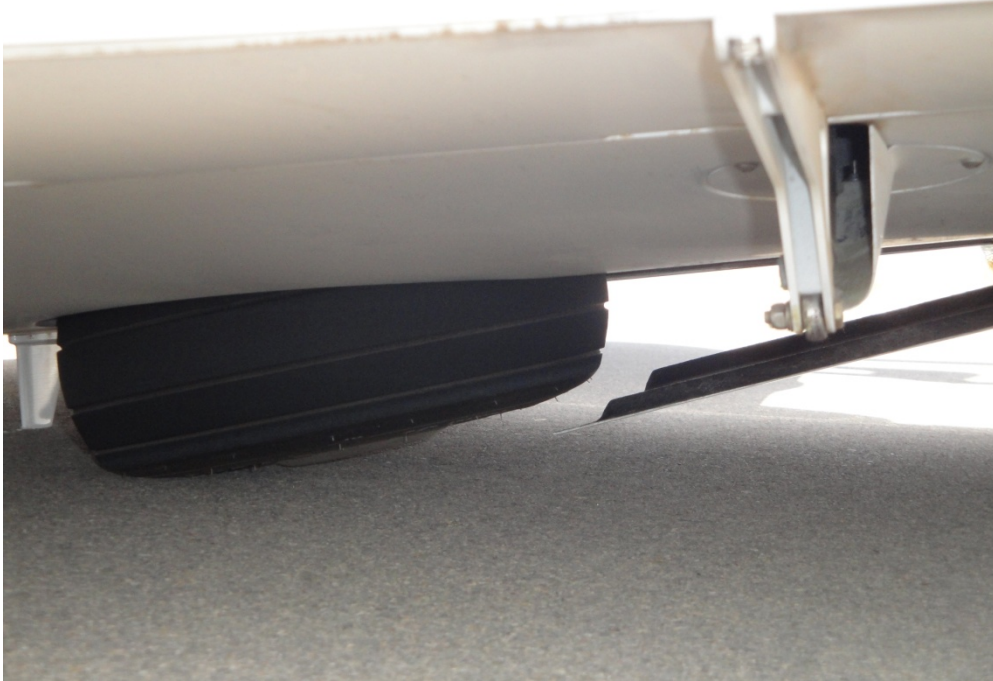
Figure A1-21

Right main Landing gear condition when the aircraft at full stop on the runway

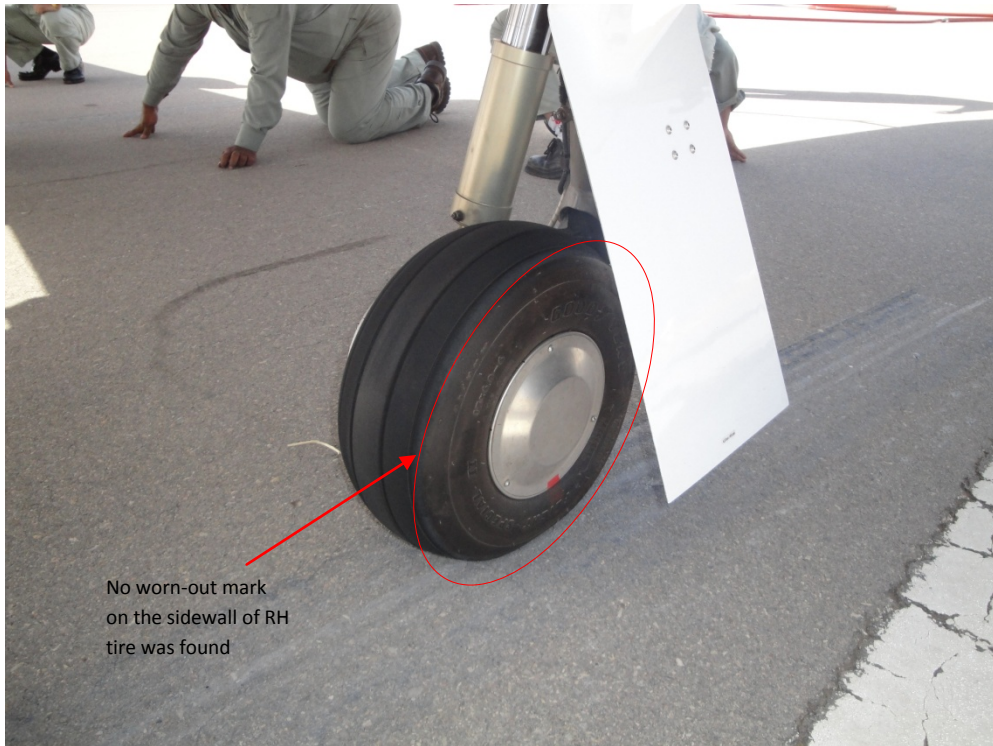
Figure A1-22

Right main landing gear condition after lifting up the aircraft

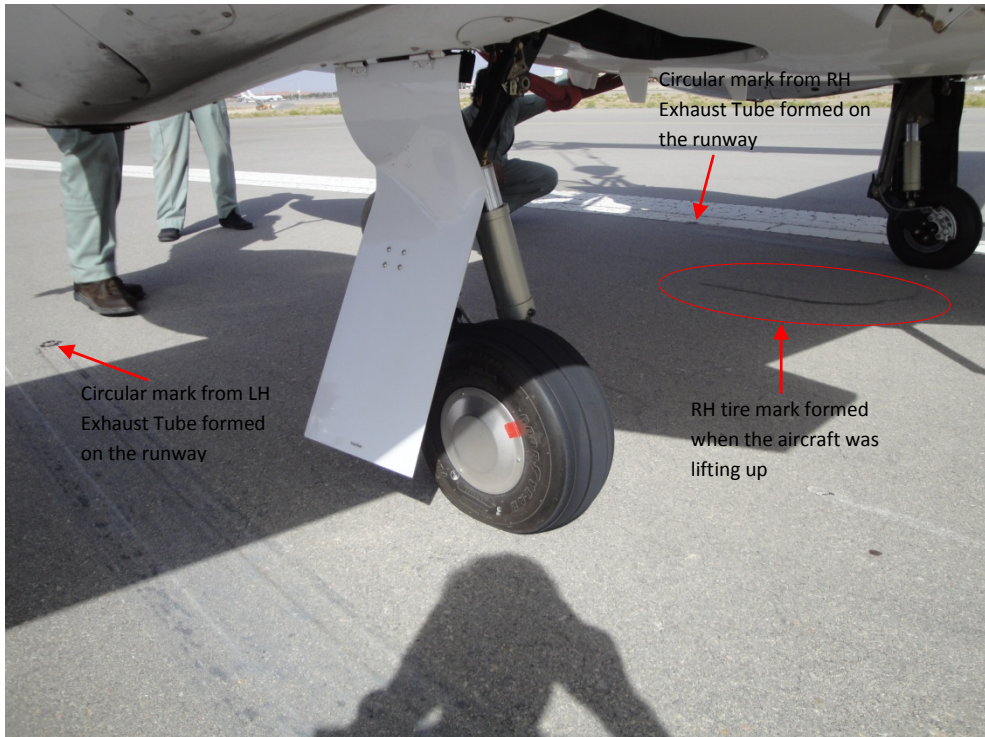
Figure A1-23

According to the maintenance engineer of the training organisation, who supervised the Aircraft removal, while the Aircraft was being lifted up by the crane and slings, the landing gear extended by gravity. Before the Aircraft was able to stand on the runway with locked down gears condition, the ELECT MASTER had been switched to ON. After the Aircraft was on the runway with locked down landing gear, the ELEC MASTER was switched to OFF again and thereafter the Aircraft was pushed away from the runway (see Appendix A1).

Landing gear was able to extend when lifting up the aircraft

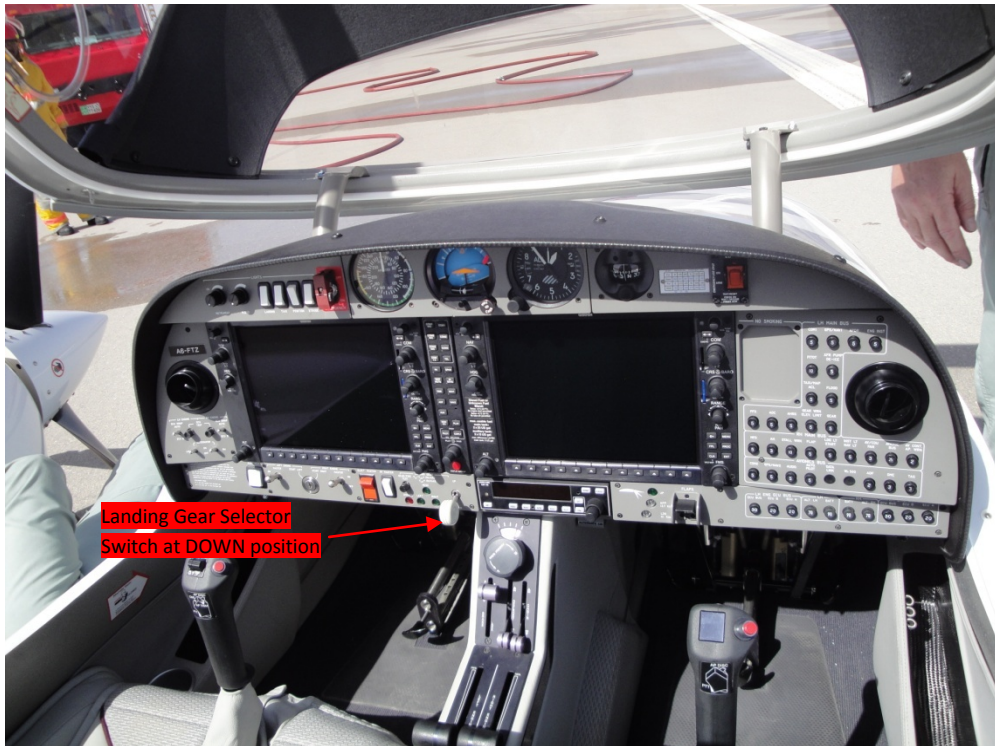
Figure A1-26 Cockpit after the Occurrence
