**General Civil Aviation Authority**  
**Air Accident Investigation Department**  
**Abu Dhabi, UAE**  
**02/2010**

**FINAL REPORT**

**AIRCRAFT INCIDENT INVESTIGATION**

National Air Services  
Gulfstream GIV-X (G450), Registration N452NS  
Dubai International Airport,  
United Arab Emirates

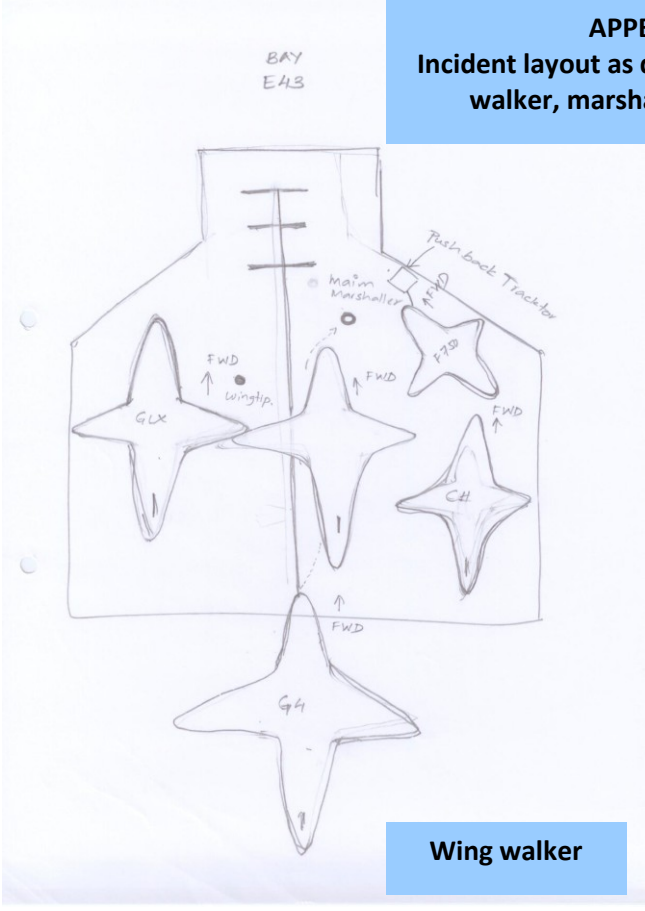
**Wing walker**

The wing walker stated that he was requested by the marshaller to proceed to Bay E43 for wing tip clearance for Aircraft type G4. On this Bay there was 3 other aircraft parking, left side Galaxy, right side Challenger 60, in front of that Falcon 750. The marshaller was planning to park this G4 in centre line to keep distance to other aircraft. For this we need to bring the Aircraft between the Galaxy and

Challenger and turn it to right then left (Zig Zag). The wing walker he was right side to the marshaller near front side of the Galaxy wing. G4 was approaching to the Bay, it was straight and I gave the marshaller clearance and signal to turn left (right turn). The marshaller was giving turning signals, but Aircraft was moving fast, turning was not proper.

Then, the wing walker added, I observed from distance of 2 to 3 m that the Aircraft needed more turn, I gave turn signal. The marshaller continued turning but Aircraft turning was not successful. The wing walker added: I gave stop two meters away from Galaxy, when I gave a stop, immediately the marshaller gave stop. When the captain was stopping, the Aircraft nose wheel rolled and slips forward and then the Aircraft hit the Galaxy right side winglet.

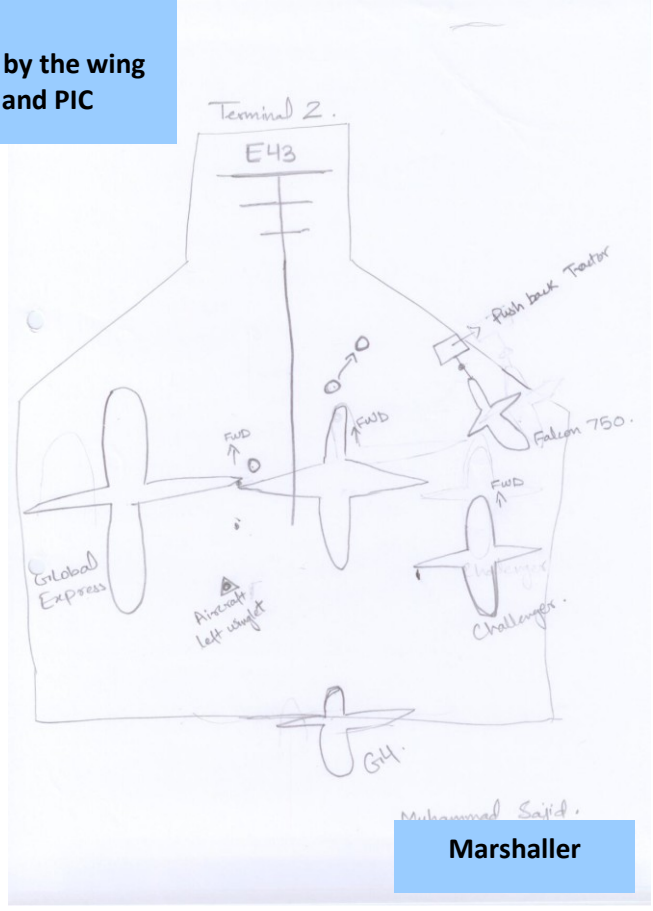
Muhammad Saïd  
**Marshaller**

The marshaller stated that he was planning to park the Aircraft at Bay E43 which was a multiple aircraft parking bay. He called a wing walker to give him wingtips from his right hand side where a Global Express (Galaxy) aircraft was parking. The wing walker was giving thumbs-up signal which meant that it was clear. When the Aircraft came near to Global Express around 6-7 meters, the wing walker gave him left turn (Aircraft right turn) signal. The marshaller started left turn signal. Captain was turning slow to left (right turn) side and moving ahead fast. It was 1-2 meters far from Global Express winglet when the wing walker gave the marshaller stop signal.

The marshaller added: I also gave stop but it was too late for captain to stop the Aircraft. G4 hit the winglet of Global express on right side of me. I realise that the signals took time. Like the wing walker gave me stop. I follow him, I gave stop to the captain and he followed me. Captain was late to stop the Aircraft. I also realised that the time distance which we were having was not enough to communicate. I also realised that the captain stop the Aircraft but it was still rolling forward for a second. The result was Global Express winglet was damaged and G4 was not damaged. The Incident happened because of the speed of Aircraft G4.

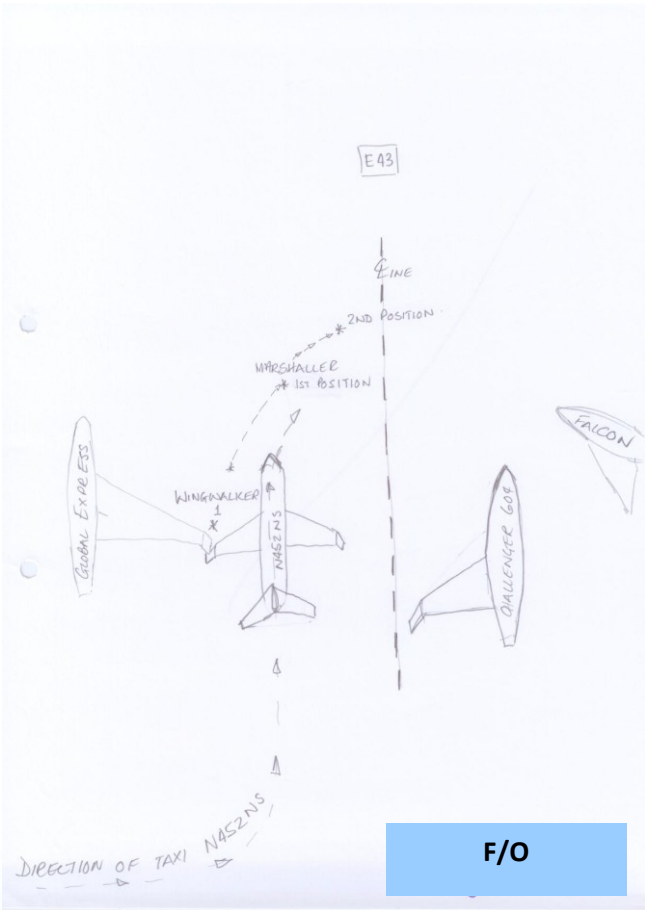
**F/O**

The F/O stated that the marshaller and a right hand wing walker signalled to move forward, at the same time he, the marshaller, started walking backwards and to his left. The right side of the G450 was clear of the Challenger. With the sideways movement of the marshaller, a right turn was initiated, as we started moving right a "shuddering" was felt in the Aircraft, the Aircraft was stopped and brakes applied. The F/O added that: at no time did the marshaller signal a stop. As it was a congested area our taxi speed was below a walking pace, i.e. very slow.

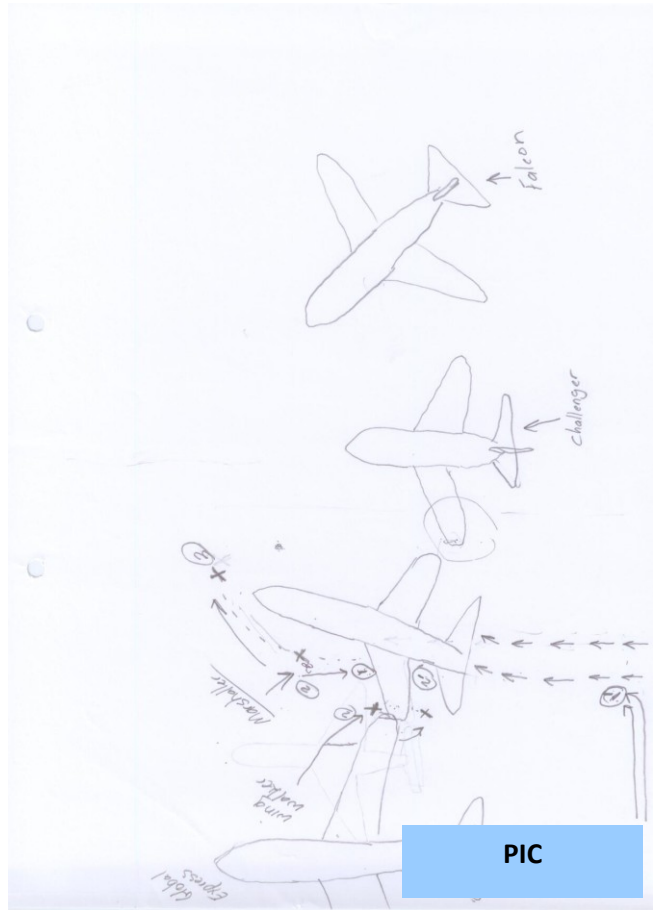
**PIC**

During his interview, the PIC stated that while the Aircraft was taxiing on taxiway P, he observed marshaller in position directs him into parking. His positioning indicated to the for the the crew to taxi straight ahead towards him to the left of parking line between/behind a parking Galaxy aircraft on the left and a Challenger aircraft on the right. There was a wing walker positioned at the Galaxy’s right wing and the Challenger left wing. The Aircraft taxied forward following the marshaller signals

and glance 2 to 3 times out the captain's left window to observe the wing walker on that indicating a steady thump up. During the forward taxi, the marshaller was positioned straight ahead and the PIC was getting verbal confirmation from the F/O that the right wing walker had seen the Aircraft cleared the Challenger's wing. Shortly after clearing the Challenger's wing, the marshaller began drifting to his left, the PIC's right, to turn the Aircraft as otherwise the PIC said that he lost sight of the marshaller. The position for a marshaller is either straight ahead or sometimes to the captain's side to ensure he is seen. The PIC added that: shortly after beginning the right turn, the crew felt a shudder go through the Aircraft; the PIC applied the brakes to stop.

The PIC added: "only after stopping ourselves did we observe the marshaller indicate for us to stop . When the marshaller began drifting to his left/my right I wasn't able to glance towards the left wing walker so don't know if signalled for the marshaller to stop us before winglet contact or not, or even with his new/changing positioning if he could see his wing walker on that side. At no time did the marshaller indicate to us where he ultimately wanted to park us, as is the norm. It is assumed to be where he is standing, but from the time he began moving his intentions for us became unclear because his first position indicated that the plan was to simply pull up and stop somewhere behind the right of the Galaxy and next to the Challenger".
