# Air Accident Investigation Sector

### - Summary Report -

AAIS Case N°: AIFN/0009/2011

## Fumes in Passenger Cabin

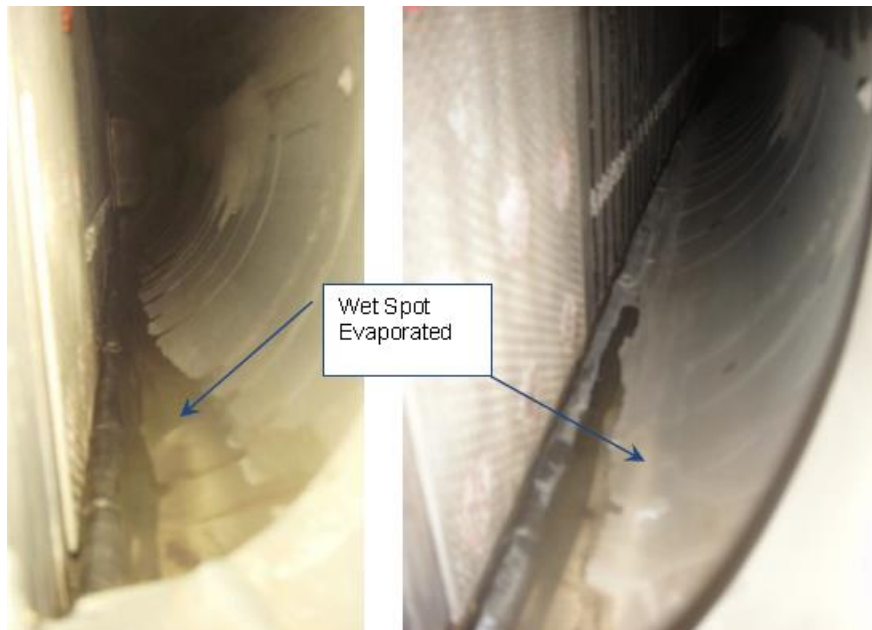
The HX exhibited what appeared to be a wet spot of evaporating liquid in the secondary inlet (see figure 2). An attempt was made to pour any residual liquid out for analysis but nothing could be collected. The wet spot was examined and was determined to be water.

**Figure 2.** HX Secondary Inlet Photo Taken at the Operator's Facilities (left) and at the Inspection Facilities (right).

The HX was cleaned as per CMM 21-52-02.
