Serious Incident - Final Report -

AAIS Case No. 08/2011

Failure of Undercarriage AFT Crosstube

Type: Bell 412EP

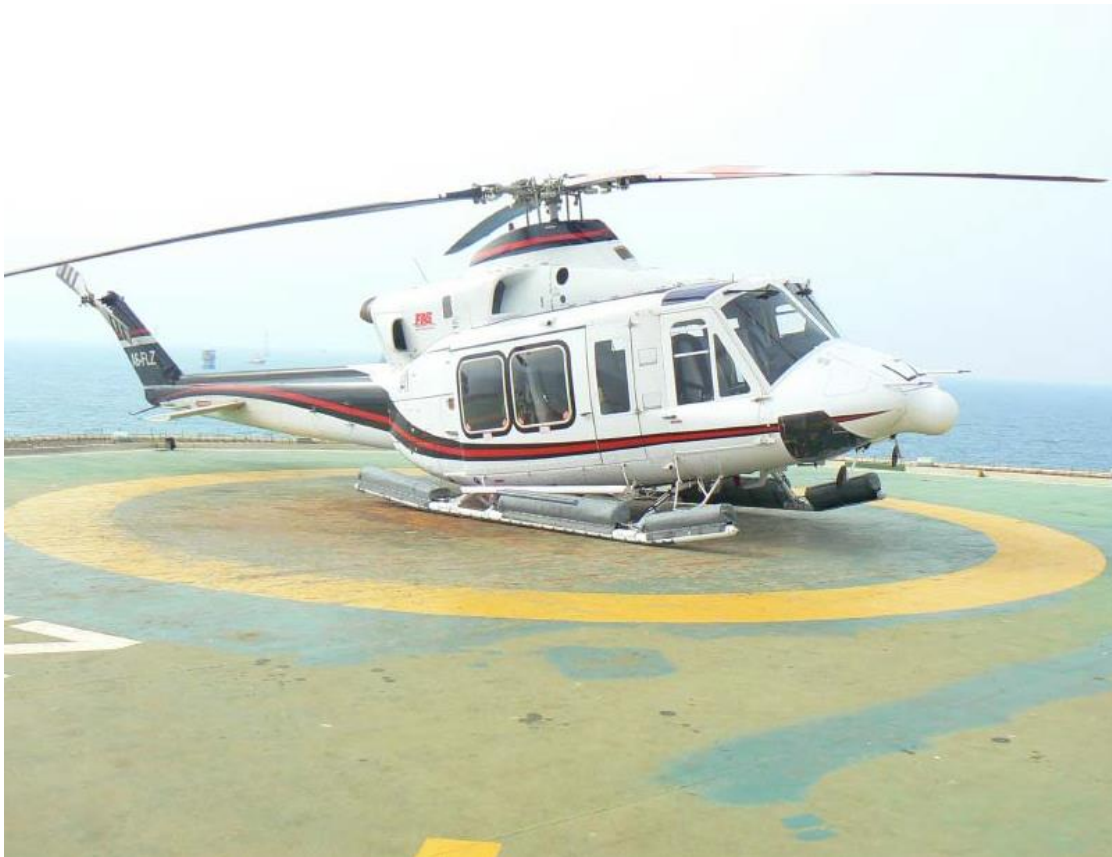
Photo 1 A6-FLZ following the crosstube fracture.

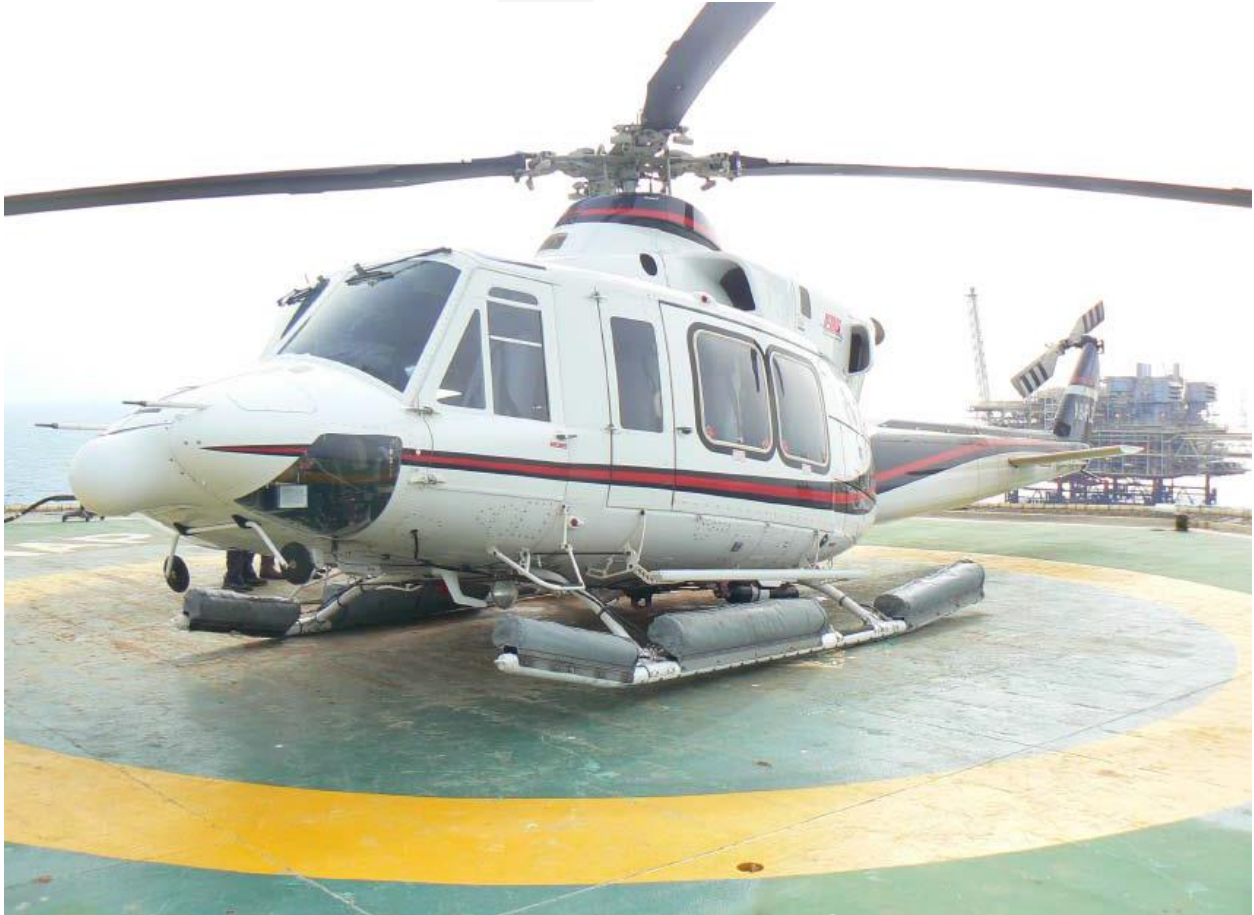
Photo 2. A6-FLZ following aft crosstube failure

Damage to the Aircraft consisted of the failed undercarriage right side of the aft crosstube, part number D412-664-203, and resulting damaged fuselage skin panels in the area of the aft crosstube tunnel, near the grounding receptacle, on both sides of the fuselage.

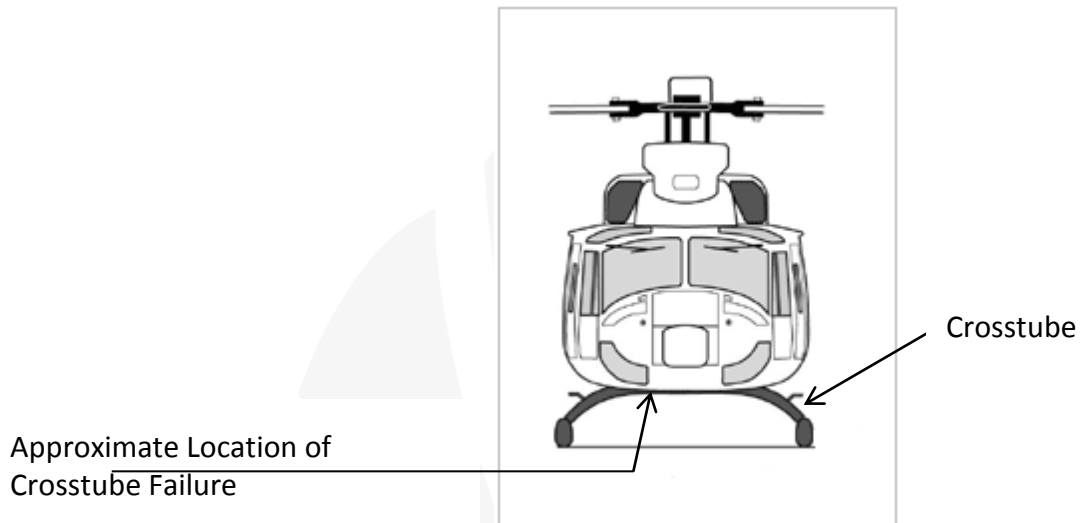
Figure 3. Bell 412 location of Crosstube Failure

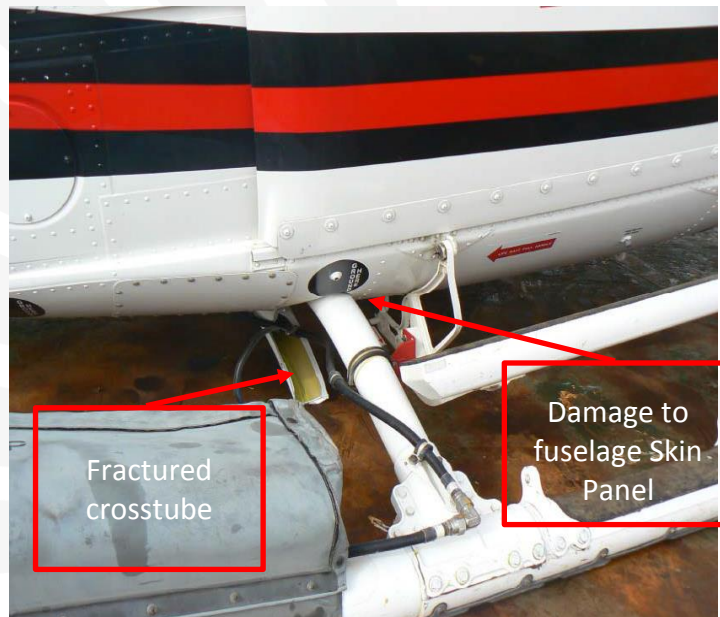
Photo 3. Damage to Fuselage Skin Panels fractured crosstube and Aft Crosstube Tunnel Skin Panels.

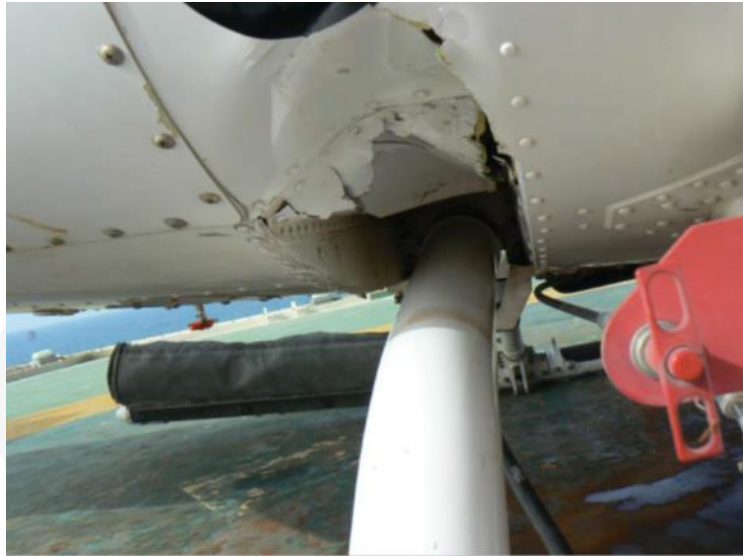
Photo 4. Damage to Fuselage Skin Panels and Aft Crosstube Tunnel Skin Panels.

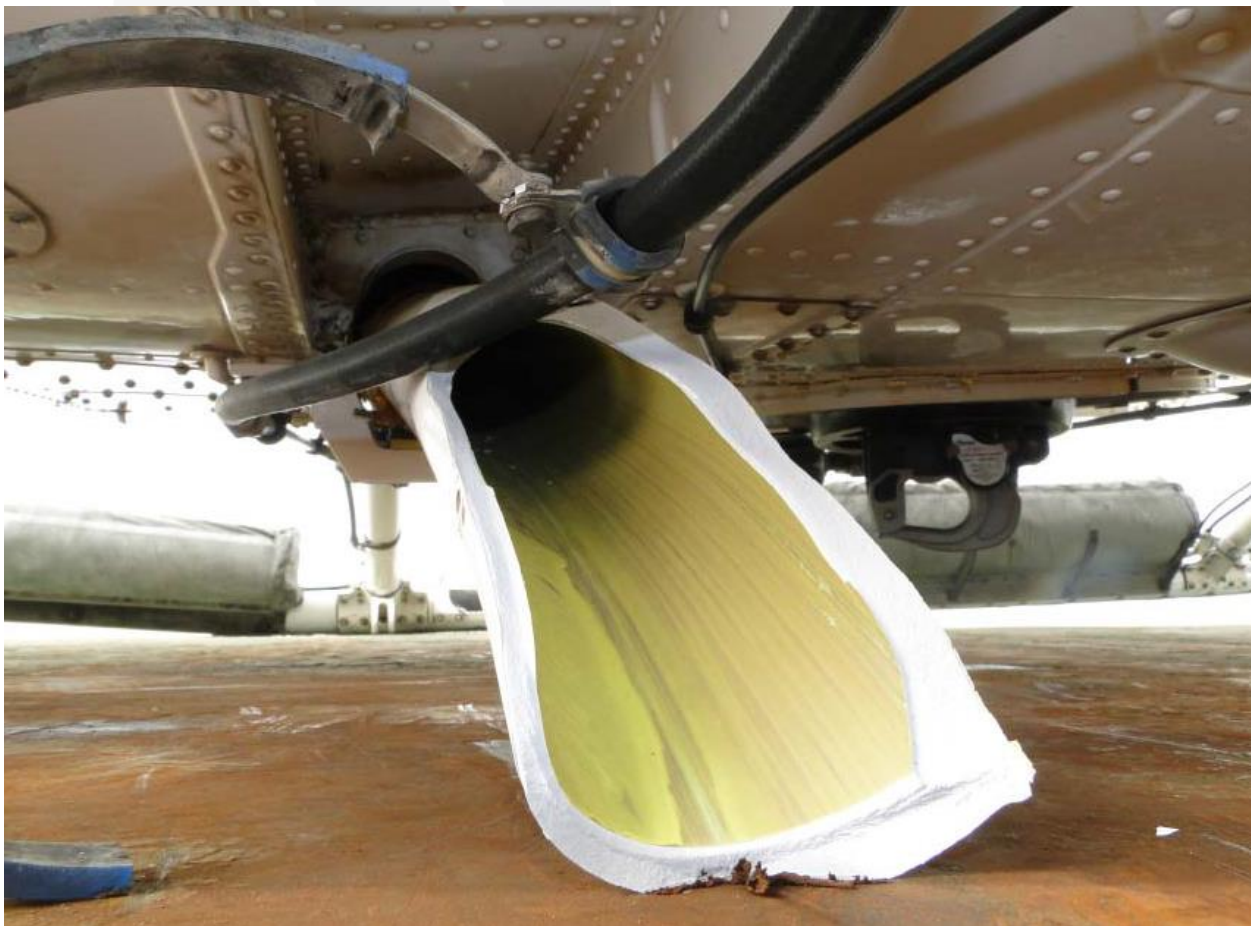
Photo 5. Fractured crosstube attached to the helicopter.

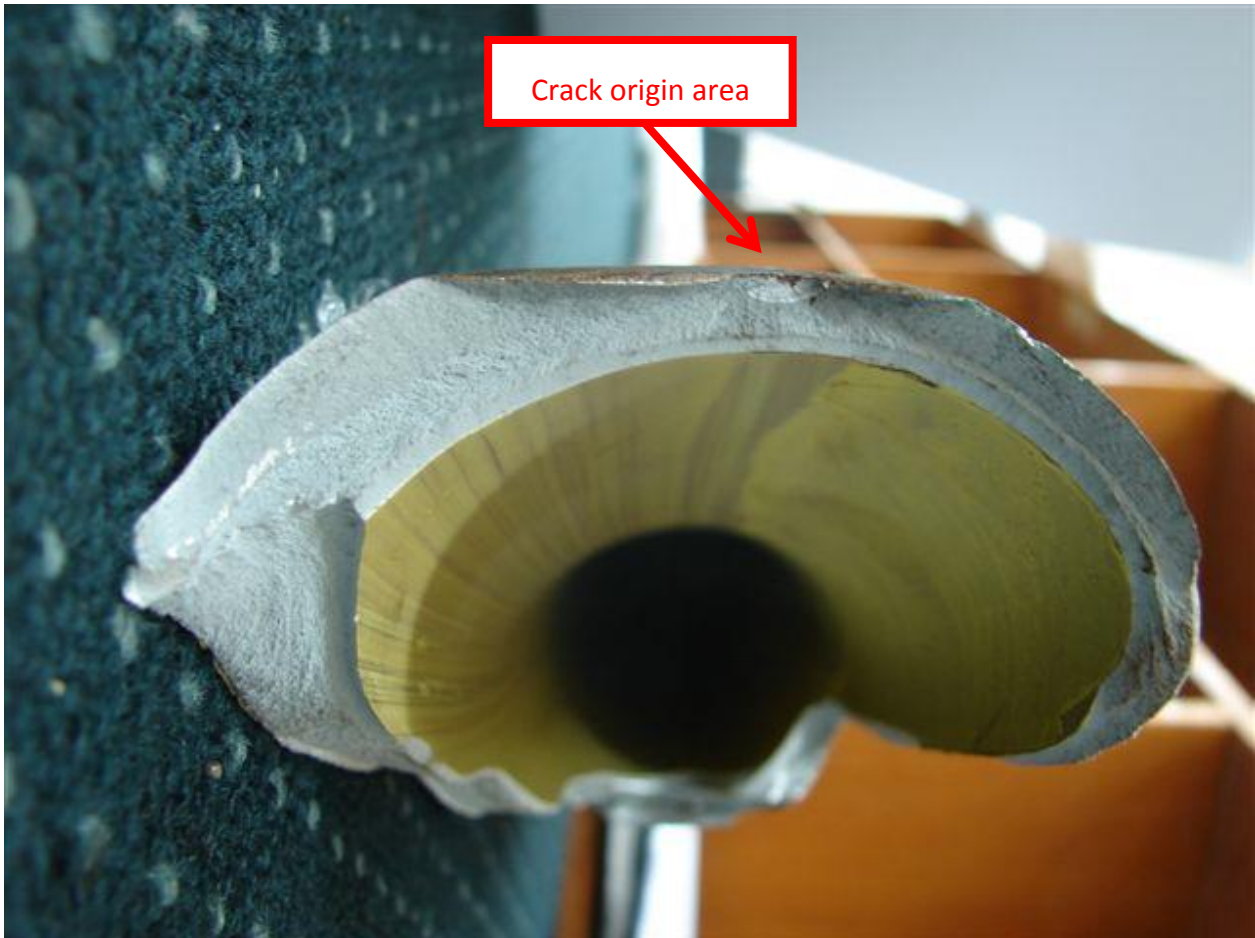
Photo 6. Fracture surface exhibited beach marks / striations originating from the surface of the inner radius of the bend.

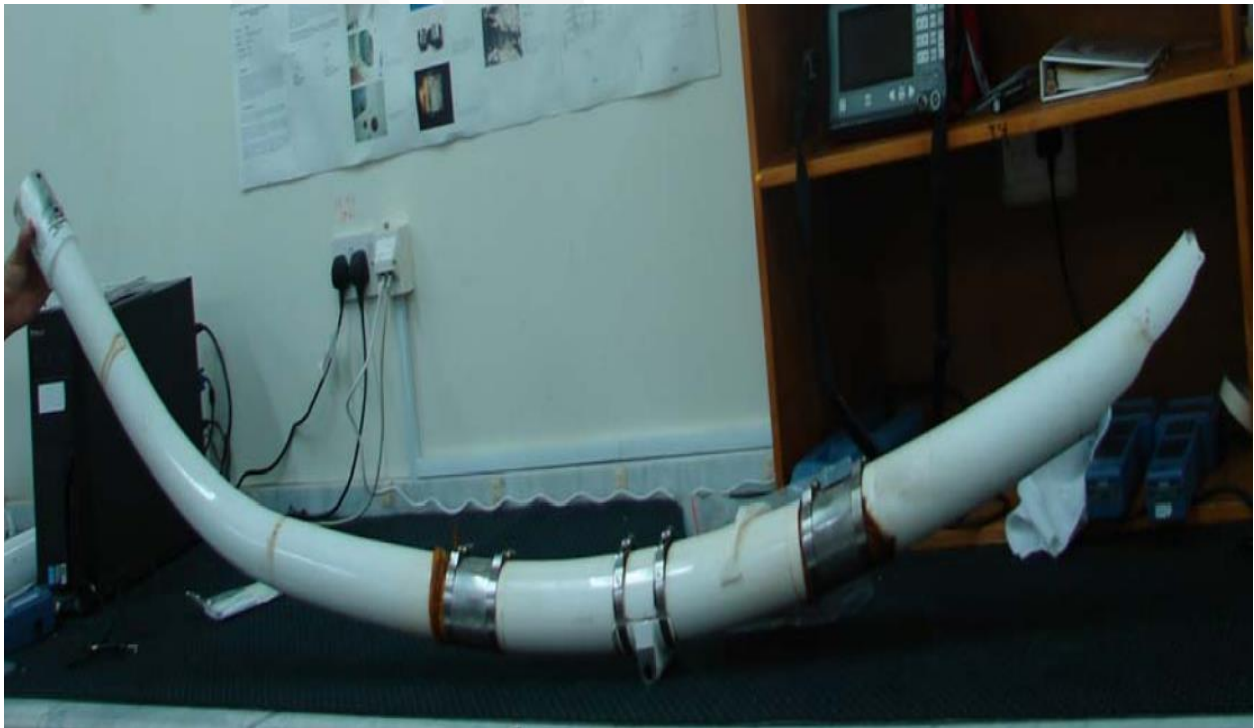
Photo 7. The failed crosstube as received in the metallurgical Laboratory.

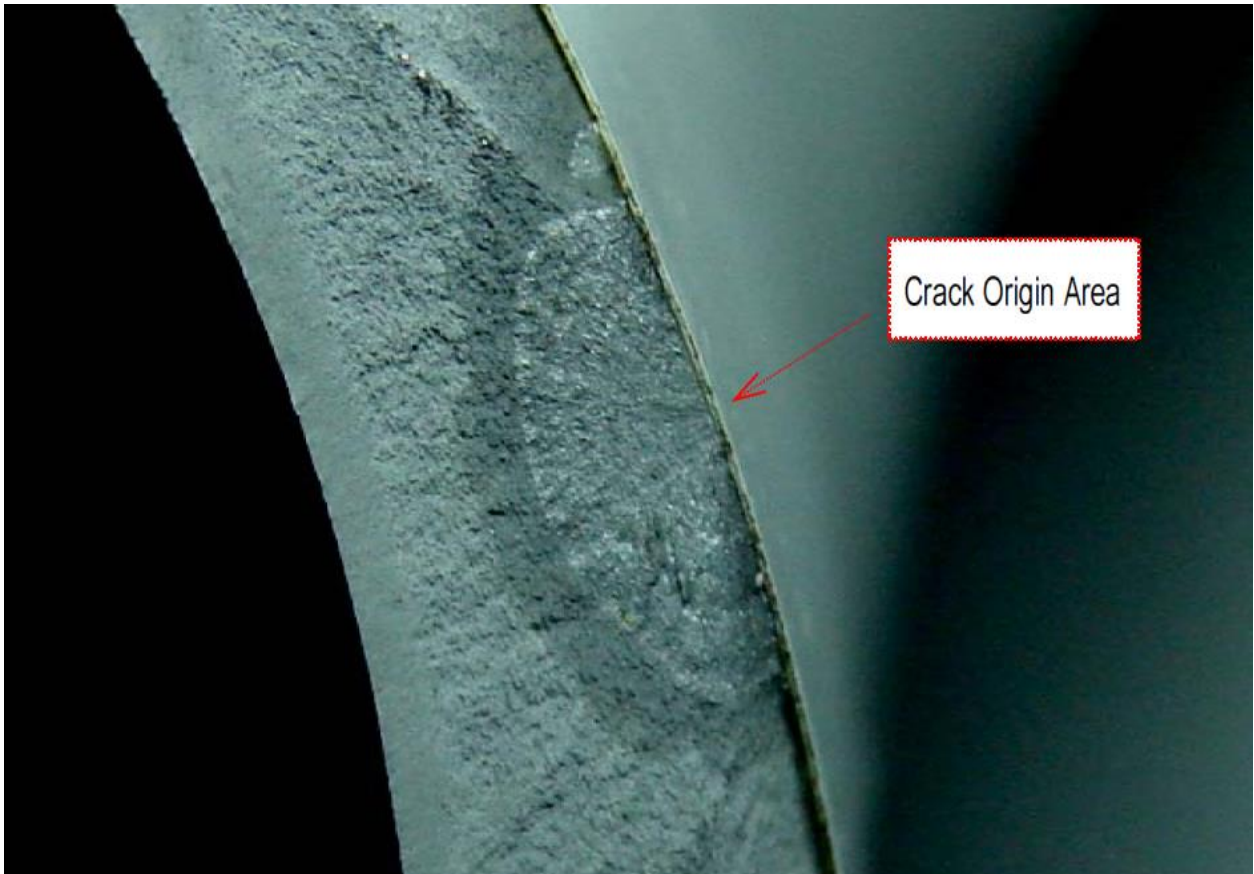
No external damages, scorings marks or impact were noticed on the crosstube surface. The fractured surfaces of the crosstube exhibited beach marks/ striations originating from the inner radius surface of the bend as shown in photo 8. As it is evident the photo below clearly indicates that there was no external damage close to the originating crack area on the paint surface of the tube.

Photo 9. Fractured surface exhibiting beach marks originating from the surface of the inner radius of the bend.

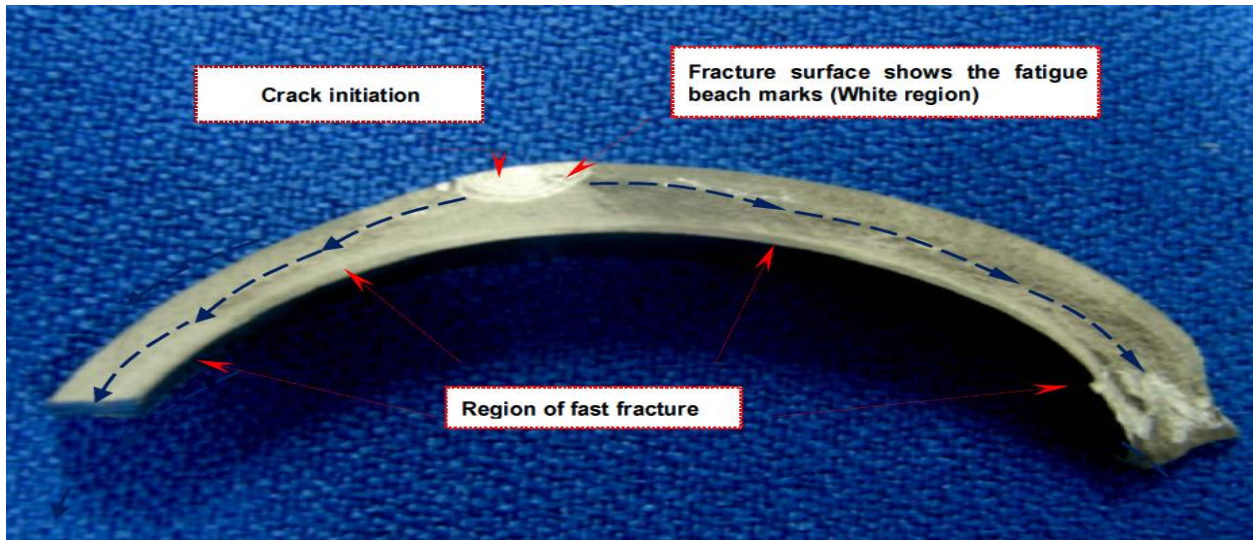
The report indicates that the crack, originated *from inner radius surface of the bend and propagated into the wall thickness for approximately 3.5mm in fatigue mode (which is approximately 45% of tube wall thickness)*. Further, *this thumbnail region the crack propagated in fast overload failure mode*. In the photo below, arrows show the crack propagation path of during fracture. Additionally the large thickness variation of the tube on the section from left to right can be seen (see photo 10).

Photo 10. Shows the crack initiation point and different regions of fracture.

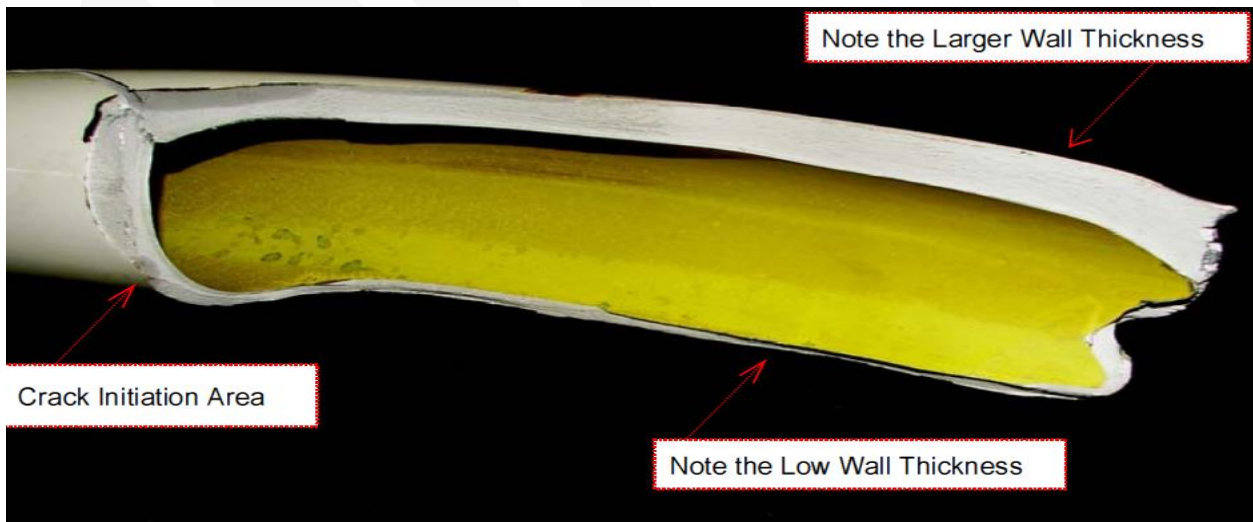
Photo 11. A6-FLZ failed crosstube indicating the originating crack along with the thickness difference.

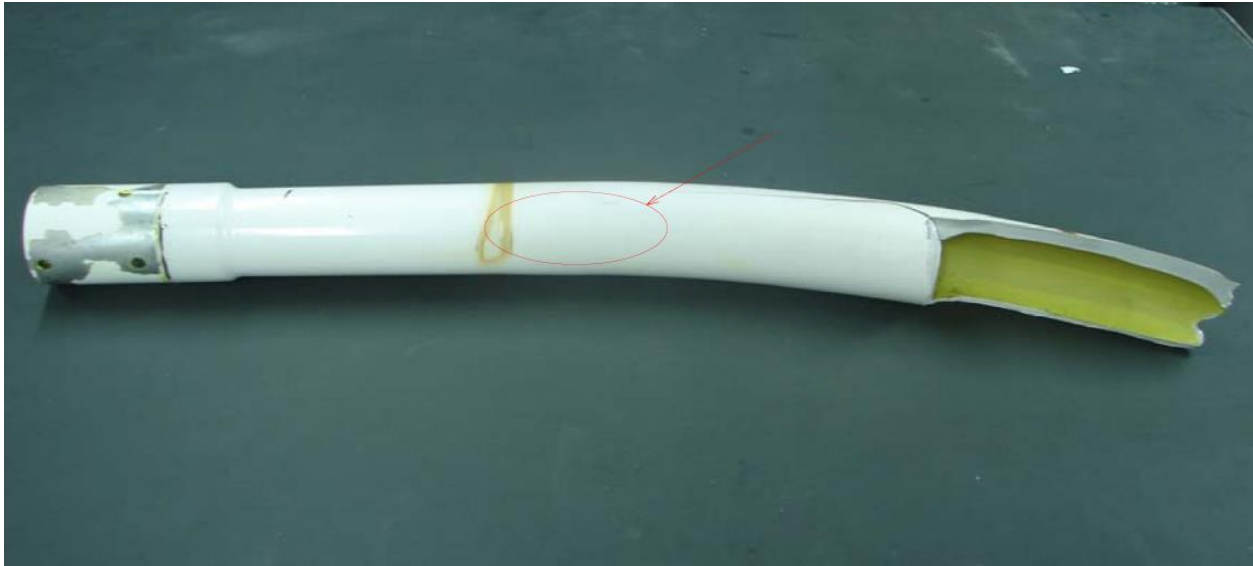
The laboratory report also indicated *that there were four line indications, suspected to be cracks were visible on the inner radius surface of the crosstube*. In the photo below (photo 12) the red circle indicates the area of the suspected cracks.

Photo 12. A6-FLZ failed crosstube as received in the metallurgical laboratory.

The laboratory measured the suspected cracks, which were found to vary *between 3.4mm to 4.6mm in length along with approximately 4.2mm intervals. These were at a distance of 200mm from the fracture and these indications lie on the inner bend radius of the Tube, from where the fatigue crack originated leading to tube failure.*

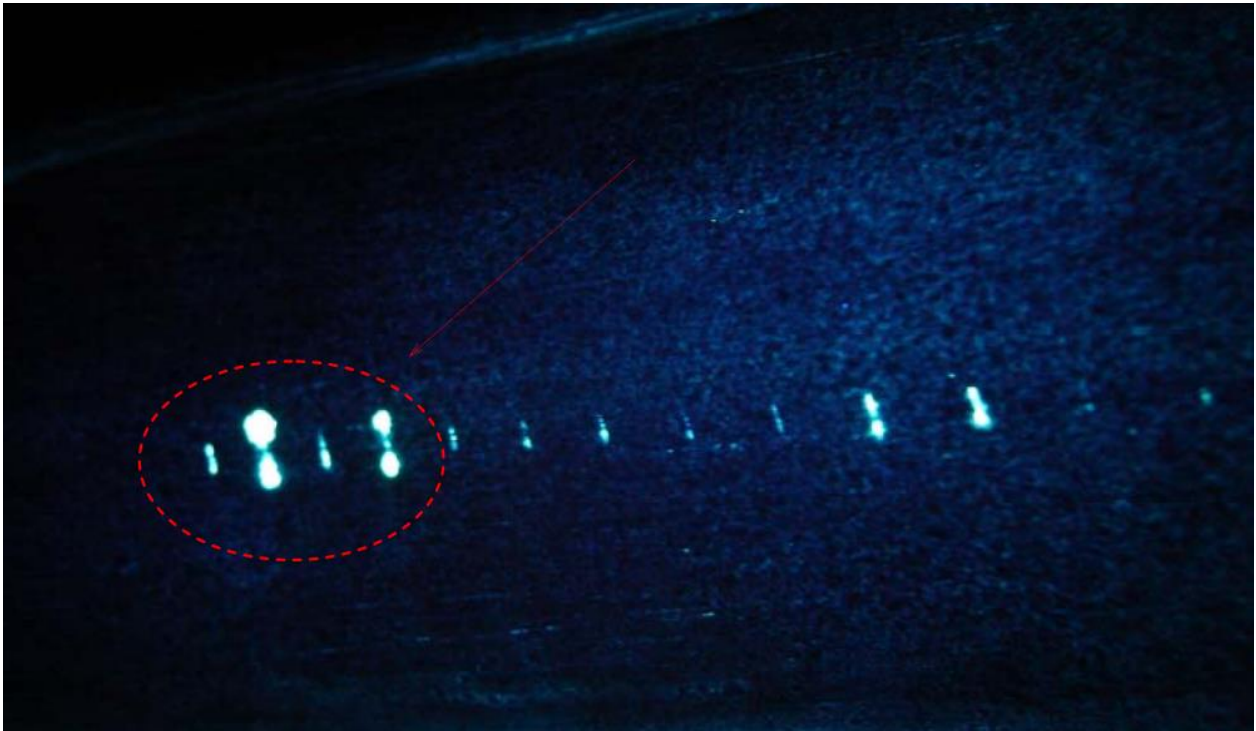
The Eddy Current Inspection confirmed that the four indications were cracks as can be seen in photo 13. The suspected four cracks visible on the surface before the paint strip are shown in the red dotted ellipse.

Photo 13. Shows the cracks found on the A6-FLZ paint stripped crosstube after FPI Inspection.

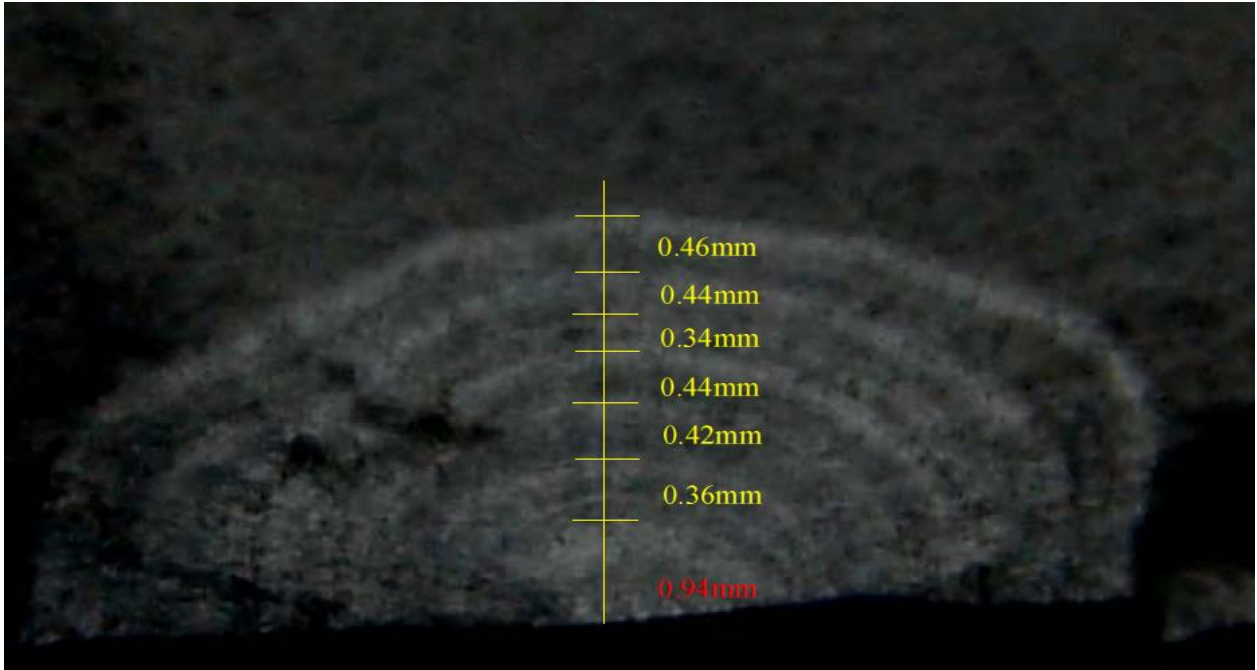
Fracture surface at the thumb nail region showed seven distinct beach marks with spacing of approximately 0.45mm between them, which can be seen in the figure below. In addition the distance between the two beach marks intervals can be seen (see figure 8).

Figure 6. Fracture surface beach marks of crosstube at 20X.

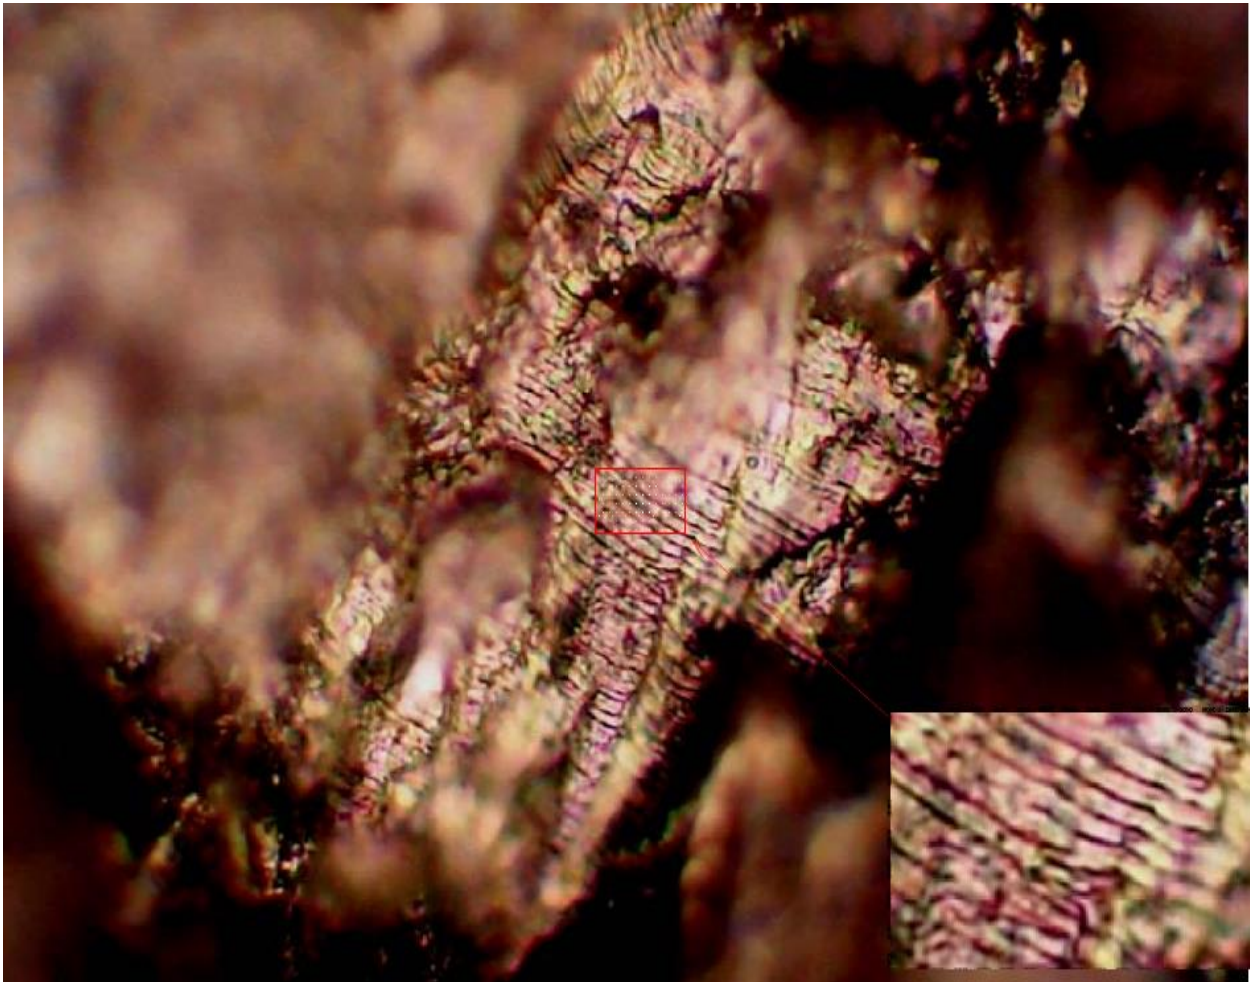
The report indicated that the spacing between the striations was measured under the metallurgical microscope using 1000X magnification and was found to vary from 0.75 to 1.0 microns. However, due to the limitations of the optical microscope with regard to the depth of focus, the entire fracture surface cannot be observed as a sharp image as which would have been possible in using a Scanning Electron Microscope (SEM) . Nevertheless, the fatigue striations were clearly visible.

Figure 7. Shows the fracture surface having fatigue striations of cross-tube examined at 1000X.

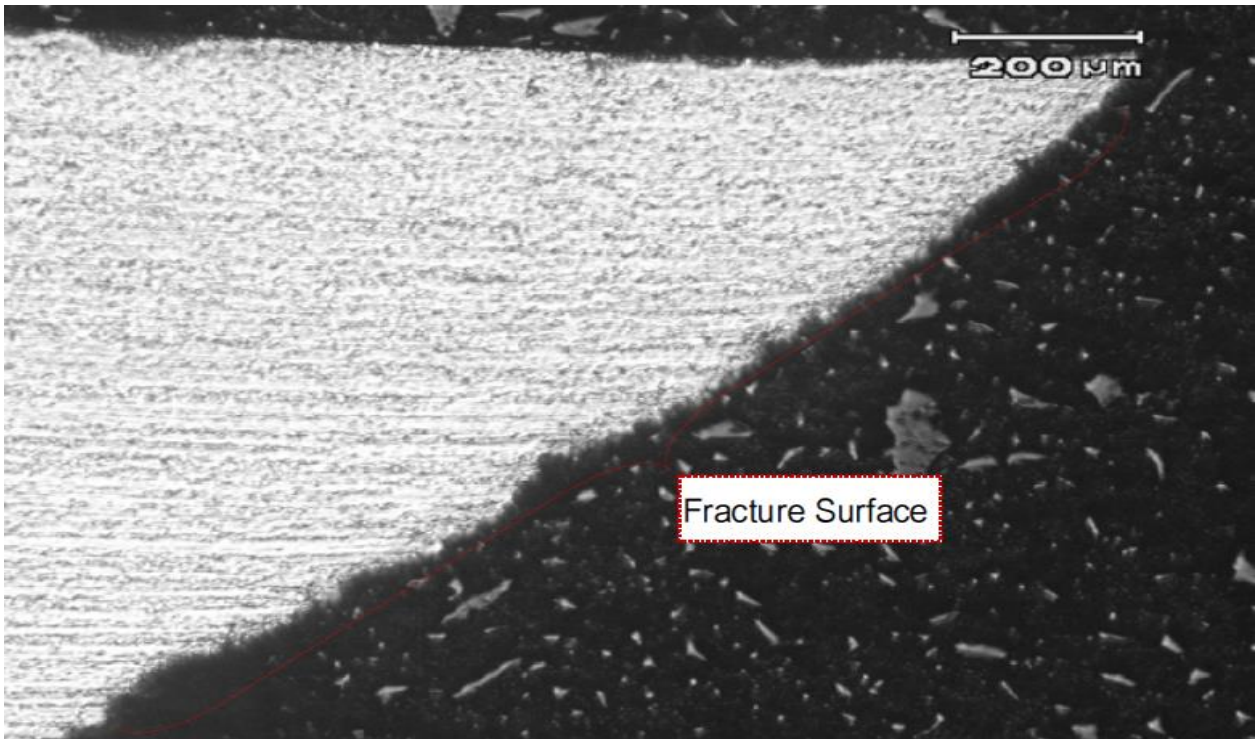
Microstructure examination in a polished condition revealed no abnormalities or secondary cracks on the cross-tube. In figure 10 the fractured surface of the cross-tube can be seen at a magnification of 50x.

Figure 8. Shows grain pattern adjacent to fracture surface of crosstube ~50X .
Arrow indicates the fracture surface.

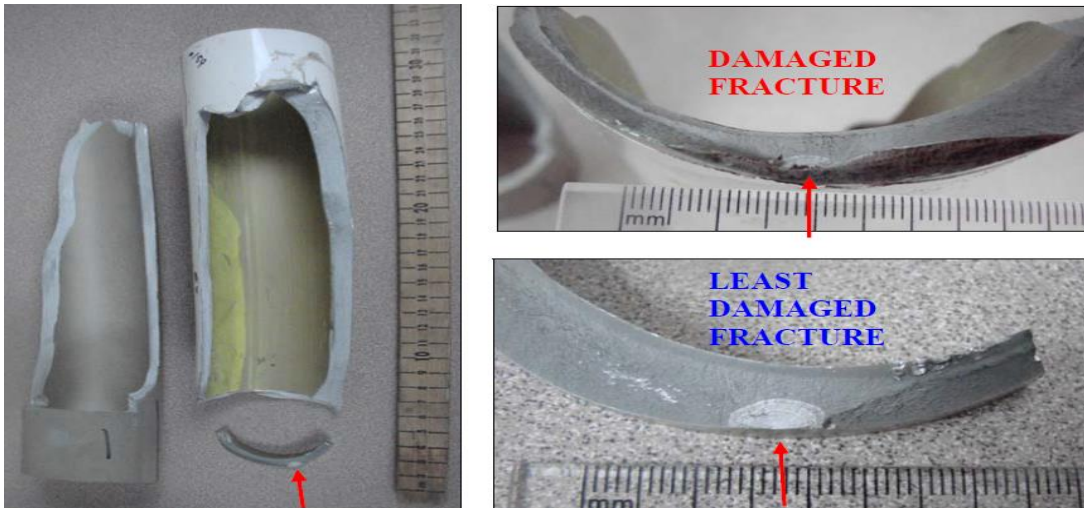
Figure 10. The fractured component as received by the testing facility.

The semicircular shaped bright areas are the fatigue fracture zone (refer to red arrows). The remaining dull grey zone is the final fracture zone.

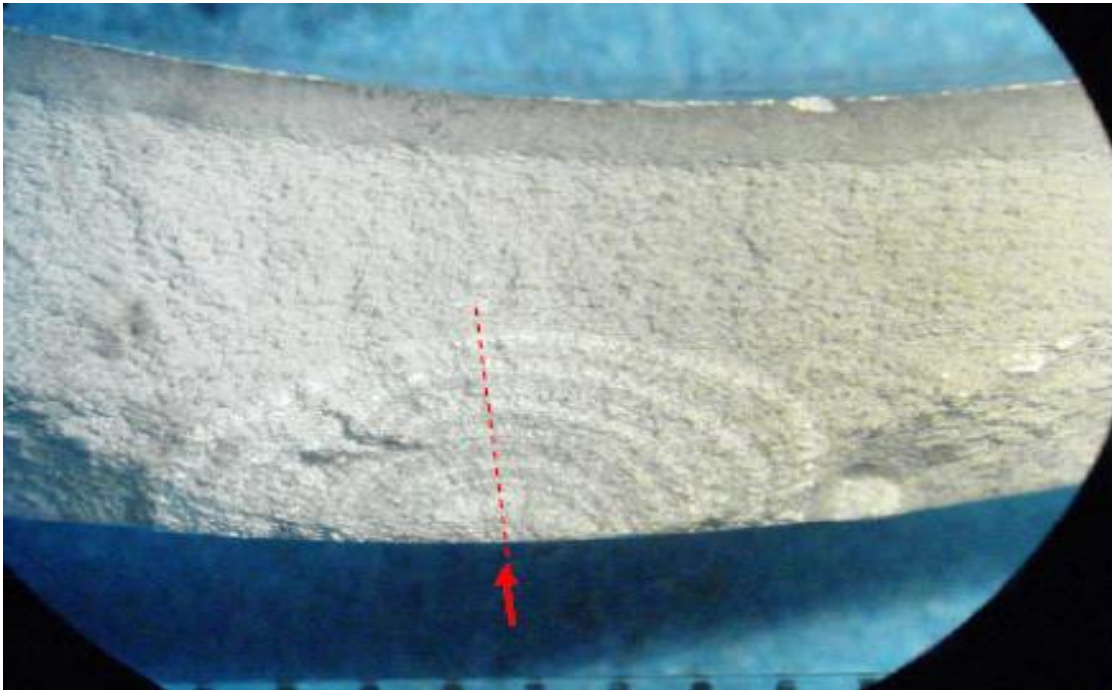
The fracture surface was cleaned with alcohol in order to remove dirt and foreign particles, while an effort to prevent further damage. Photo 17 below, which illustrates an approximately 3.5 magnification, the red dotted line indicates the locations along which the striation counts were taken and extends from crack initiation at the tube outside diameter to the final fracture zone.

Photo 17. The fatigue portion of the fracture surface is bright with semicircular beach marks.

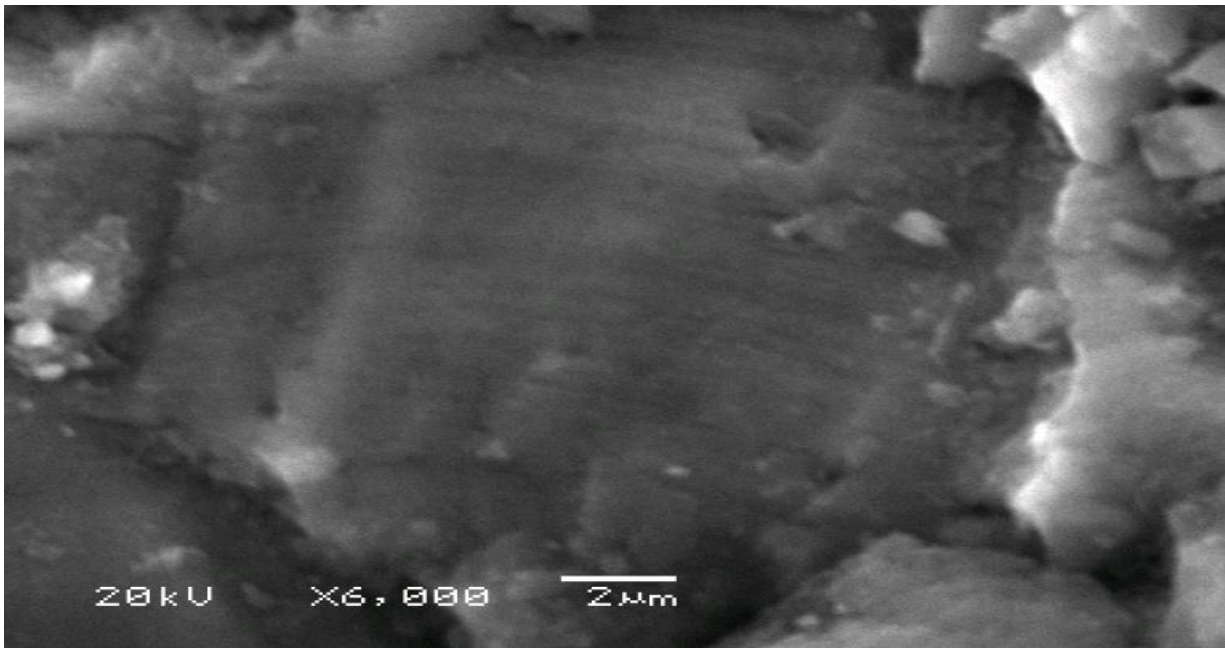
Figure 11. Image showing fatigue striations (parallel features) near the crack origin.

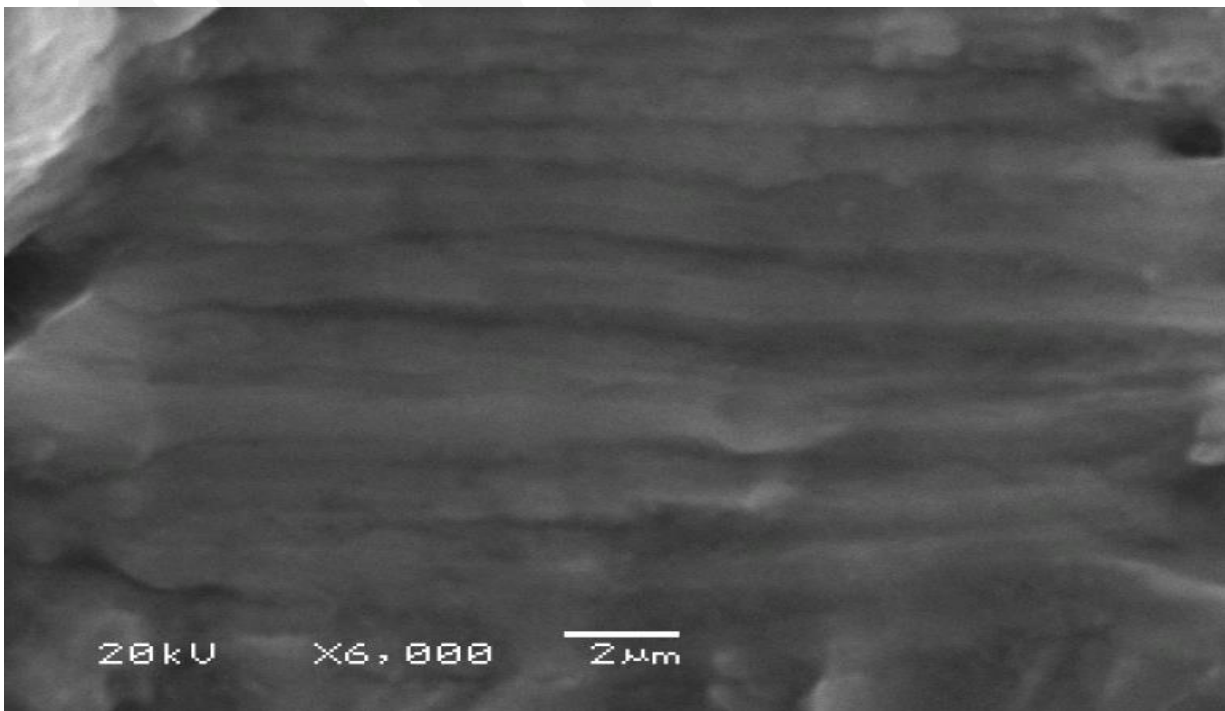
Figure 12. Image showing fatigue striations (parallel features) near the crack origin.

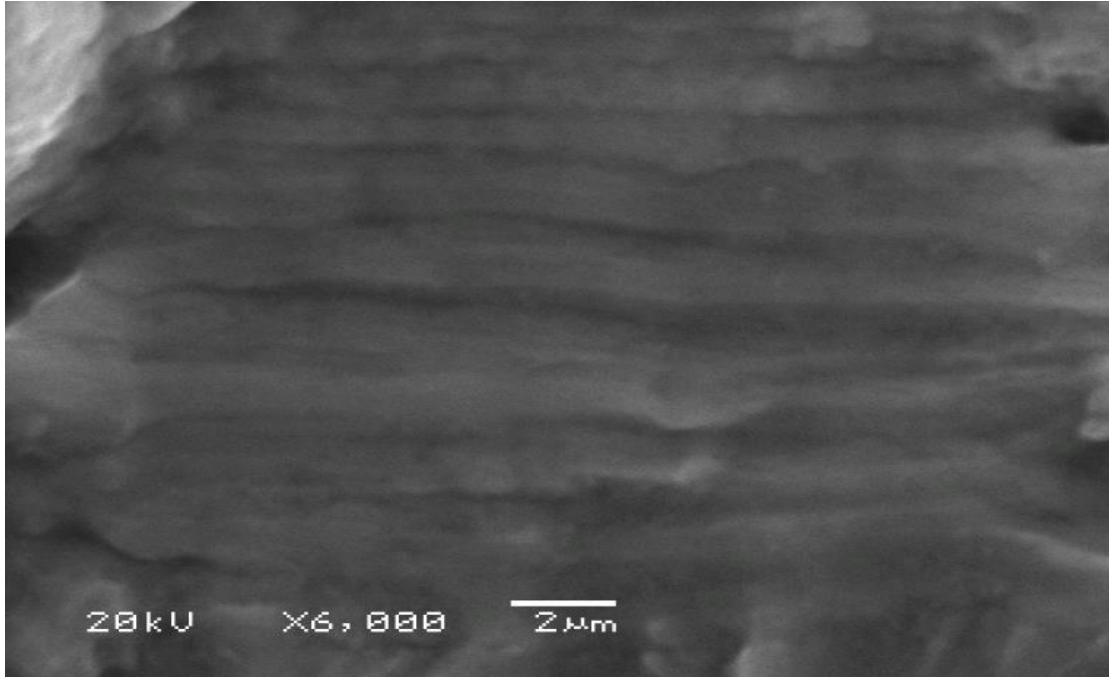
Figure 13. Image showing fatigue striations (parallel features) at the middle of the fatigue fracture zone.

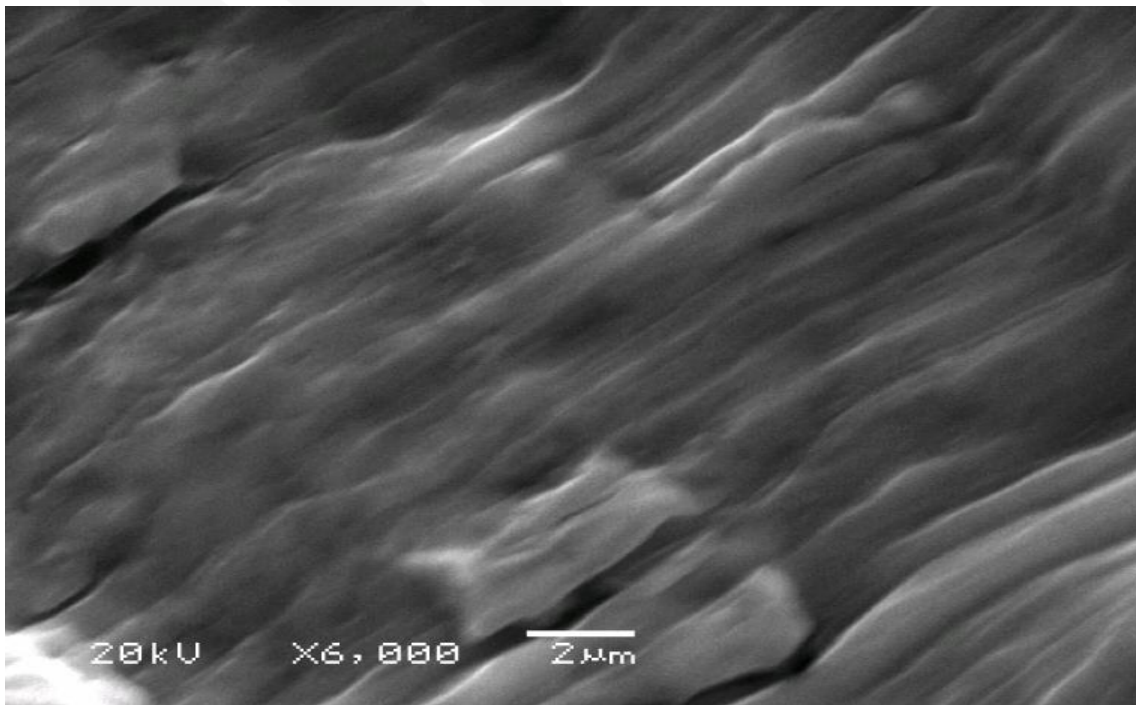
Figure 14. Image showing fatigue striations (parallel features) adjacent to the final fracture zone.

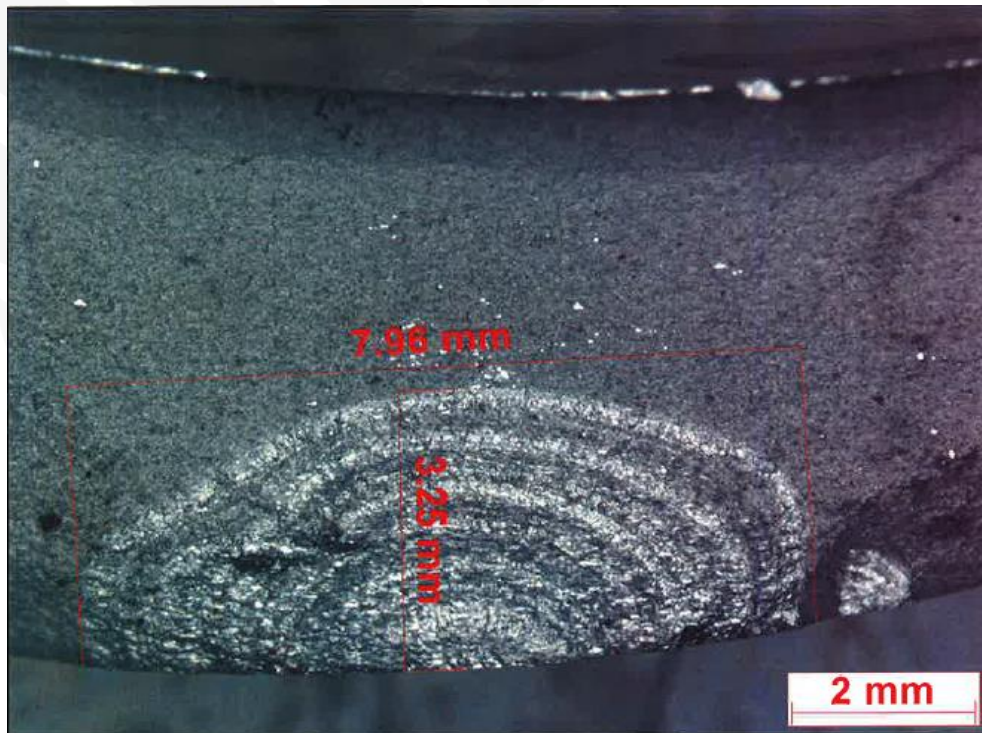
Photo 20. Fatigue crack area.

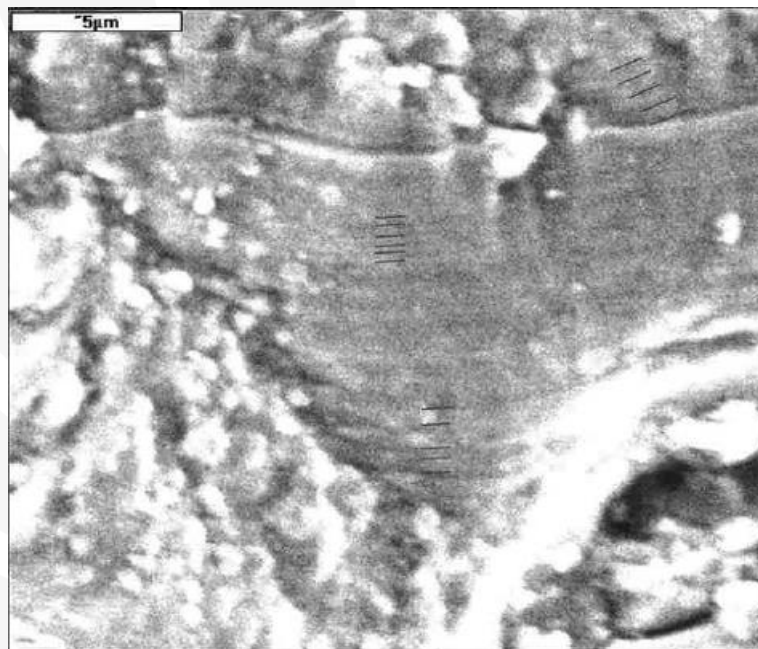
Figure 15. Striations observed at 0.16 mm away from the crack initiation area.

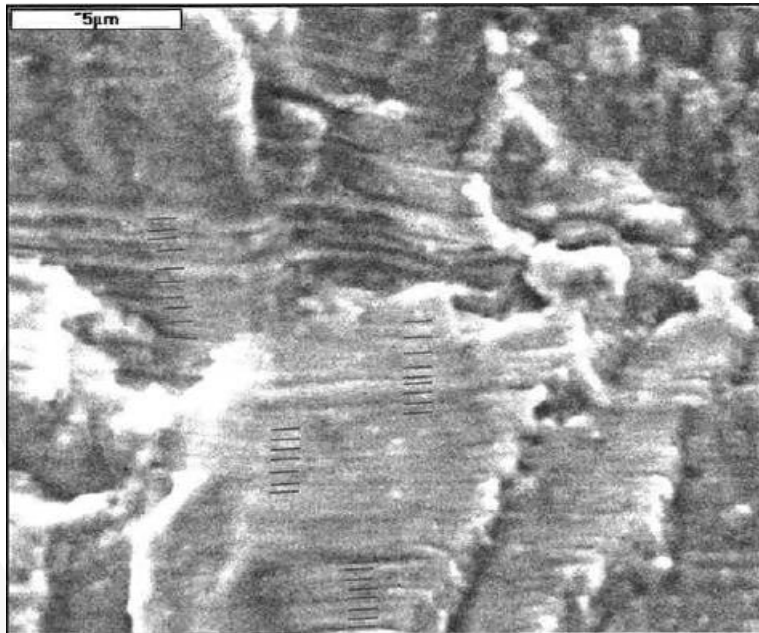
Figure 16. Striations observed at 0.67 mm away from the crack initiation area

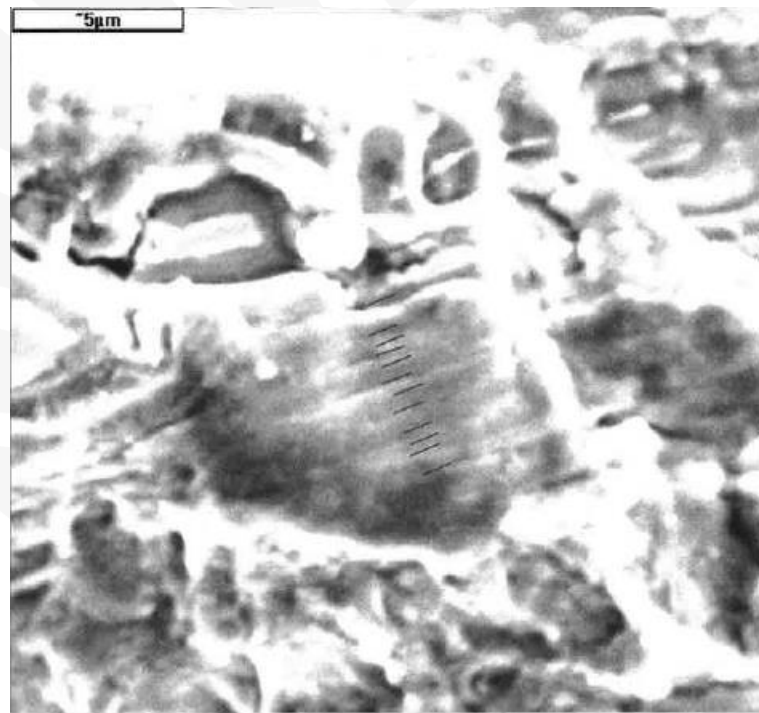
Figure 17. Striations observed at 1.79mm away from the crack initiation area.

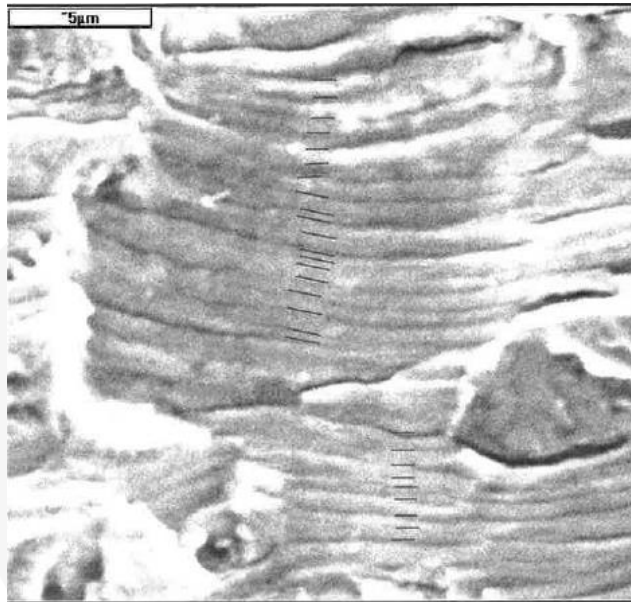
Figure 18. Striations observed at 2.19 mm away from the crack initiation area.
