Serious Incident - Final Report -

AAIS Case No. 08/2011

Failure of Undercarriage AFT Crosstube

Type: Bell 412EP

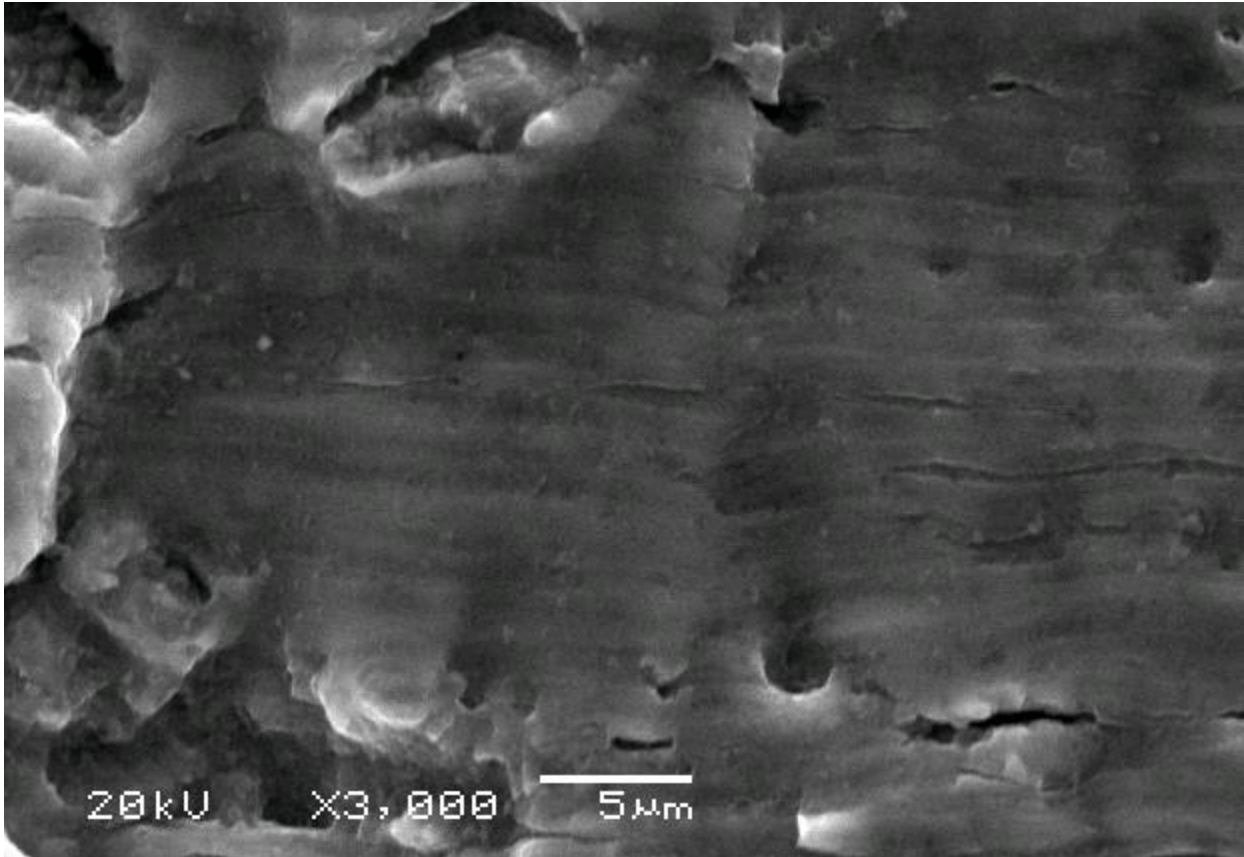
Image 1 Showing fatigue striations (parallel features) at the middle of the fatigue fracture zone.

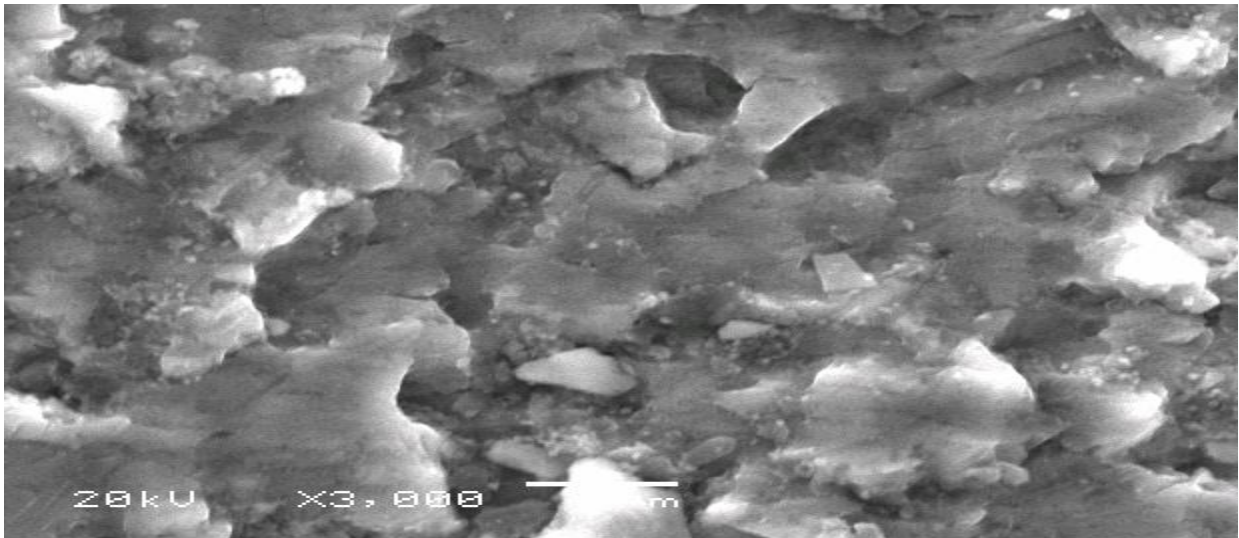
Image 2. Faint fatigue striations (parallel features) of a field near the crack origin (field 2).

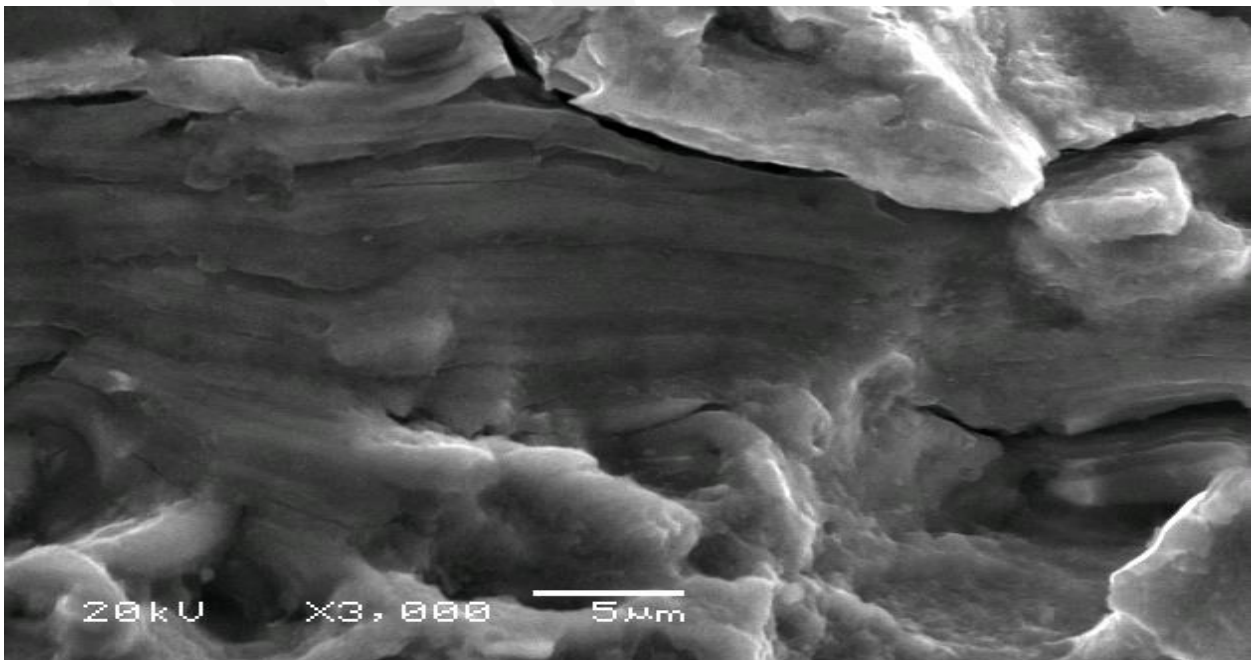
Image 3. Fatigue striations (parallel features) adjacent to the final fracture zone.

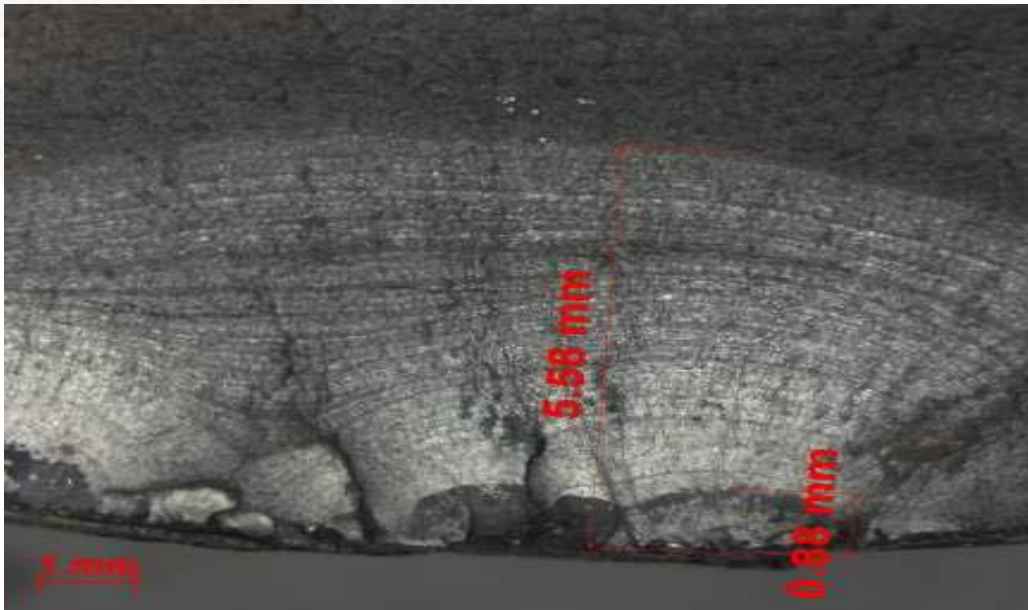
Figure 20 Fatigue Cracked Area
