# Incident Investigation - Summary Report – Aircraft collision with building

AAIS Case AIFN 0006/2011

Agusta 109S  
A6-FLS  
Dubai  
United Arab Emirates  
18 April 2011

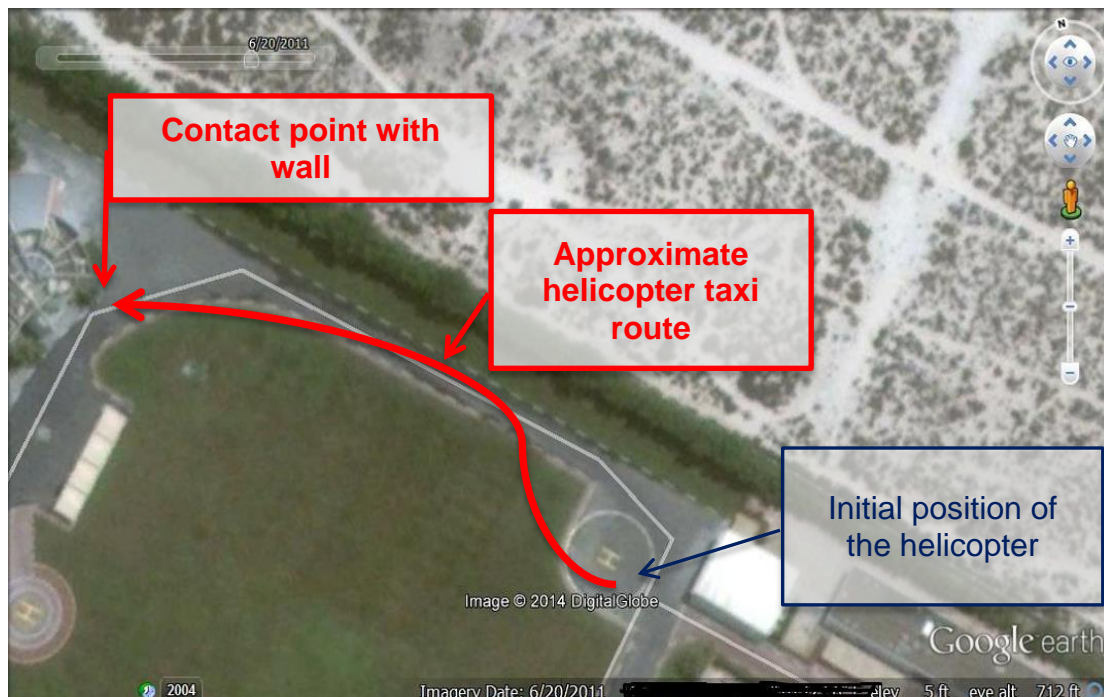
Figure 1. Approximate taxi route of the Incident helicopter

Following an uneventful engine start, the pilot elected to taxi the helicopter away from the designated helicopter landing area and to position it near the residence building to embark the passengers. While ground taxiing the aircraft the main rotor blades came into contact with an adjacent wall (see figure 1).

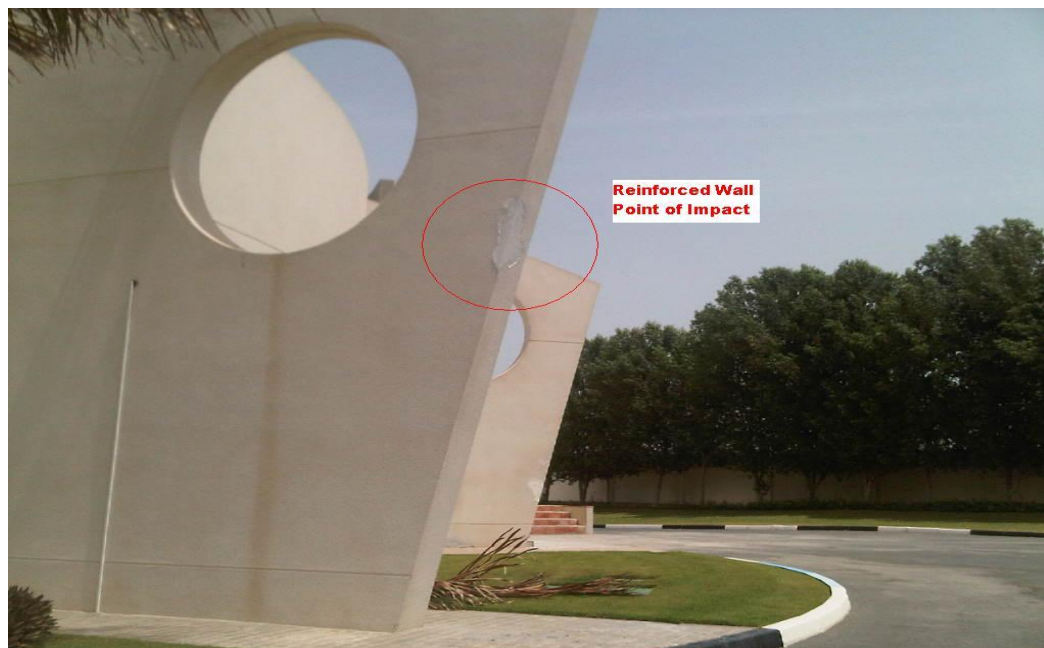
Figure 2 Point of contact of the main rotor blades with the reinforced wall

The Helicopter main rotor blades contacted the wall of a building due to distraction of the pilot as he attempted to avoid contact with a foreign object, which had suddenly come into his vision.

The pilot stated that a clear plastic, most probably a bag from a nearby construction site, “*came close to the aircraft main rotor*”, and distracted him. He stated that he “*moved to avoid*” the FOD. He also stated that the wall angle gave him a false sense of clearance at eye level (see figure 2).

- 3.1.8 The main rotor blades came in contact with a nearby building wall.
- 3.1.9 The main rotor blades were damaged due to their contact with the nearby building wall.
