# Air Accident Investigation Sector

### - Final Report –

AAIS Case N°. AIFN/0002/2012

## Attempted Takeoff from Runway Edge

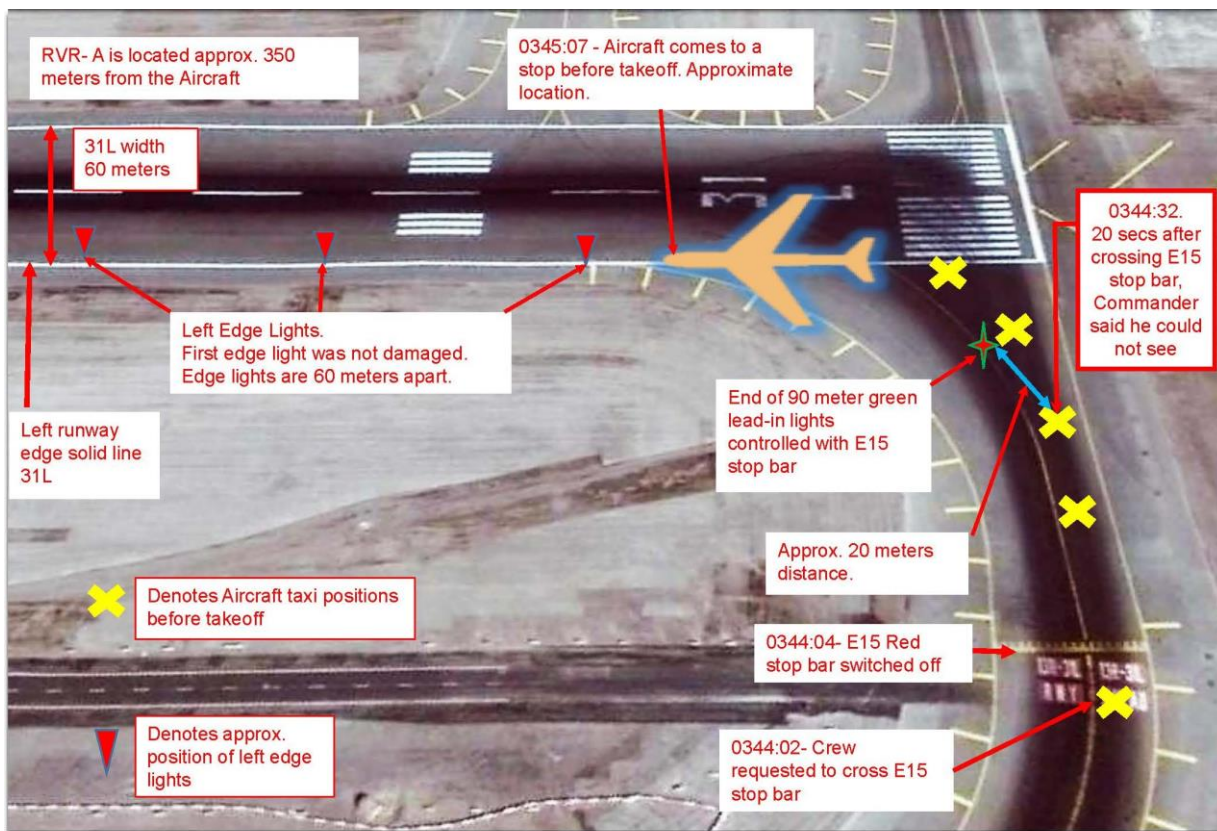
Figure 3. Incident flight taxi to runway31L

The crew confirmed to the tower ATCO that they could see the green taxiway centerline lights and the Commander continued to taxi the Aircraft along the taxiway. However, before reaching the end of the 90 m straight taxiway section which was calculated to be at approximately 70 m the crew lost external visual reference. The Investigation believes that the crew visual reference was partially regained when they both observed a white light to their left which they mistook as a centerline light and steered the Aircraft towards this light.

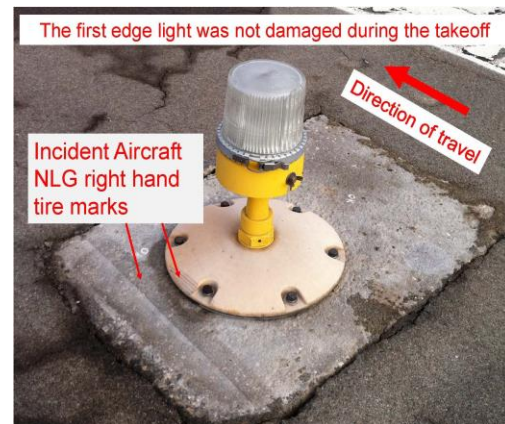
Figure 4. Edge light with tire marks

Figure 4 shows the first left hand edge light with the imprint of the right hand nose landing gear tire marks.

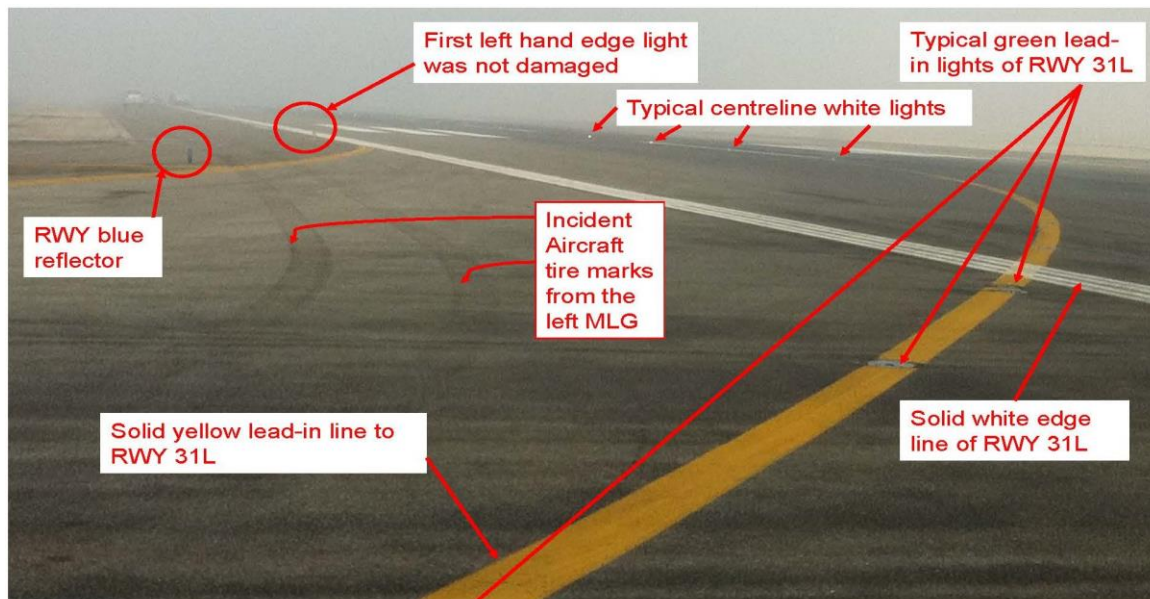
Figure 5. Left hand main landing gear tire marks

Figure 5 shows the imprint of the left hand main landing gear tires on the runway as the Aircraft was turned away from the centerline lead-in yellow line in order to align with the left hand edge light. The first left edge light was not damaged during the attempted takeoff. The figure also shows that the left main gear outer tire passed less than one meter from runway blue reflector.

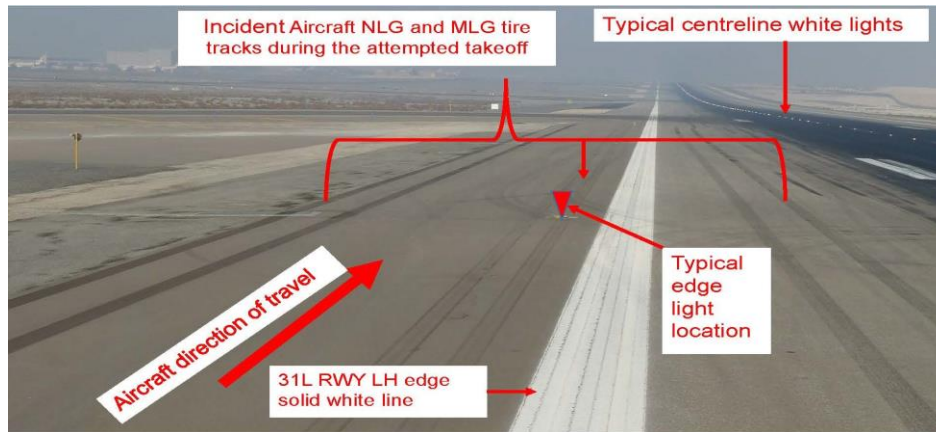
Figure 6. Aircraft NLG and MLG tire tracks

Figure 6 shows the imprint of the Aircraft nose gear tires, and the left and right main landing gear tires during the attempted takeoff.

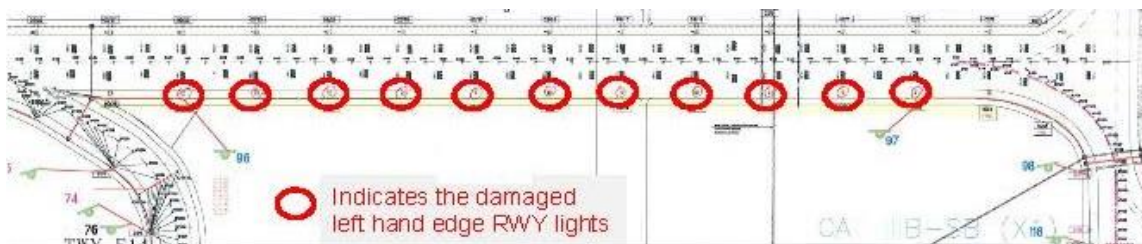
Figure 7. The red circles indicate the damaged edge lights

Figure 7: Starting with the second light, 11 consecutive left hand edge lights on runway 31L were damaged as a result of the Aircraft nose gear tires colliding with the lights as the Aircraft accelerated for the attempted takeoff.

After the Aircraft had impacted nine left hand runway edge lights, the Commander rejected the takeoff. The Aircraft continued to impact two additional lights before becoming to a complete stop on the runway edge. The Commander’s decision to reject the takeoff was based on the unusual sound and thumps coming from the nose landing gear wheels. The Investigation believes that the thumps were a good triggering event that caused the crew to reject the takeoff. Without the thumps, and if the takeoff had continued, it may have resulted in severe consequences.

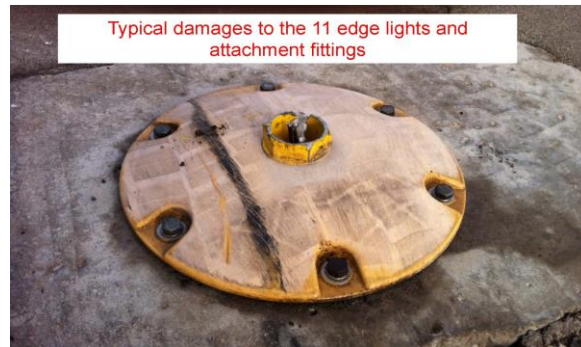
Figure 8. Typical edge light damage

Figure 8: Typical damage found to the 11 edge light base fittings that held the light fixture in position. The glass that surrounded the lights were all broken.
