AAIS Case Reference: 12/2012

AIR SERIOUS INCIDENT INVESTIGATION REPORT

TIRES' DAMAGE ON LANDING DUE TO PARKING BRAKES INFLIGHT ACTIVATION

IL-76TD
UP-I7625
Air Trast
Al Maktoum International Airport
Dubai, the United Arab Emirates
21 June 2012

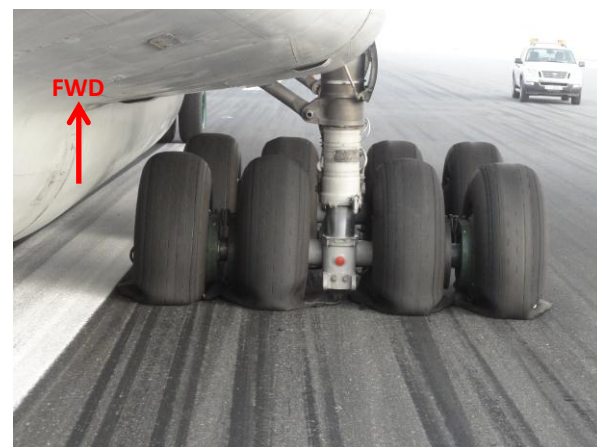
Figure 1- Skid marks at the runway

The Aircraft was intact. Each side of the deflated tires left four continuous skid marks on the runway consistent with the tires lockage. The marks changed to wider and more intense at the ends after the tires completely deflated by the friction and wear caused by the skid. (Figure 1).

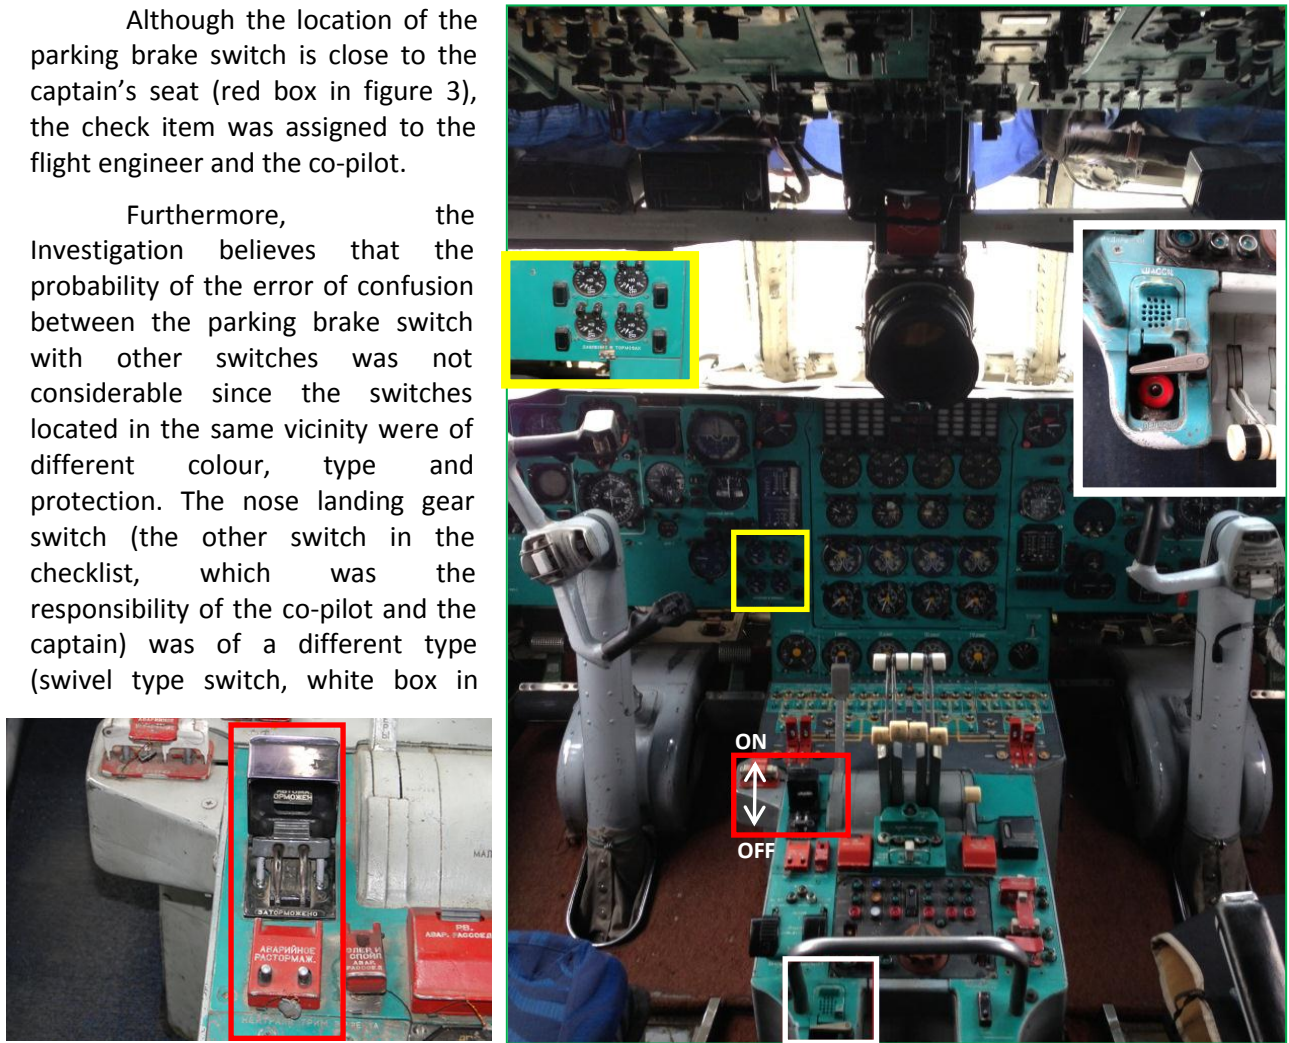
Figure 3- Central pedestal

Although the location of the parking brake switch is close to the captain’s seat (red box in figure 3), the check item was assigned to the flight engineer and the co-pilot.

Furthermore, the Investigation believes that the probability of the error of confusion between the parking brake switch with other switches was not considerable since the switches located in the same vicinity were of different colour, type and protection. The nose landing gear switch (the other switch in the checklist, which was the responsibility of the co-pilot and the captain) was of a different type (swivel type switch, white box in

figure 3) thus the probability of confusion error between the nose landing gear switch and the parking brake switch (toggle type switch) is minimum.
