AAIS Case N°: AIFN/0015/2013

Helicopter Collision with Jetblast Fence during Taxi

Operator: Falcon Aviation Services
Type: Agusta 109S
Registration Mark: A6-MSM
Place of Occurrence: Al Ain International Airport
State of Occurrence: United Arab Emirates
Date of Occurrence: 31 December 2013

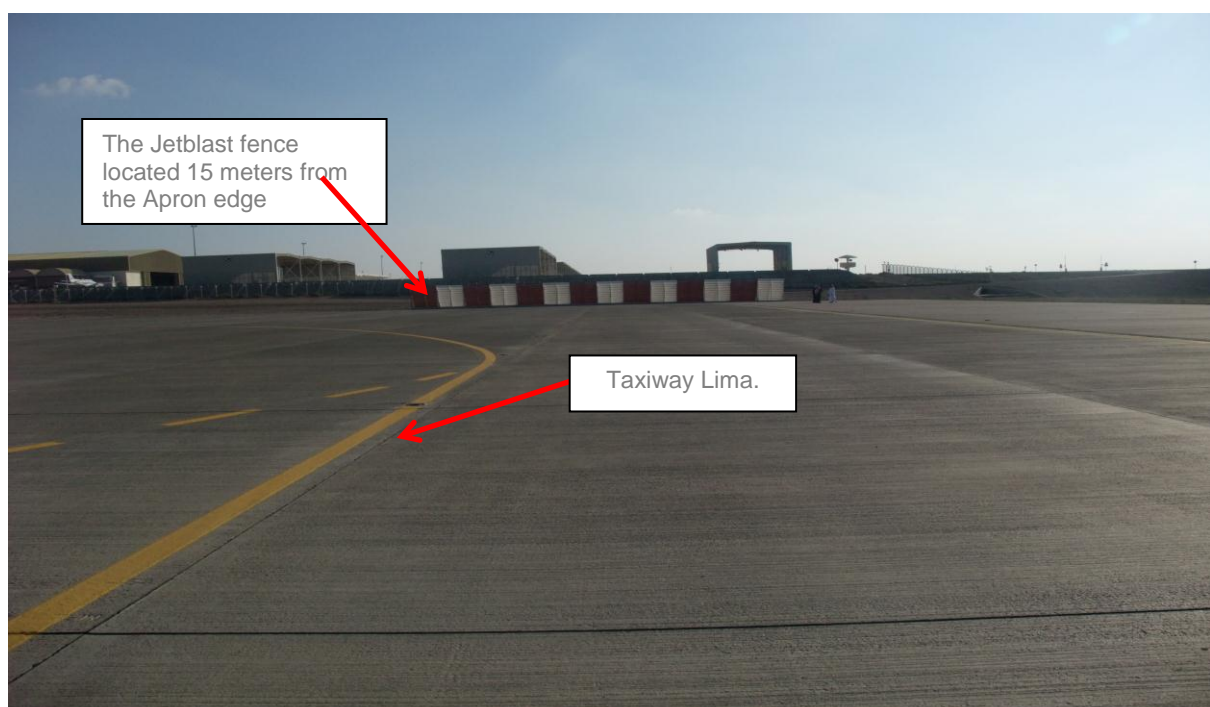
While Falcon 55 was taxiing inbound, it taxied straight ahead towards the jetblast fence, the Helicopter taxiing track did not follow the lead-in line, Taxiway Lima (Figure 1), but crossed the lead-in line to the right hand side for more than 30 meters towards Jetblast fence, at that time the ATC did not inform the crew that they are two closed to the Jetblast fence. At 02:55 UTC ATC contacted the crew and informed them that the Helicopter might have approached very close to the jetblast fence situated on the edge of the ramp to the right hand side of the Helicopter.

Figure 1. Apron area including jetblast fence, taxiway Lima and ramp

There was a stand lead-in line for the taxi phase, but the commander did not follow it, and the helicopter movement was towards the jet blast fence, which was located 48 m from the lead-in line. The Helicopter deviation towards the edge of the apron where the metal fence was located indicated that neither the commander nor the co-pilot was visually observing the taxiing. This resulted in the Helicopter main rotor blades contacting the jet blast fence which was located to the right of the Helicopter's direction of movement.

- 3.2.5 The taxiway lines were of a conspicuous color.
- 3.2.6 The Helicopter crossed the lead in line of Bay nine (Taxiway lima) at a distance of more than 48 meters, moved too close to the jetblast fence.

Enhance the crew training including the external peripheral during helicopter ground movement for taxiing and parking phases.

Improve the level of ATC visual watch of manoeuvring/taxiing areas during aircraft ground movement.
