Air Accident Investigation Sector

- Final Report -

AAIS Case AIFN/0010/2013

Runway Excursion

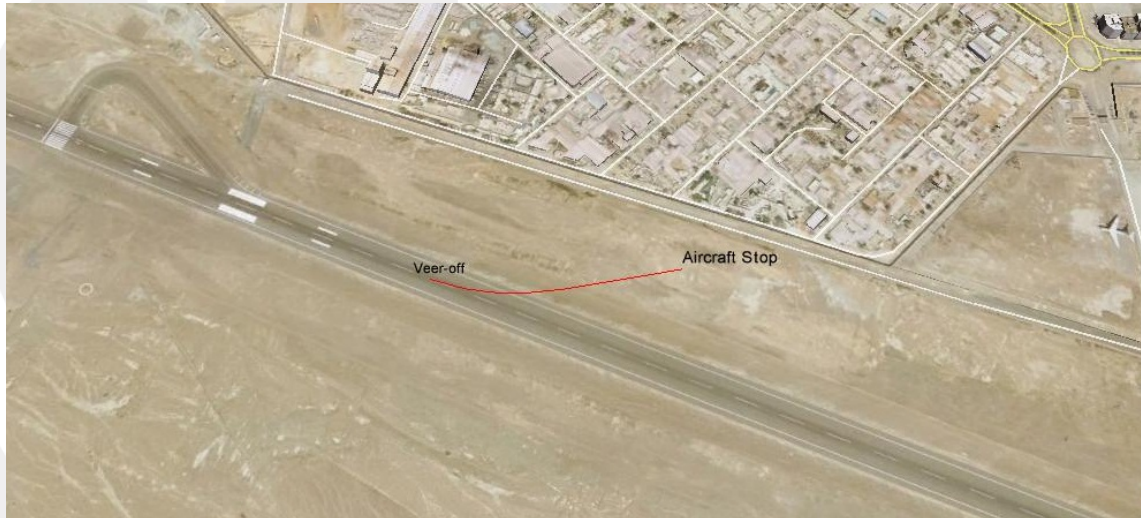
Figure 1. Runway Excursion Layout

After touchdown on Runway (RWY) 11, the Aircraft veered to the left from runway's centerline, exited the runway and continued rolling on the runway's strip. Finally, the Aircraft came to a complete stop on a point of about 359 meters from the initial veer off location.

The location where the Aircraft came to rest was at about 326 meters longitudinally and 151 meters laterally from the centerline departure point (See Figure 1 and 2).

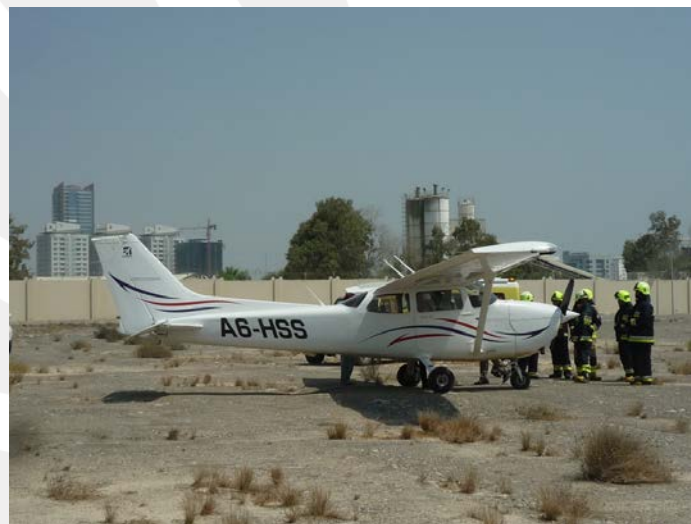
Figure 2. Intact Aircraft Rest Place

The Aircraft was intact with no revealed damage resulting from the Incident.
