# Air Accident Investigation Sector

- Final Report -

AAIS Case File AIFN/0014/2014

## Runway Excursion following Hard Landing and Separation of the Right Hand Main Landing Gear

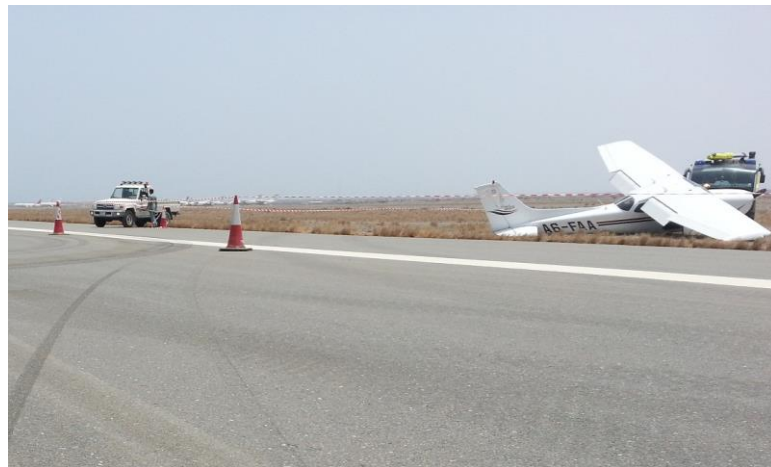
Figure 2. Accident Aircraft final position

After 30 meters veering to the right on the runway, the Aircraft came to rest about 3 meters off the runway shoulder (figure 1).

The RH MLG separated from the Aircraft due to the heavy landing. During the landing sequence the Aircraft sustained damage to the lower right hand side of the fuselage in the area where the undercarriage had separated. There was also damage to the right wing tip and bending of the right hand horizontal stabilizer upper and lower surfaces.

The right wing and right hand horizontal stabilizer control surfaces were slightly deformed due to contacting the runway. The fuel tanks and habitable living space in the cockpit remained intact.
