الهيئة العامة للطيران المدني  
GENERAL CIVIL AVIATION AUTHORITY

# Air Accident Investigation Sector

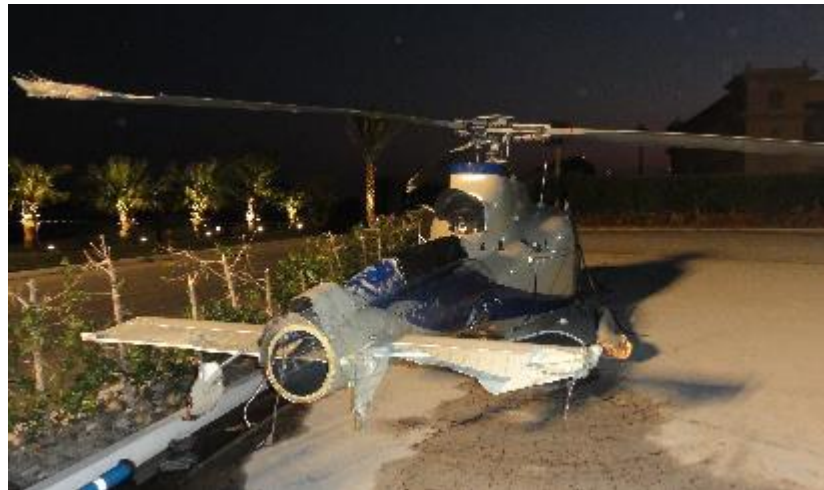
Figure 2. Aircraft on the heliport

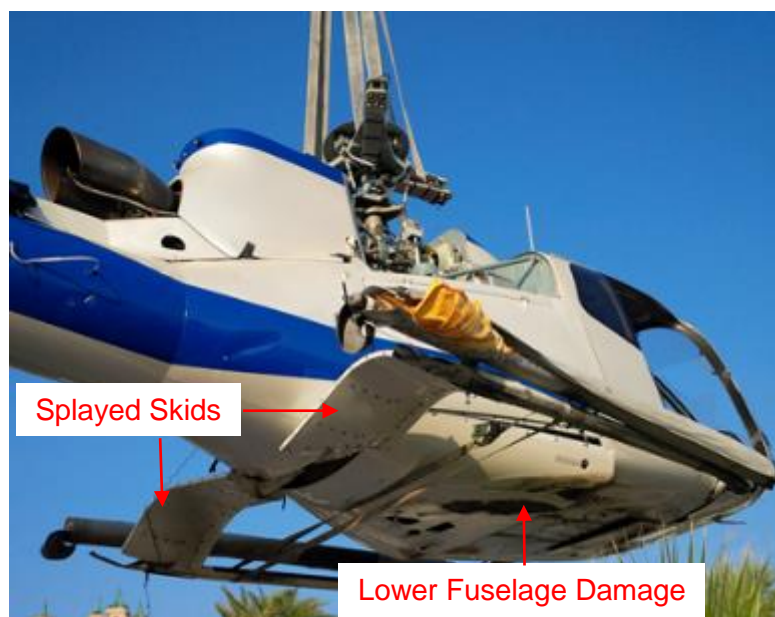
Figure 3. Lower fuselage damage

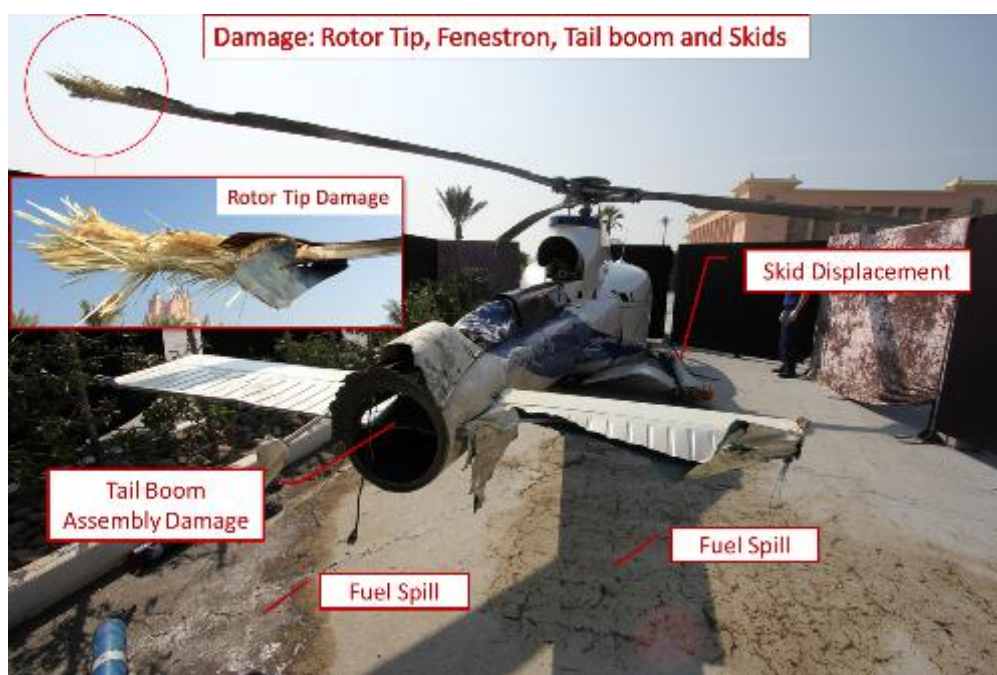
Figure 4. Aircraft damage viewed from the rear of the helicopter

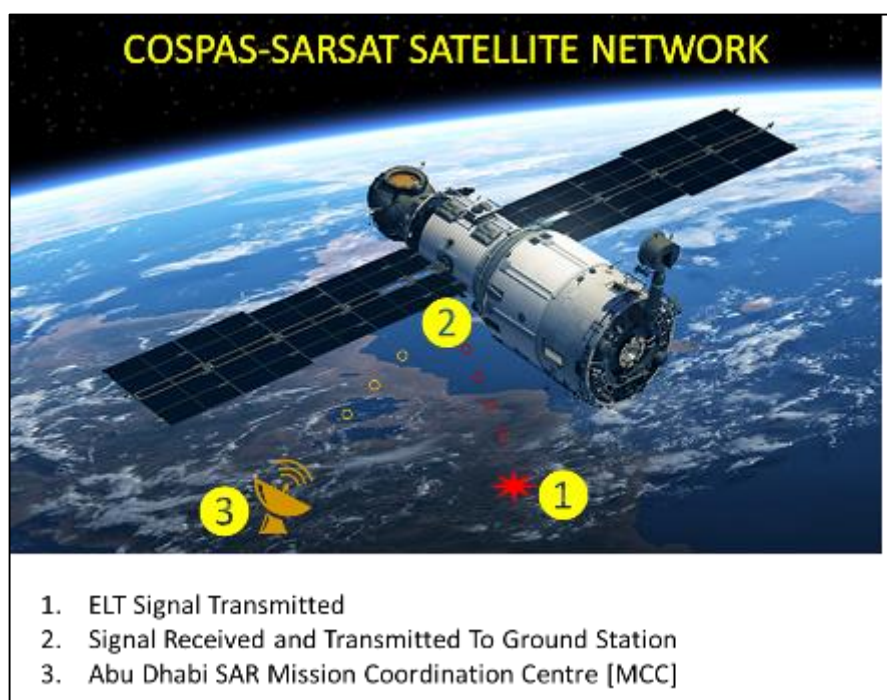
Figure 13. COSPAS-SARSAT

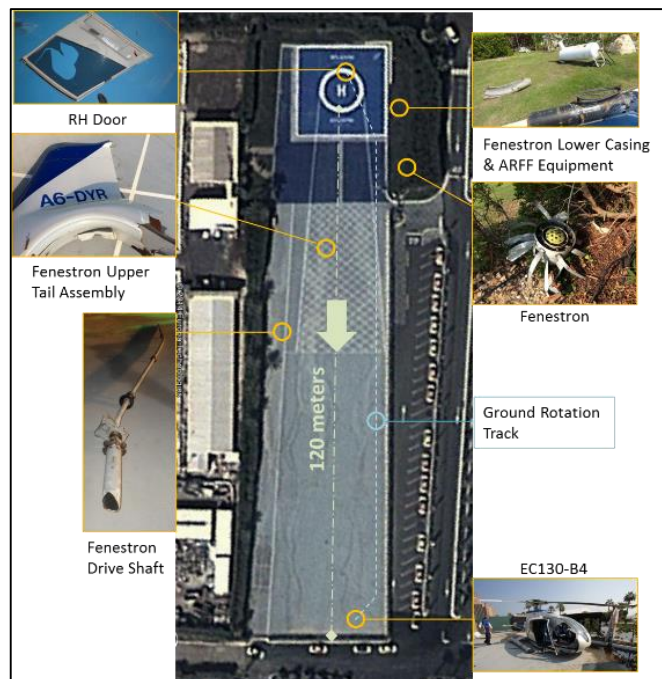
Figure 17. Debris pattern and component locations

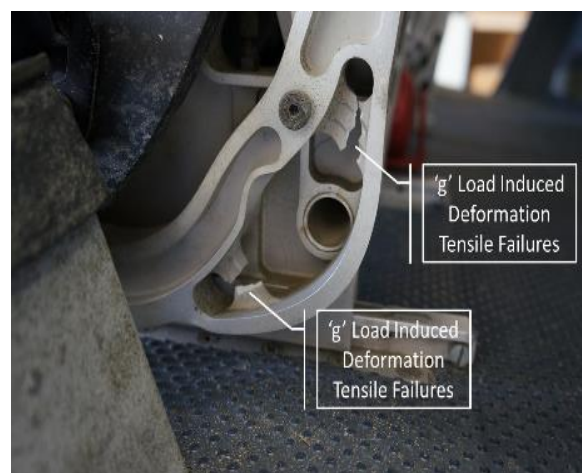
Figure 11. Pilots seat deformation/structural

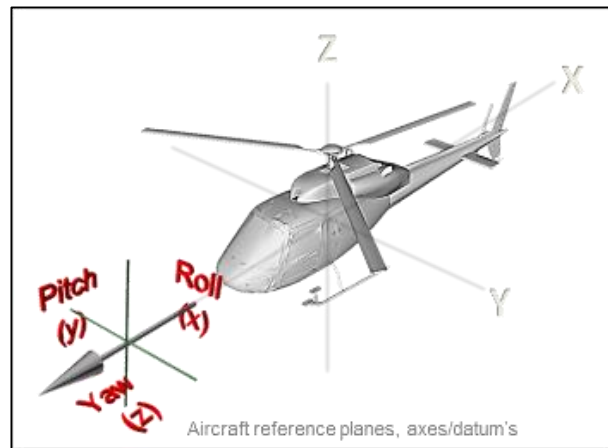
Figure 24. Aircraft reference planes, axes, datum

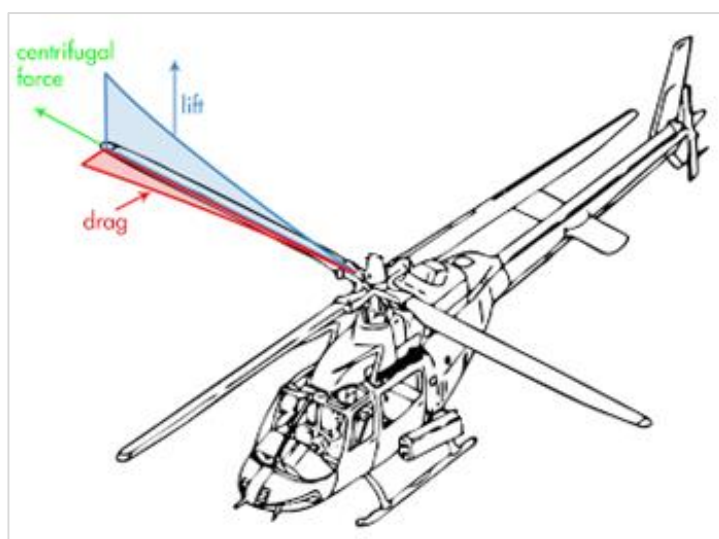
Figure 14. Rotor blade coning angle – blade force resolution

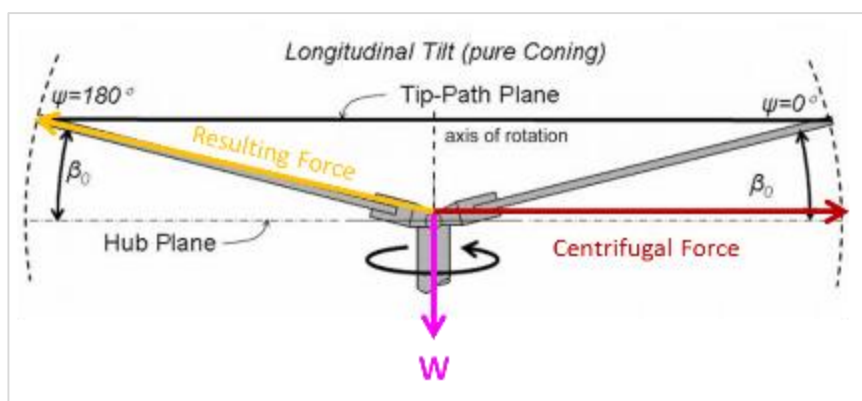
Figure 15. Longitudinal tilt coning angle

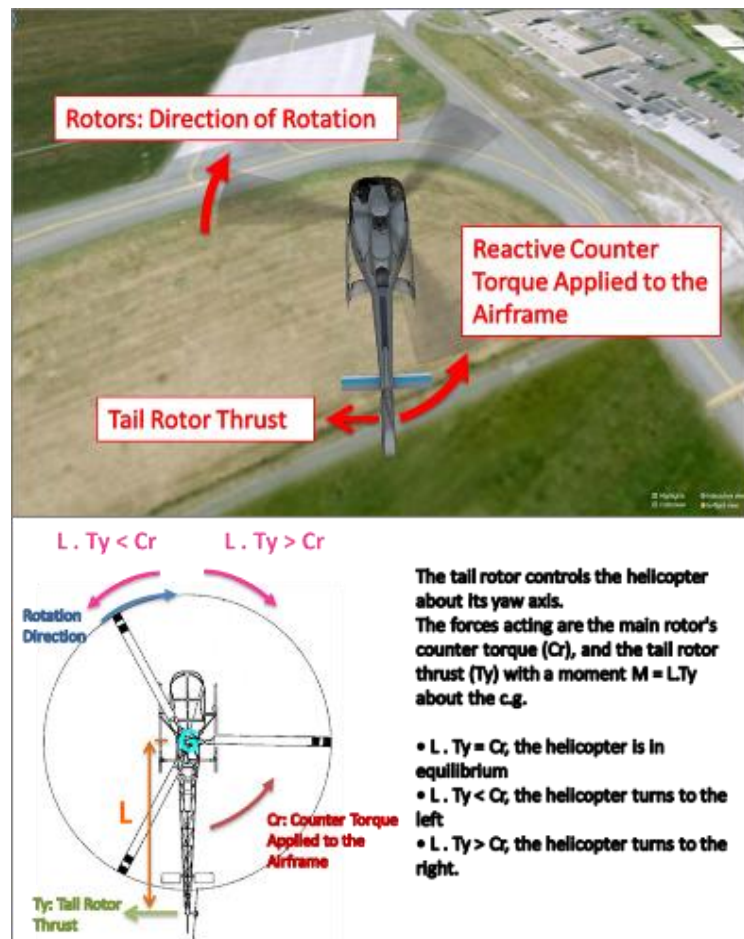
Figure 29. Helicopter control of yaw diagram

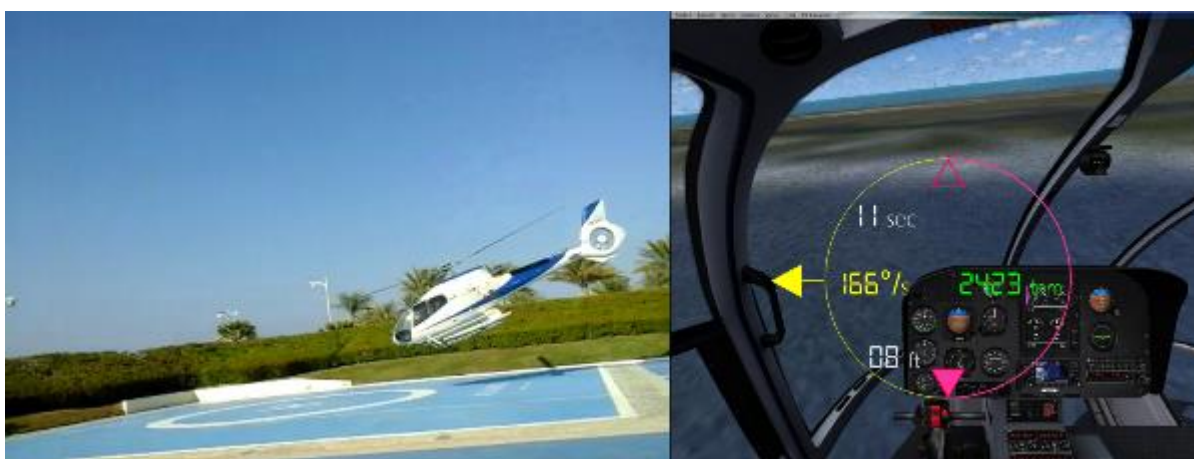
(L) The dynamic condition of the Aircraft immediately prior to the heliport impact was the following:

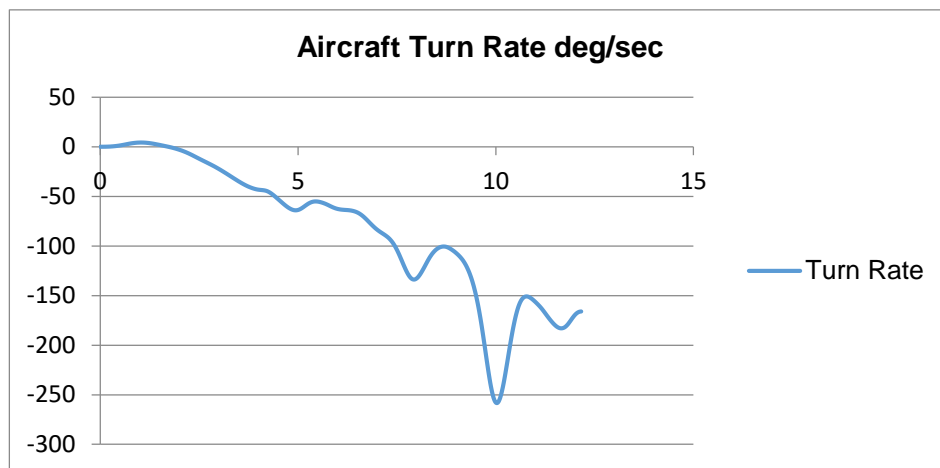
- Rate of Descent = 2423 feet per minute
- Rate of Rotation = 166° per second

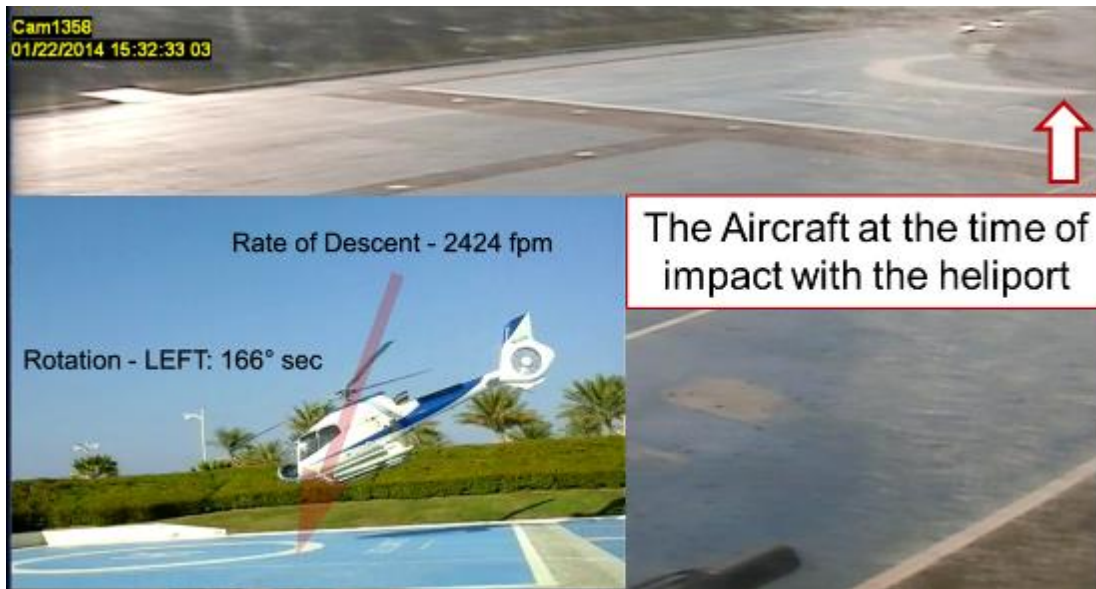
Figure 36. Aircraft dynamic condition at point of impact

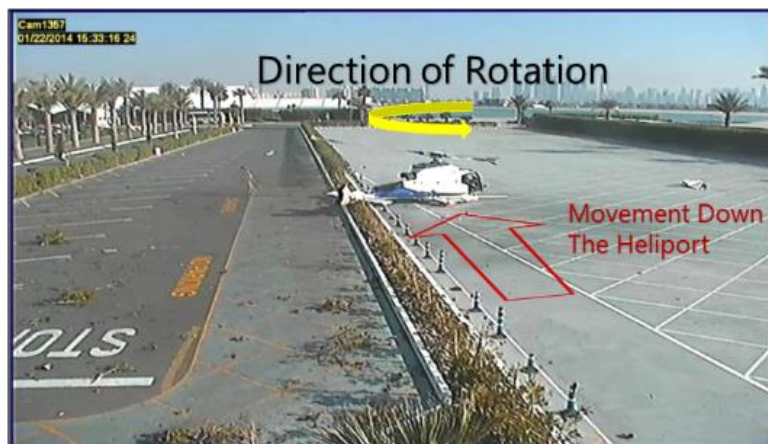
**Figure 39.** CCTV Image of Aircraft movement on the heliport

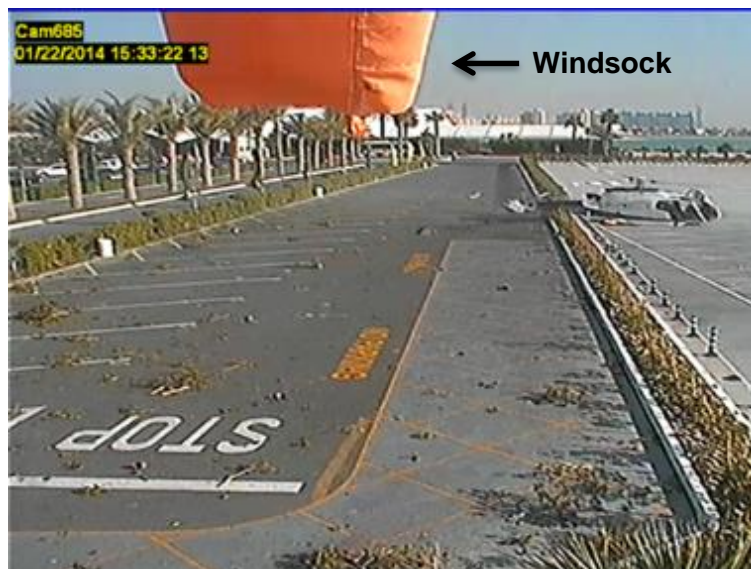
Figure 46. Wind direction indicator (WDI)

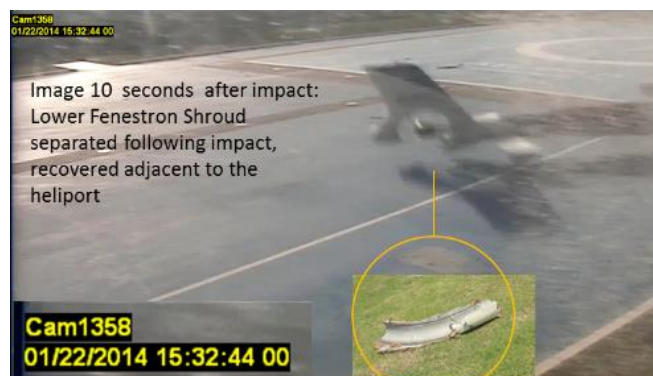
Figure 47. Fenestron shroud damage immediately following the impact

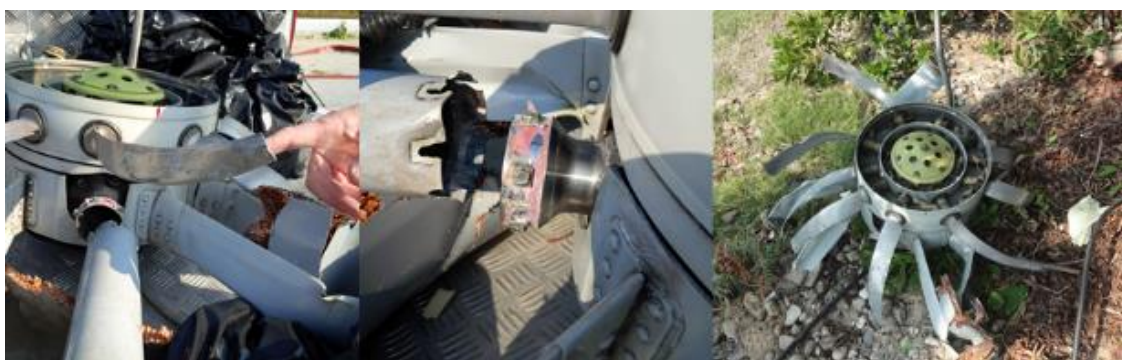
Figure 48. Fenestron and torque tube damage

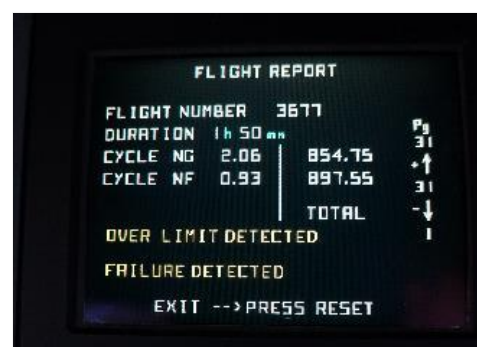
Figure 49. VEMD screen capture of the Accident

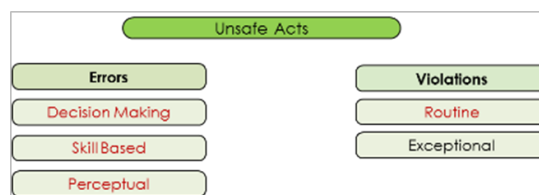
### HFACS Level 2: Preconditions for Unsafe Acts

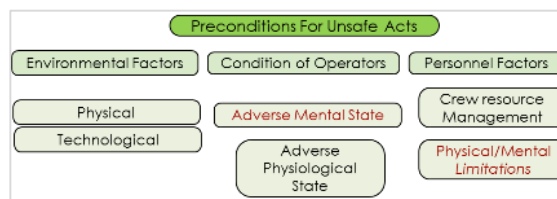
### HFACS Level 3: Unsafe Supervision

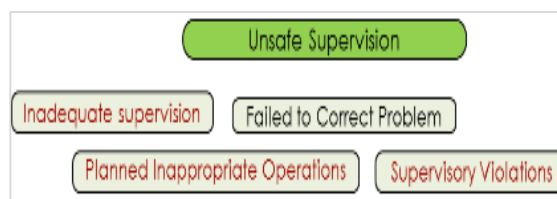
### HFACS Level 4: Organizational Influences
