# Air Accident Investigation Sector

AIFN/0008/2014

## Smoke Emission from Passenger Entertainment System Video Display Unit

Operator: Flydubai  
Type: Boeing 737-800  
Registration: A6-FEK  
Location: Enroute Dubai to Kiev  
Date of Occurrence: 19 April 2014

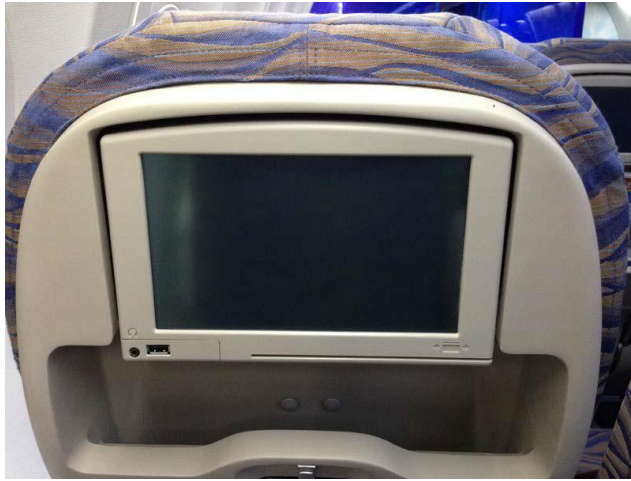
Figure 4. Seat 9A VDU prior to removal

The affected VDU was shipped to the manufacturer for forensic laboratory examination. According to the examination report, there were no external visible signs of smoke, fire, or other noticeable damage to the VDU. Internal damage was limited to the power transformer circuit board components and the area of the fuse that had overheated and emitted smoke and odors momentarily until power to the IFE system was shut off.

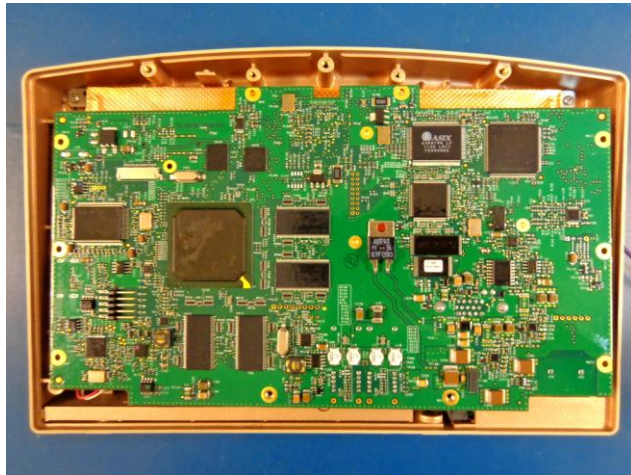
Figure 6. VDU Main CCA – bottom side

The teardown examination found that the component that had failed was the backlight inverter circuit card assembly (CCA) which provides operating power to the cold-cathode fluorescent (CCFL) backlight of the LCD display. The inverter card assembly is mounted on the main circuit card assembly as a daughter card. Its purpose is to output an alternating current (AC) high-voltage signal to power the CCFL backlight tube.

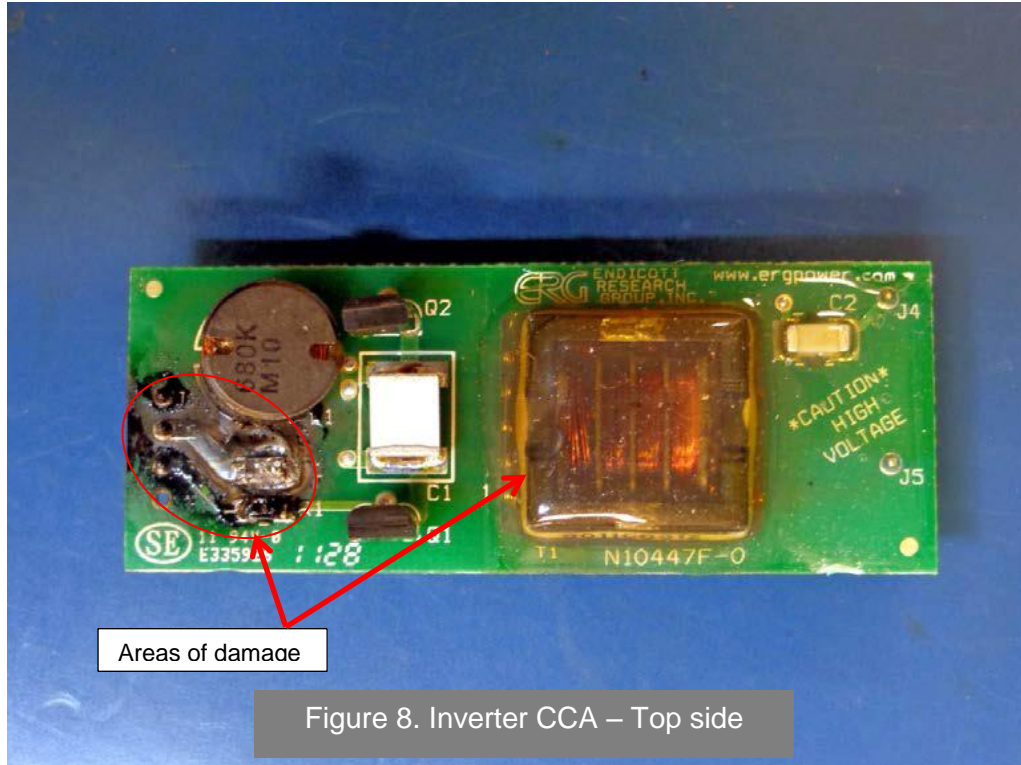
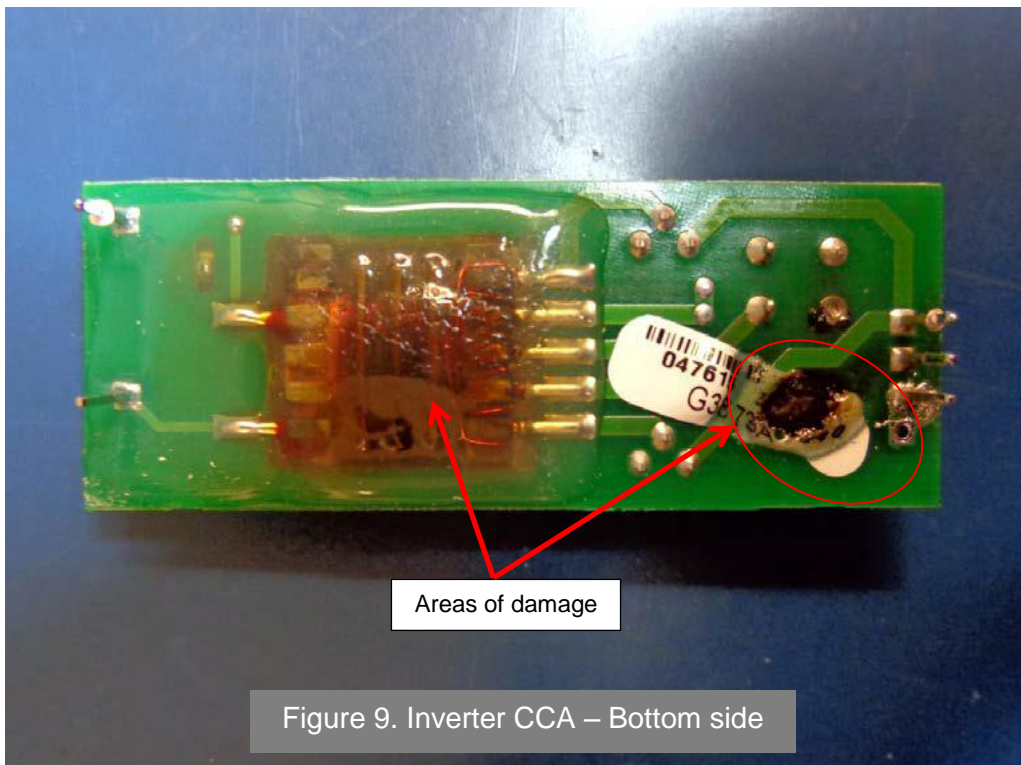
Stage 1: failure of the secondary winding of the power supply transformer, which developed a break leading to increased current demand and failure of the primary side transistor components causing a low impedance path to circuit ground through the input fuse.

Stage 2: the resultant increased input current was not enough to blow the fuse open quickly, but caused the fuse itself to heat up and smolder in that area of the printed circuit board (PCB) until it eventually opened fully.

For the in-service VDUs, and whenever the VDU is shipped to the manufacturer's facility for repair, the manufacturer will replace the existent fiberglass substrate material fuse with a ceramic body, suspended-in-air filament fuse. The modified VDUs will be recognized by the 'modification plate' located at the bottom of the VDU.

Where feasible, and whenever the VDU is removed from the aircraft for any reason; the VDU to be shipped to the manufacturer for replacement of the fiberglass substrate material fuse by a ceramic body, suspended-in-air filament fuse.
