- Preliminary Report -

AIFN/0020/2014

Loss of Control Inflight Resulting in a Heavy Landing

Operator: Falcon Aviation Services
Type: AgustaWestland AW109SP
Registration: A6-FLP
Location: Emirates Palace Hotel Heliport
Date of Occurrence: 15th December 2014

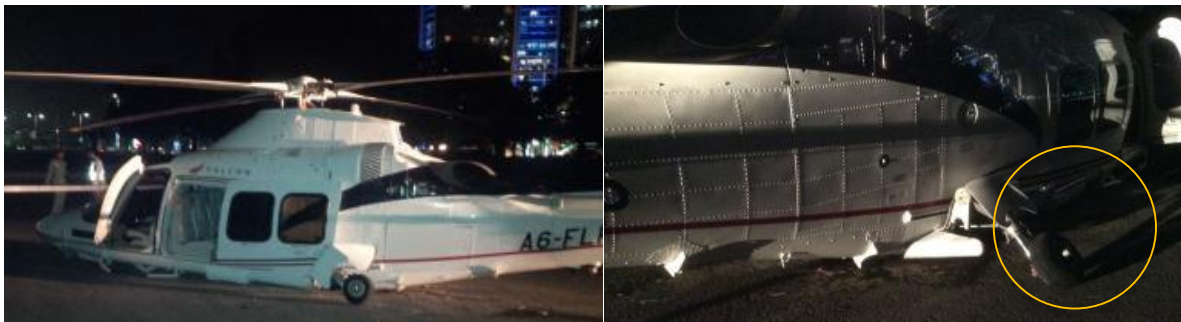
Figure 2: A109SP Accident Aircraft Damage

The landing gear forward and aft was damaged as was the tail rotor, tail rotor boom with internal damage to the tail rotor torque tube and associated surrounding structure.

The aircraft was substantially damaged as a consequence of the uncontrolled descent and abnormal runway contact⁷.

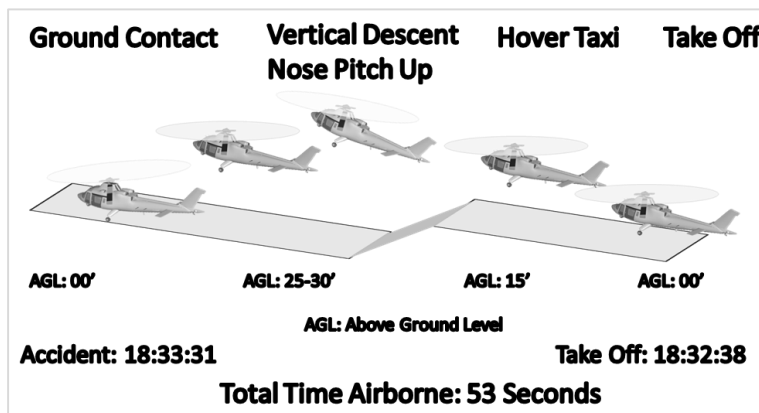
Figure 4: Simplified Accident Diagram

The accident sequence after contact with the ground is that the aircraft pitched forward, yawed/rotated approximately 20 degrees to the right before coming to a full stop with the engines running and the aircraft lower fuselage contacting the ground.

The location of the accident was on the area adjacent to the heliport, on a 045° radial from the helipad.

The simplified graphic below of the accident timeline moves from right to left.
