Air Accident Investigation Sector

- Final Report -

AAIS Case File N° AIFN/0009/2015

Cabin Crew Serious Injury Due to Turbulence

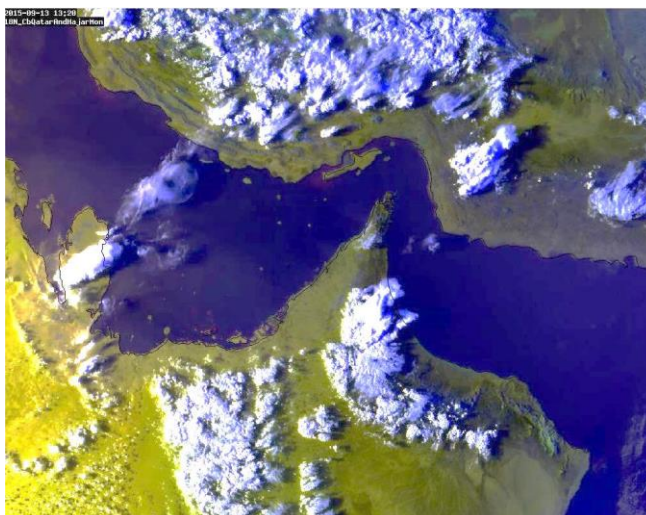
Figure 1. UAE weather at 0900 UTC

The summary of the weather at around 0900 UTC, was scattered low clouds starting to develop over the western part of the UAE to Abu Dhabi city (bases about 4,000ft and tops about 7,000ft) and towering clouds started to develop along the mountains with a base of about 3,000ft.

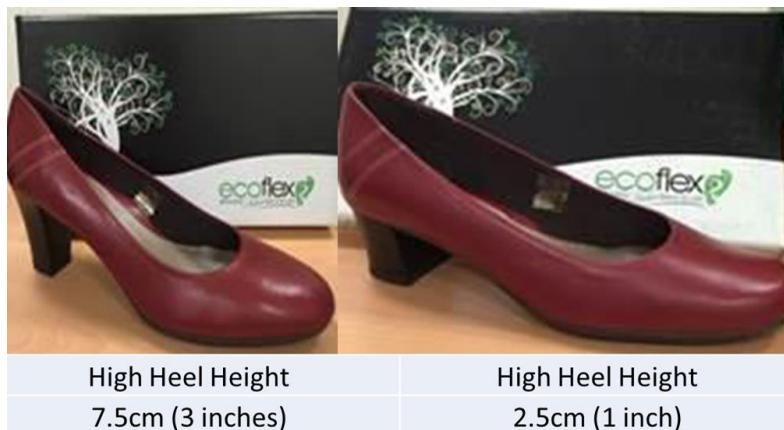
At the time of the event the cabin crewmember was wearing the heel high shoes below, 7.5cm, 3 inches high.

Figure 2. Cabin crew high heeled shoes

The injured cabin crewmember was wearing high heel shoes during the approach phase of the flight which did not provide stable support in turbulent conditions.

The injured cabin crewmember lost her balance due to the unexpected high g-force, combined with the lack of support provided by the footwear that she wore for that phase of the flight.

The cabin crewmembers' change from flat sole footwear to high heel footwear resulted in insufficient support to enable her to maintain her balance during the turbulence encounter.

The AAIS find that the risk assessment that was carried out by Emirates in May 2016 underestimated the severity of the risk and classified it as "minor" whereas the Investigation believes that the severity classification should have been "hazardous". Therefore it is recommended that the safety risk assessment be revised.

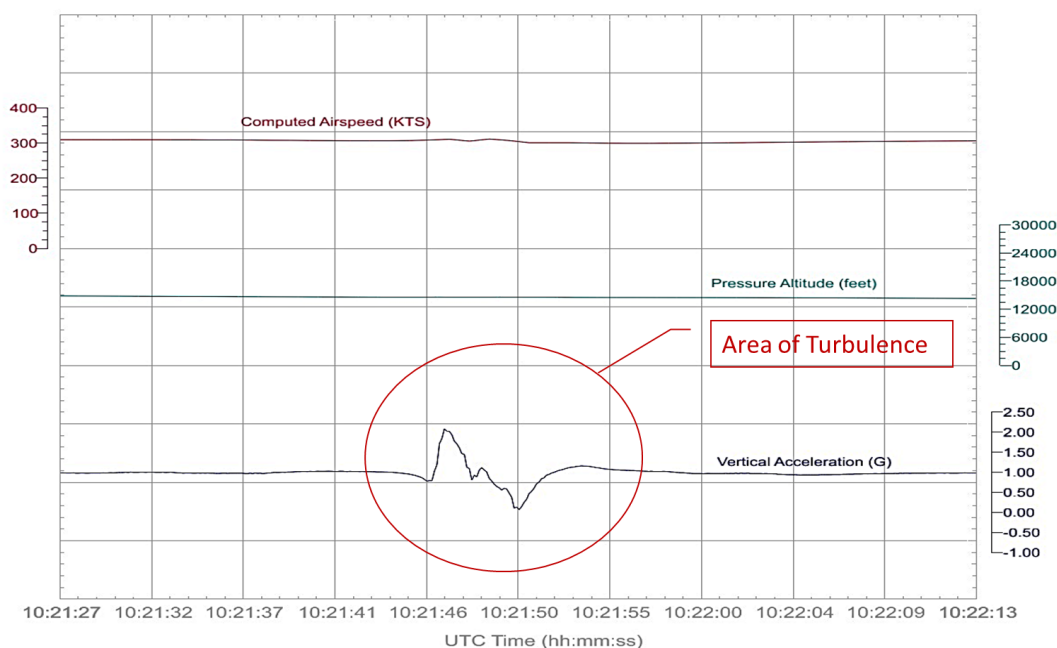
The analysis of the flight data recorder indicated that the Aircraft vertical acceleration during the turbulence encounter varied between +2.2g to +0.07g when the Accident occurred, with a corresponding minor speed fluctuation.

All parameters stayed within Aircraft limitations during the turbulence encounter.

Figure 3. Vertical acceleration loads during the turbulence encounter [Source: FDR]
